Retrofitting of Confined Brick Masonry with FRP

Salman Hameed¹, Samiullah Qazi² Muhammad Asif³, Sardar Ali⁴ ¹M.Sc. Student in Department of Civil Engineering, UET Peshawar ²Assistant Professor in Department of Civil Engineering, UET Peshawar ³M.Sc. Student in Department of Civil Engineering, UET Peshawar ⁴M.Sc. Student in Department of Civil Engineering, UET Peshawar

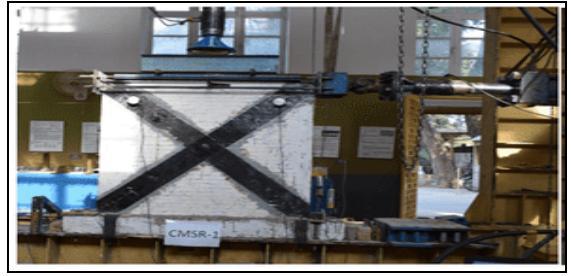
Figure 4. Load setup and instrumentation details

All the models were investigated in Structural Engineering laboratory. The bottom of specimen was fixed with stiff steel girder through bolts. Top of the specimens were kept free to allow free translation and rotation. This setup is used to simulate cantilever type setup. One actuator of 50-ton capacity was used to subject constant vertical compression load. Another actuator of same capacity was used to subject horizontal load. Vertical load was subjected on steel girder placed on 1.5" steel roller. The steel roller was roll ed on 1.5" inch thick steel plate placed on the top beam, which in turn distributed vertical load uniformly s shown in figure. Three LVDTs were connected to record horizontal displacement. LVDTs along the diagonals were also connected. Location of various LVDTs are shown in Figure 3.25. As illustrated in the figure, strain gauges were also utilized to record strain in the FRP strip at various points. As indicated in the diagram, all of these instruments were linked to a data logger machine (UCAM 70). All the LVDTs were calibrated in the UTM machine before test. Also, the load cells and data cable were checked and calibrated.
