Volume: 9 Issue: XII Month of publication: December 2021 DOI: https://doi.org/10.22214/ijraset.2021.39307

Retrofitting of Confined Brick Masonry with FRP

Salman Hameed¹, Samiullah Qazi² Muhammad Asif³, Sardar Ali⁴ ¹M.Sc. Student in Department of Civil Engineering, UET Peshawar ²Assistant Professor in Department of Civil Engineering, UET Peshawar ³M.Sc. Student in Department of Civil Engineering, UET Peshawar ⁴M.Sc. Student in Department of Civil Engineering, UET Peshawar

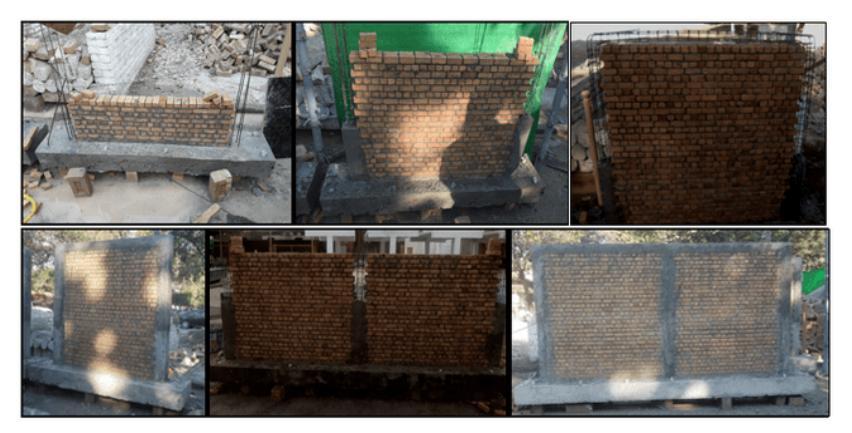
Figure 2. Models construction phases

A typical confined brick masonry walls of single bay and two bays was fabricated which replicated the walls of room of a typical building in Pakistan. The walls' dimensions were $1/3^{rd}$ scale down due to limitations of the working space available in the research laboratory i.e. (UET) Peshawar. Dimensions of the Single Bay and two bay confined masonry walls was 46"x47" and 89"x47" respectively. These walls were constructed over 6" reinforced concrete pad with pre holes provided for securing it to the floor of testing frame. The walls were built using brick masonry in an English bond pattern with a thickness of 3" (76.2mm) and a 1:6 cement-sand mortar, as is typical in the area. In order to eliminate any vertical joint in the masonry each layer of the bricks is laid in a staggered pattern 0.75" toothing was provided in every course of masonry. Walls was confined by tie column having a size of 3"x3". 4 #1 longitudinal bars and #1 stirrups @ 6" c/c were used to for column reinforcing. Stirrups were made by combining three wires of 1mm diameter of binding wire. Tie beams were casted over the walls having a size of 3"x3" and reinforced with 4 #1 bars tied by #1 stirrups @ 6" c/c.

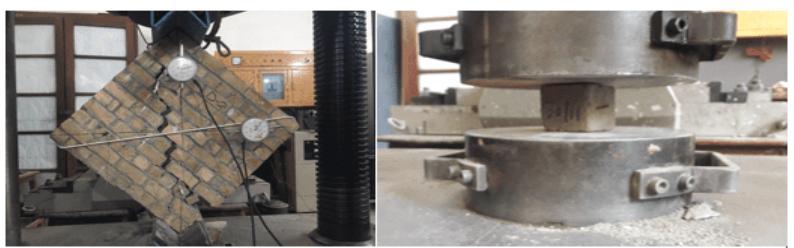
Figure 3. Diagonal Compression and Mortar Compressive Test

1/3rd scale brick of first class was selected after performing different types of tests from a local vendor. The Scale down brick replicated actual bricks qualitatively and quantitatively. After collecting all the essentials materials for the construction of walls, the second stage of experimental study was the testing of constituent materials to determine the different material properties. Compressive strength of masonry unit was calculated according to ASTM C-67 specification. Compressive strength of masonry unit was calculated according to ASTM C-67 specification. In order to measure the initial rate of absorption of brick units, Section 10 of the ASTM C-67 test specification was used. In compliance with the ASTM C-109 specification, the compressive strength of mortar used in brick masonry walls was determined using 2-inch mould. For the preparation of concrete, a standard ratio of 1:2:4 (1-part cement, 2 parts sand and 4 parts coarse aggregate) with a water-cement ratio of 0.6 was used. ASTM C39 parameters were used to measure the compressive strength of the concrete cylinder sample. The masonry tensile strength ft was obtained by testing three masonry square prism of dimension 16"x16" under diagonal compression load as specified by ASTM 519 (ASTM C1391). All the results are shown in table 1.

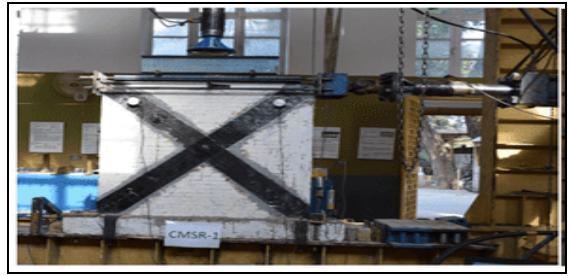
Figure 4. Load setup and instrumentation details

All the models were investigated in Structural Engineering laboratory. The bottom of specimen was fixed with stiff steel girder through bolts. Top of the specimens were kept free to allow free translation and rotation. This setup is used to simulate cantilever type setup. One actuator of 50-ton capacity was used to subject constant vertical compression load. Another actuator of same capacity was used to subject horizontal load. Vertical load was subjected on steel girder placed on 1.5" steel roller. The steel roller was roll ed on 1.5" inch thick steel plate placed on the top beam, which in turn distributed vertical load uniformly s shown in figure. Three LVDTs were connected to record horizontal displacement. LVDTs along the diagonals were also connected. Location of various LVDTs are shown in Figure 3.25. As illustrated in the figure, strain gauges were also utilized to record strain in the FRP strip at various points. As indicated in the diagram, all of these instruments were linked to a data logger machine (UCAM 70). All the LVDTs were calibrated in the UTM machine before test. Also, the load cells and data cable were checked and calibrated.

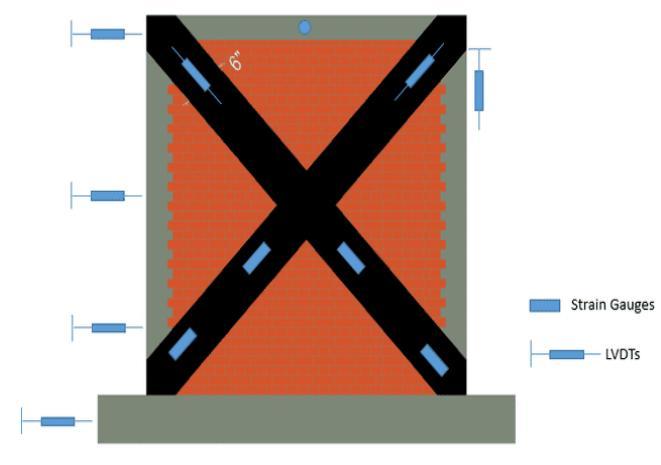
Figure 5. Instrumentation details

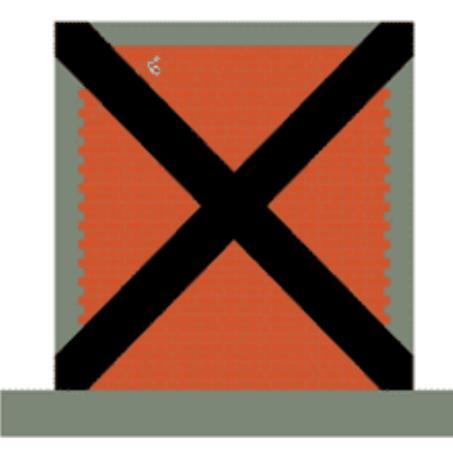
Figure 6. FRP Retrofitting configuration

FRP strips were bonded to both surfaces of damaged walls as part of the retrofitting process. Before joining the FRP strips, the cracks were cleaned with a brush and a blower but not sealed. A typical hand-held grinding machine was used to polish the surfaces of the walls. In orders to achieve uniform and proper bonding between FRP and wall, surface along the diagonal strips were levelled with chemical mortar (Ultra Fairing Coat) as shown in figure. Diagonal configuration of FRP retrofitting was considered. Diagonal strips of width 6" were bonded in each direction on both sides of the wall as shown in figure. First, one coat of epoxy was applied to wall surface, then strip of FRP was bonded to pre-coated surface. Another coat of epoxy was applied over FRP strips with help of blade. In order to avoid detachment of FRP strips and to enhance the bond performance between the FRP and masonry substrate anchors were provided. Holes were driven at specific locations and then cleaned with pressurized air. Epoxy was injected in the hole through 100 ml syringe. Anchors made from FRP fiber were inserted in the holes and then fan out on FRP strips as shown in Figure 6.

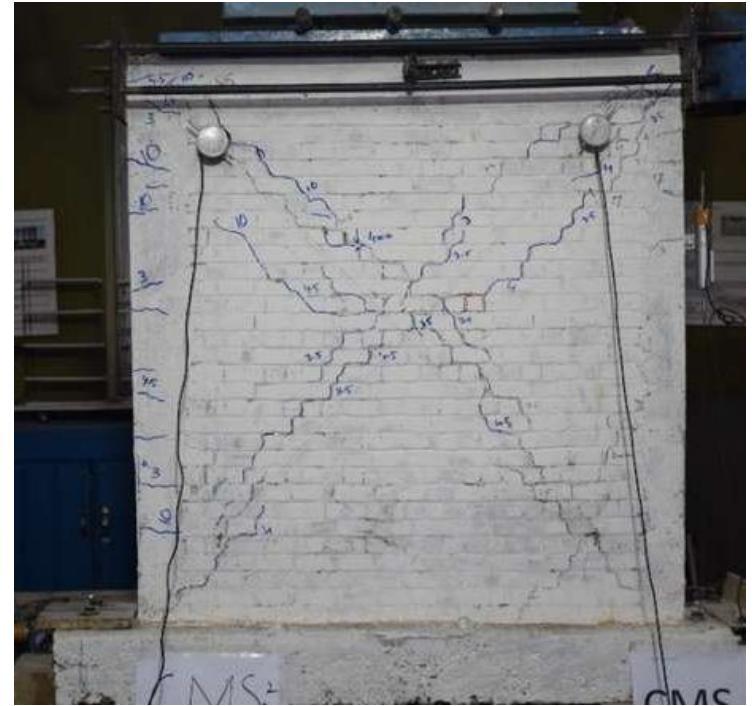
Figure 7: Damage pattern before retrofitting

A quasi-static load was performed in the specimen. The damage pattern of the specimen is shown in Figure 7. The dominant failure pattern was step crack passing through mortar joints. First crack was noticed at 2mm displacement cycle at bottom left corner. Major crack along the diagonal was started at 2.5mm displacement cycle. The cracks were mostly concentrated along the both diagonals. Cracks in the tie column was observed after 3mm displacement cycle. Some minor cracks originating from top corners were also noticed. The test was stopped at the maximum displacement of 10mm at which damages were of moderate. Hysteresis Curves and Bilinear Curve is shown in Figure 8 and Figure 9 respectively.

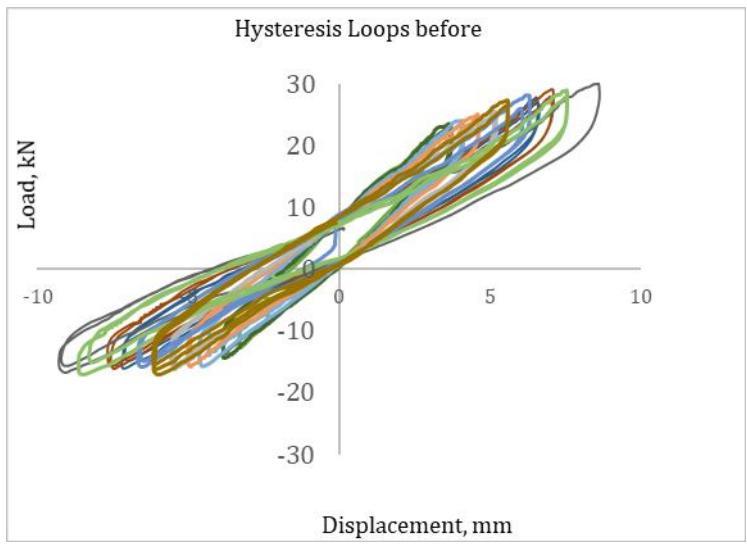
Figure 8: Hysteresis Curves before Retrofitting

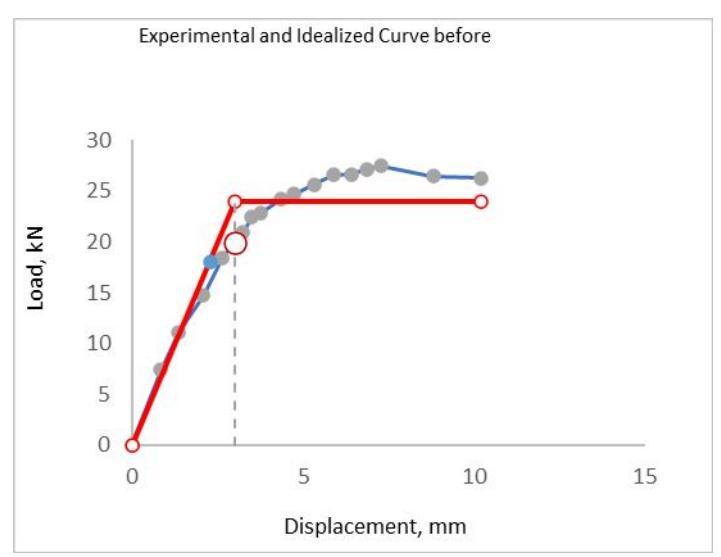
Figure 9: Bilinear Curve Before Retrofitting

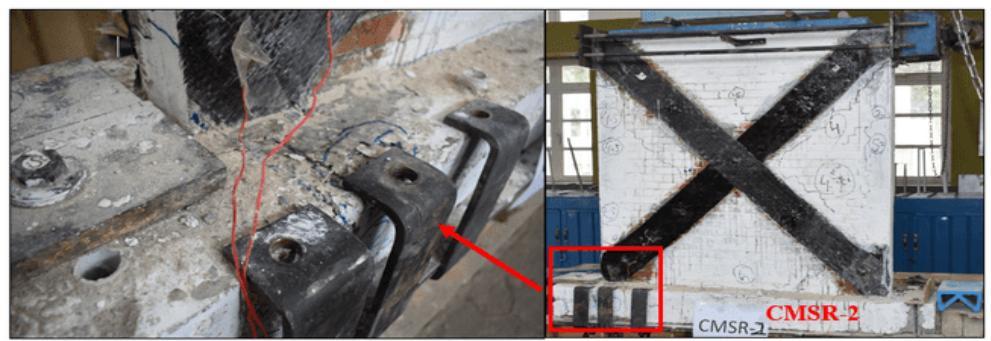
Figure 10. Crack pattern an d failure mode after Retrofitting

The damage specimen and cracks pattern are shown in Figure 10. Formation of first crack occurred when the specimen was subjected to 2.5mm displacement. At 5mm displacement a horizontal crack at the interface of masonry and footing was observed which extend toward the tie columns in both directions. A diagonal shear crack appeared in the tie column which was wide enough to be visually seen during testing. Foundation pad become cracked at the top near the bottom of left tie column. This crack becomes wide and extended toward the bottom due to increase in lateral displacement. The test was then stopped. Hysteresis Curves and Bilinear Curve is shown in Figure 11 and Figure 12 respectively.

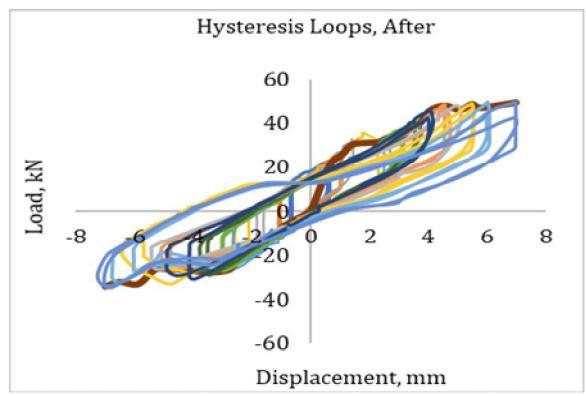
Figure 11. Hysteresis Curves after Retrofitting

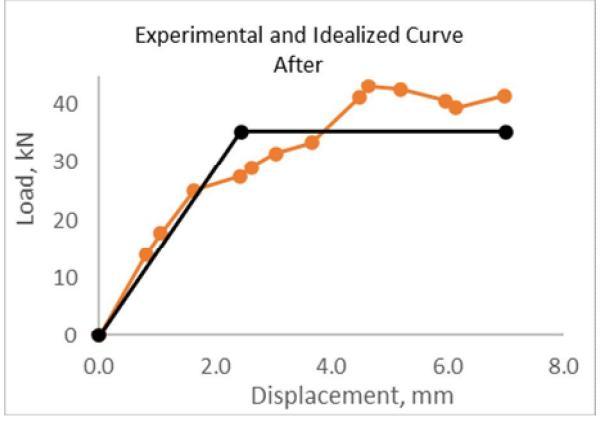
Figure 12: Bilinear Curve After Retrofitting

#	Parameter	Before	After		
1	Peak load V max (kN)	27.46	43.2		
2	Peak displacement (mm)	7.29	4.65		
3	Lateral Yield Strength, (kN)	25	35		
4	Yield displacement (mm)	3	2.44		
5	Ultimate Displacement (mm)	10.21	7		
6	Lateral Stiffness, (kN/mm)	8.33	14.46		
7	Yield Drift (%)	0.25	0.2		
8	Ultimate Drift (%)	0.86	0.59
