Volume: 5 Issue: XI Month of publication: November 2017 DOI: http://doi.org/10.22214/ijraset.2017.11087

Advanced and Improved Non-Destructive Method for Rail Axle Inspection

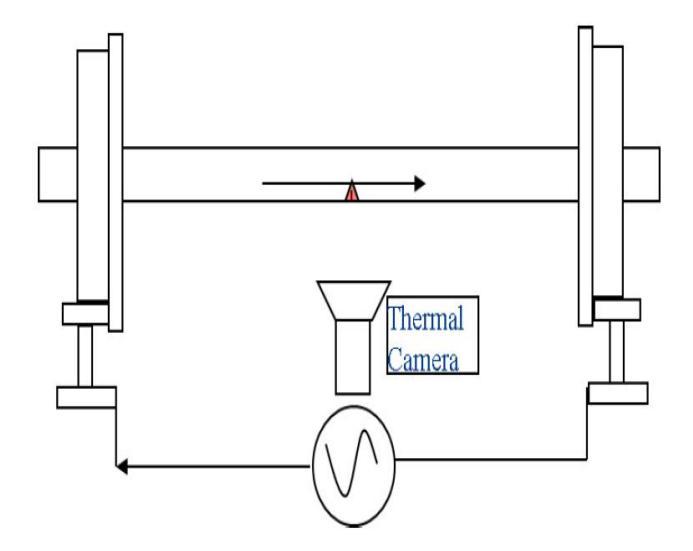
Fig 1 Principle of AC thermography technique

A high frequency electric current is passed through the axle when it passes over the inspection station, causing it to heat slightly. The current flow is distorted near a crack and this result in a different heating pattern. This method which is very sensitive and capable of detecting cracks of 0.8mm deep, only if the right conditions can be reached.

The main concept of this method is shown in Figure 1.

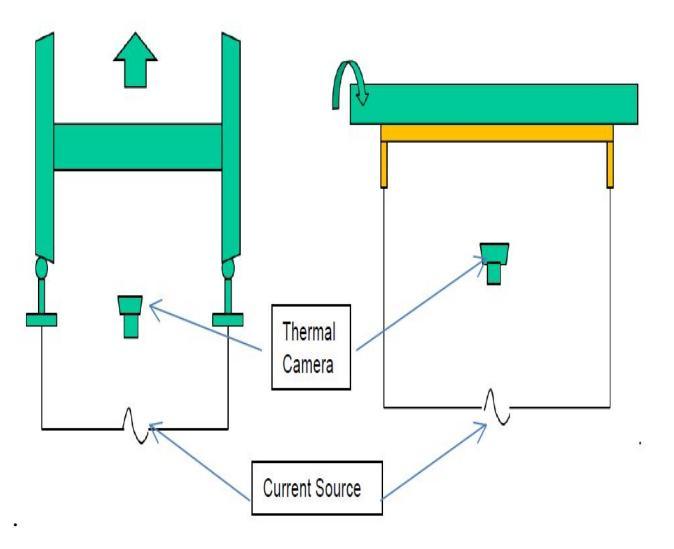
Figure 1 Configurations of the induction system

Left: track mounted system using direct AC. Right: axle mounted on rollers and workshop using induced AC. he project was attempted using modelling and with practical trials, which are described below.

However, to inspect a moving axle, the electric current has to be passed directly through the axle and this can be shown in below figure.

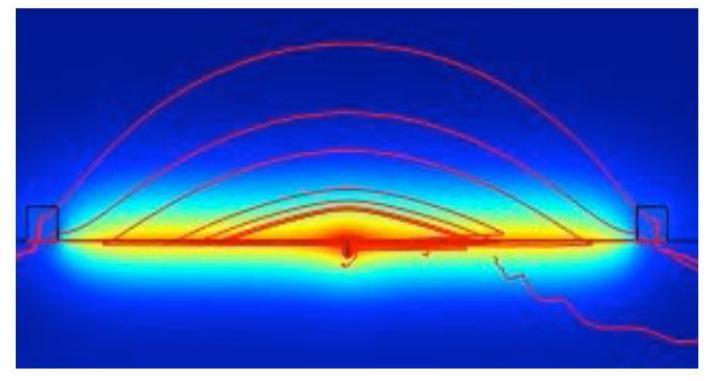
The crack gap was set at 100µm and the heating time was up to 3s. The potential at the electrodes was set at 1V (meaning that the current was less for higher frequency). 2D models were used first. Figure shows a typical result.

Fig 2 Showing heating and electric field for 20 KHz, 2 mm deep crack

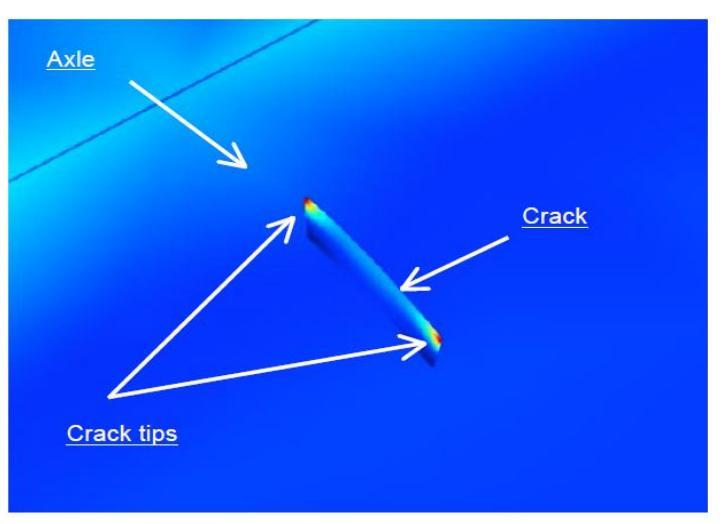
An Indication of crack through 2D models was successful to some extent but could not give a full explanation of crack depth so for this purpose 3D full size model was attempted. The potential shown by the 2D model resulted in 3D model for full axle which proved successful and this result output is shown in the following figure.

Fig 2.1 Figure showing the result output from 3D model

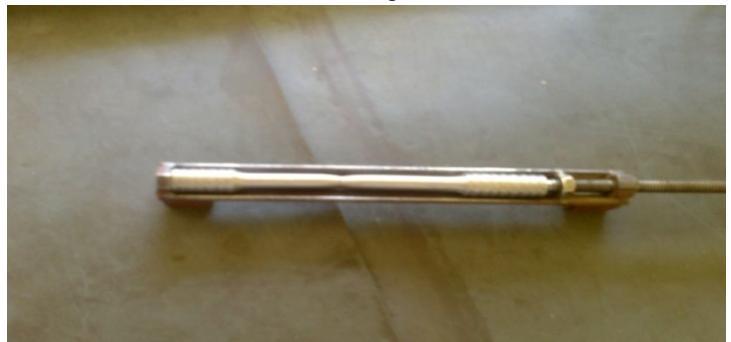
Experiments were carried out in two ways first on small scale, second on large scale full axle. This is as followed. Specimen used i.e. Steel bar of 20mm diameter is as shown in below figure

Figure showing the steel bar of 20mm diameter

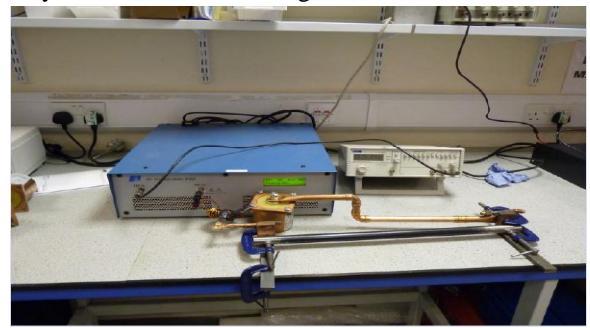
To carry out the small scale, set of three samples of 20mm steel bar were manufactured with fatigue crack of different size of 0.9mm, 1.7mm and 4.3mm deep. This fatigue crack depth was accurately measured by ACPD i.e. An ACPD method has been developed as an NDT technique that can accurately characterize surface breaking fatigue cracks in metal specimens. The required high current was able to pass through them by means of direct heating.

Direct Heating setup for a small scale sample

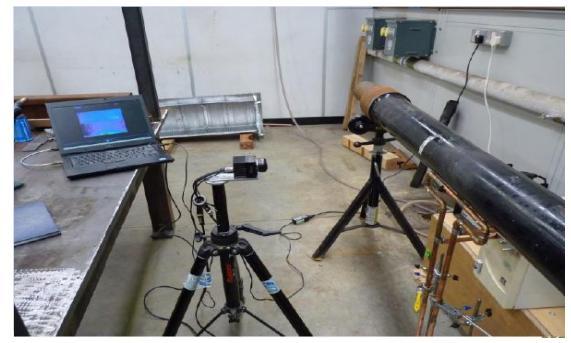
The mode of heating to this setup is through induction system. The full scale arrangements for an axle by induction heating system is shown in below figure

Figure showing the complete Induction method of full axle setup.

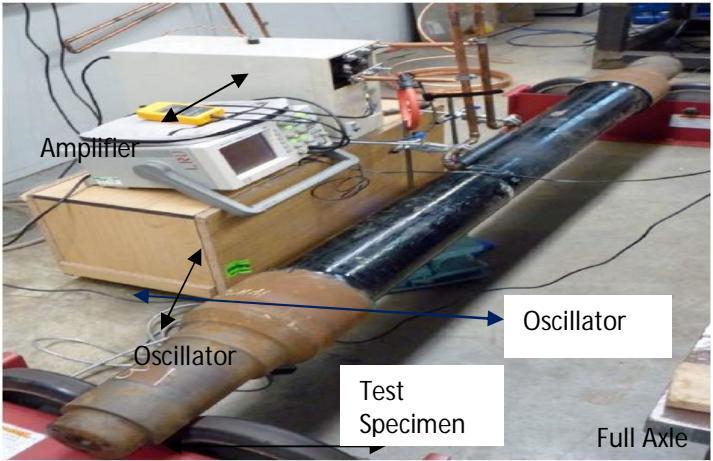
Figure showing the Induction type of heating system.

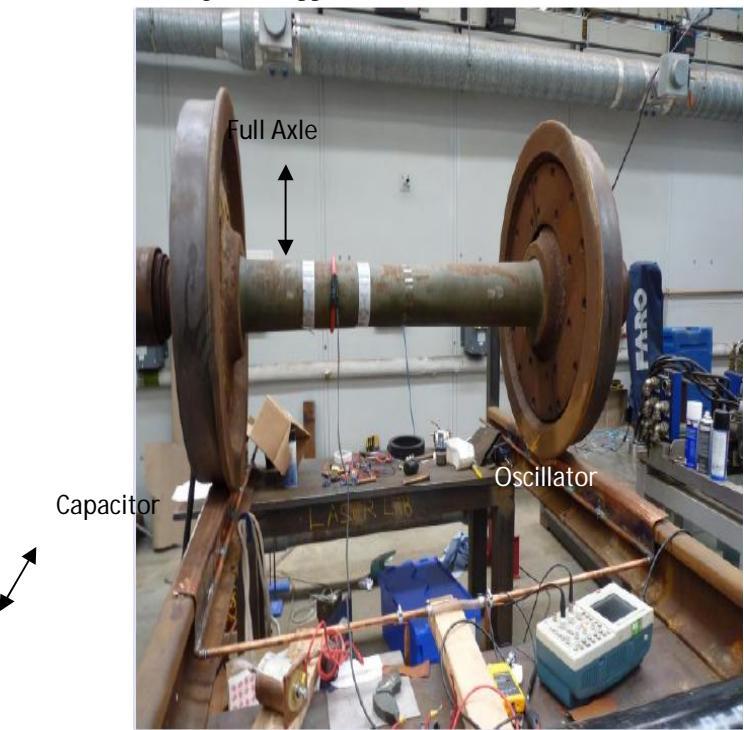
Investigations were carried out for the total view of field of the thermal camera. This was done by making a practical trial of experiment by conducting on full scale working axle. Application of direct current on full axle is as shown in figure.

Direct Heating of Complete Wheel set (Front View)

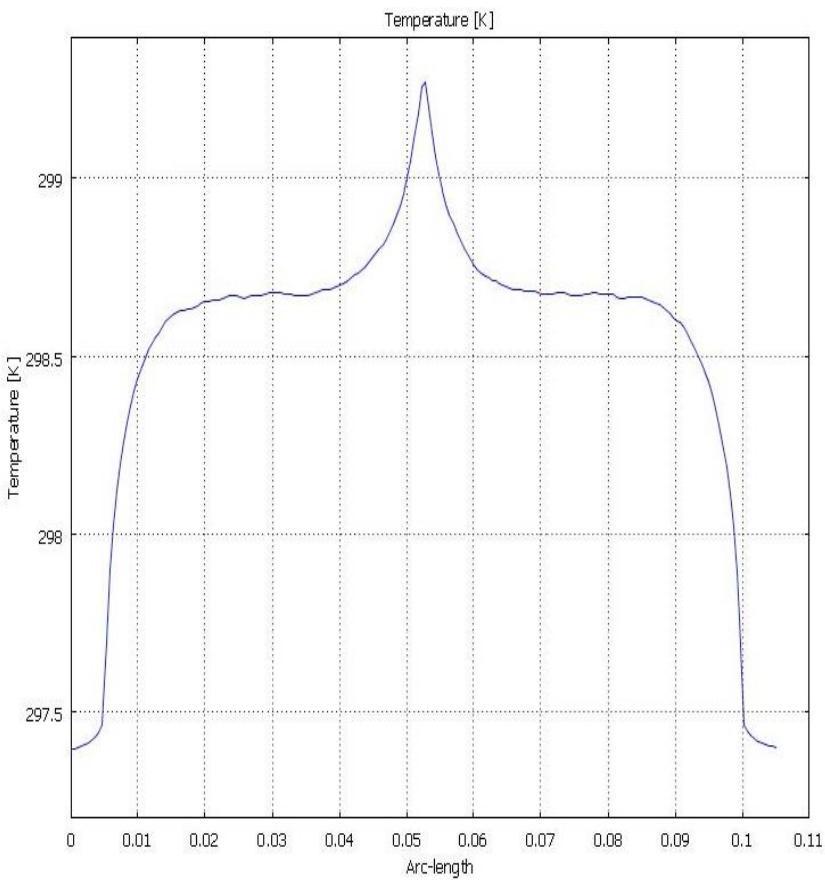
Graph2.1 Showing Surface temperature with 2mm deep crack at 100 KHz.

From the above graph 5.1 we can clearly detect the crack. It shows in X-axis the applied Temperature in Kelvin, it shows that the surface temperature is 298.65°K and crack temperature to be 299.25°K. In Y-axis is the arc length ie the length of the crack depth from the surface. This is shown in below table 2.1.

By looking at the figure 1.6 we can't understand the concept of the method and Probabality of crack detection, so to detect the crack in more easy way a cross section of the crack was taken to get a better idea and this is shown in the below figure .

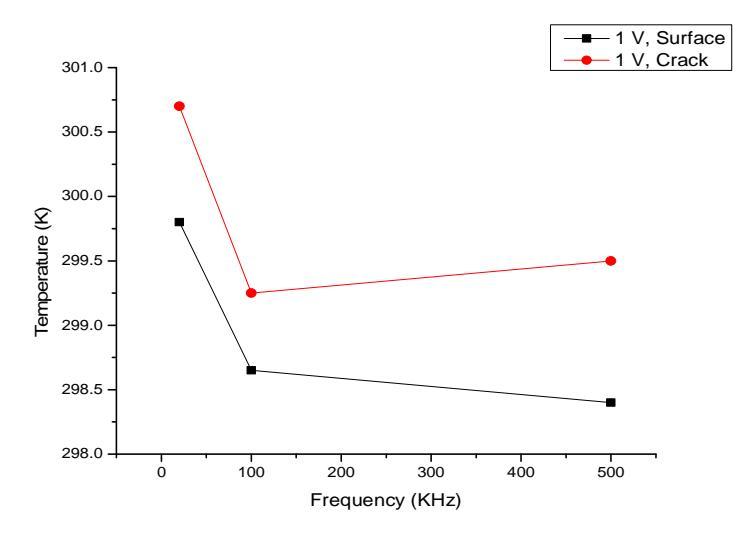
The above results were plotted in the graph 2.2 and the following results were obtained.

Graph 2.2 Crack and Surface temperature Comparison of 2D models.

From the point of view of discrimination the 2D models Showing the Graph 5.2 and Graph 5.3 it appears to be advantage to use as a high a frequency of 500 KHz and potential of 2 V. This gives the better crack detecting probability i.e. Crack temperature being 307° K as the surface temperature being 302.5° K.

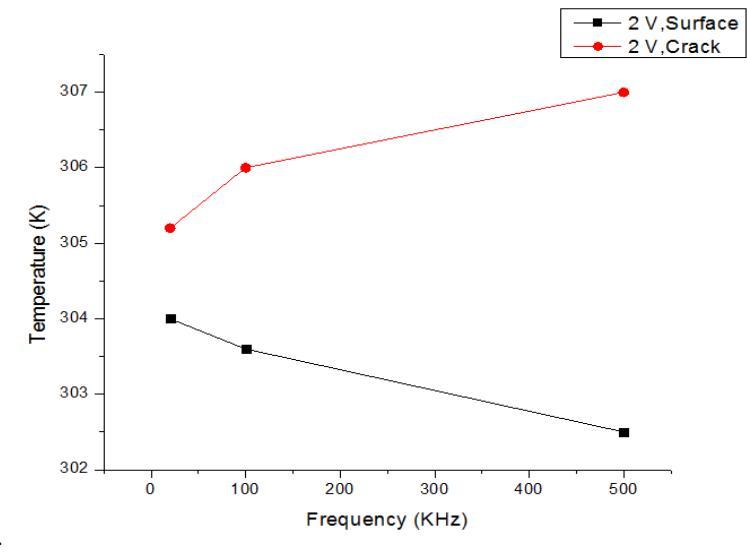
The results were observed by plotting the contents of above table 2.3 in the graph

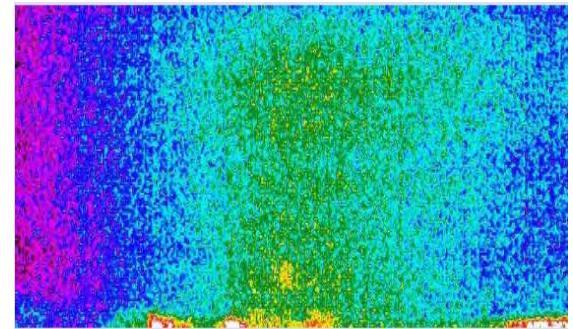
The above figure 5.1 was not pictorially clear to recognize the crack points, so the next sample of 1.7 mm fatigue crack was used again by direct heating. Again for this to no proper visibility was seen. This is shown in below figure 3.2.

Fig 3.2 Showing the fatigue crack of 1.7mm of 20mm diameter steel bar.

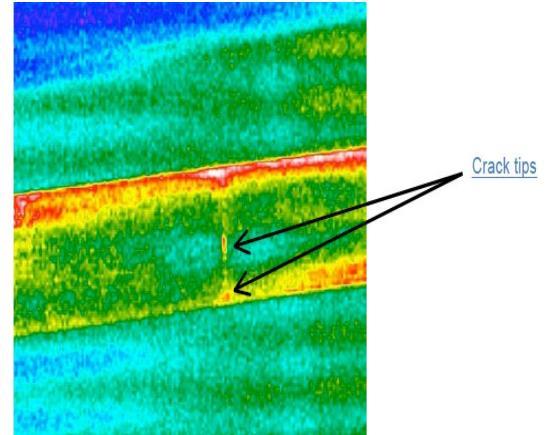
So the final sample of 4.3mm fatigue crack of steel bar was taken and experiment was carried out with direct heating. Using Thermoteknix 310L camera the thermal image was taken and could get satisfaction result of detecting the crack tips, which were morenoticeable than the rest of the steel samples. This result is seen in the below figure 3.3.

Fig 3.3 Crack tips are easily noticeable in 4.3mm fatigue crack of steel bar.

From the above figure 5.3 we could easily distinguish between the three samples of steel bar of 20mm diameter. Crack can be easily noticeable in 4.3mm fatigue crack of steel bar because reason is simple, when current is passed across the steel bar by direct heating the crack gets heats up due to this reason the crack tips can be seen. This is shown in the above figure 3.3.

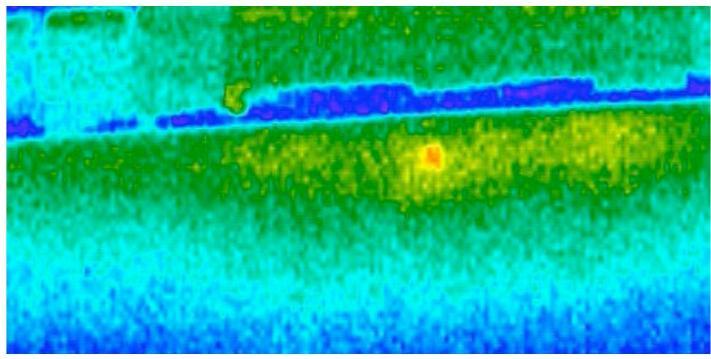
An Axle is made to rotate on its axis as shown in figure 4.11 by a set of rollers connected at the end. This is done to completely cover the axle surface without missing any portion of the surface. A thermal image was taken to see any crack defect in the full axle, by scanning the whole axle. The visibility of hot spot from crack end was seen. This is shown in the below figure 3.4.

Fig 3.4 Clear view of Hot spot from crack end.

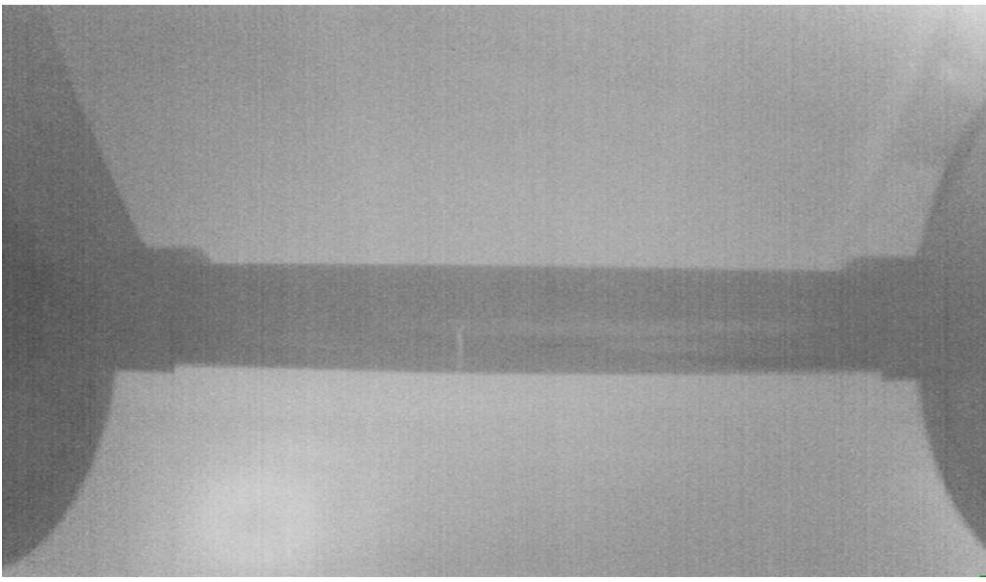
The above image was not still clear so it was magnified and again seen in the camera and could see a small thread like warm wire on an axle as shown in figure 3.5.

Fig 3.5 Showing warm wire on an axle surface.

Axle length between the wheels could be easily viewed by the thermal camera and to detect heat sources so as to check with its sensitivity provided they were above 1mm in size.
