Volume: 7 Issue: IV Month of publication: April 2019 DOI: https://doi.org/10.22214/ijraset.2019.4212

# **Advanced Road Safety for Ghat Roads at Amboli**

Prof. A. S. Manjarekar<sup>1,</sup> Rushikesh Majale<sup>2</sup>, Preetkumar Patel<sup>3</sup>, Indrajeet Patil<sup>4</sup>, Prajakta Dudhal<sup>5</sup>, Dhanashri Chavan<sup>6</sup> <sup>1</sup>Assistant Professor, Civil Engg. Department, <sup>2, 3, 4, 5, 6</sup>Student of Final Year B. E. Civil Sanjay Ghodawat Institutions, Atigre, Shivaji University, Kolhapur, India

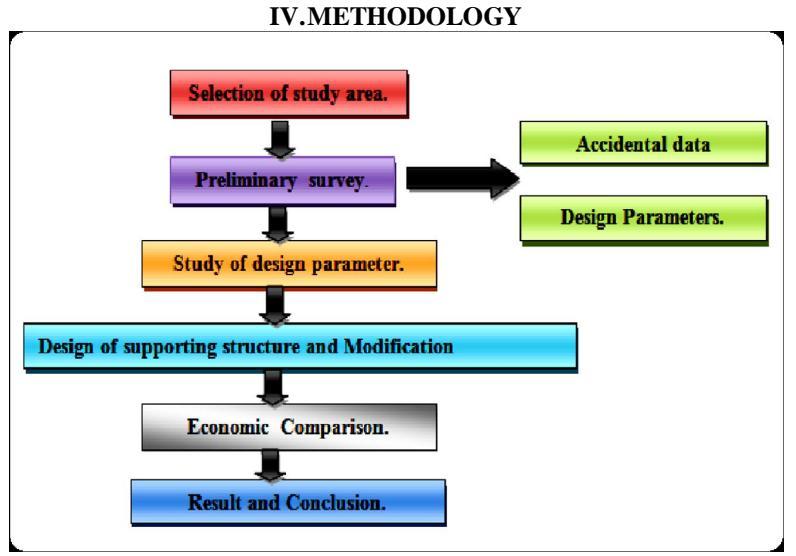
Fig no.1- Methodology

Activities which are taken grouped to prepare the detailed project report as shown in fig 1. The data collected from preliminary survey including secondary sources have been collected, compiled and analysed. The designs solutions on predefined proposed route are provided to make safe drive.

- 1) Step I: Selection of study area: First, after analysing different roads, traffic conditions, flow of traffic, causes of accidents we choose the Amboli ghat as our study area (which is from Amboli to Danoli is 13.8 km)

- 2) Step II: Preliminary survey: We divide the preliminary survey in 2 phases
- a) Accidental data
- b) Design parameters.
- *i*) Accidental data- for collecting this data we took the interviews of local, tourists, security officials and also collect data about accidents from police station.

- *ii)* Design parameters- for this we conduct actual survey on existing road and design parameters. We check are as follows; superelevation, camber, gradient, available visibility by eye estimation etc.

- *3) Step III: Study of design parameters:* After collecting the data from the field we check the parameters by comparing with standard given by IRC from that we come to know present condition of the road and what are the modifications required.

- 4) Step IV: Design of supporting structure and modification: After analysing the condition of road, present condition of guard rail, retaining structure over there we find out that guard rail, retaining structure are not properly maintained, Road sign boards are also not in good condition some are in good conditions but some required to be properly maintain

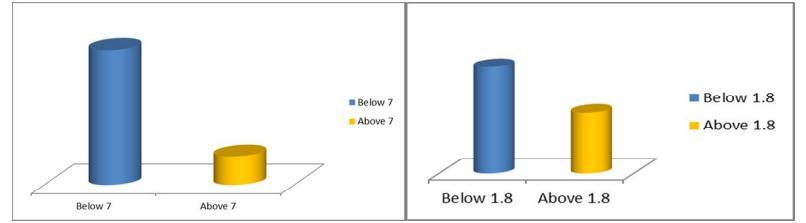
Fig no.3- Variation of carriage way width

- *a)* Width of carriage way:-Width of carriage way was measured at an every interval of 0.5 km. At also at curves. By using measuring tape, it was measured in to in distance between side margins of road in metric unit. As per IRC 52-2001 carriage width for NH double lane is min 7 m, but in Amboli there was very much variations.

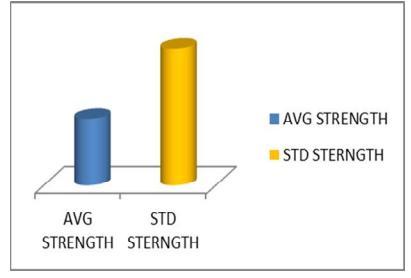
Fig no.5- Guard rail strength

- *e)* Strength of retaining wall and guard rail: By the use Rebound hammer we conducted NDT test. Strength of the RCC retaining wall was known directly by the rebound hammer very accurately.

- *d)* High Speed collision on guard rail: In case of Amboli accidents cause due to the low strength of existing guard rail. Material used for guard is not strong enough to take impact. Most of the guard rail is covered with algae, which is not acceptable. Guard rail must be strong but at Amboli guard rails are not well maintain mostly made up of 'chira' and stone masonry.

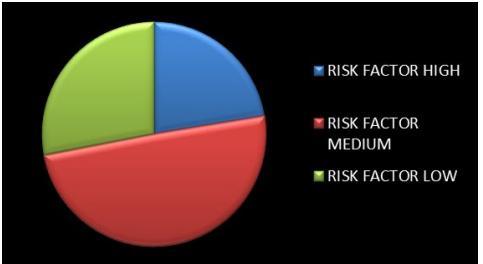
Fig no.6- Risk factor

For provision of solution we categorized this ghat into 3 stages, based on risk factor and vision factor. The risk zones are divided on the basis of various factors such as physical road conditions, intensity of curve i.e. sharp curve or smooth curve, critical points in ghat sections like waterfall, sunset point etc. There are total 107 curves are present in that some curves are critical as like hairpin bend and some are less critical.

- 1) W- beam (metal crash barrier) for low risk zone
- 2) Pre-stressed cable barrier for medium risk zone
- *3)* RCC guard rail for high risk zone

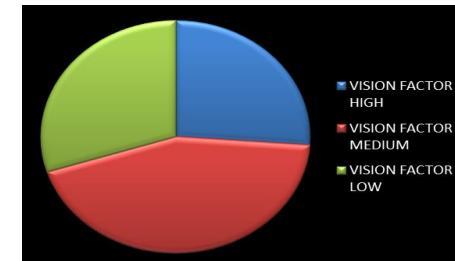
Fig no.7- Vision factor

Vision zones are also be divided. In some part of the ghat section there are obstacles are present. Trees branches are grows across the road also in rainy season due to smog and foggy environment vision problems are arrived.
