Analysis of Multistorey RCC Frame subjected to Mainshock and Aftershock Earthquake

Sharad Srivastava¹, Ganesh Jaiswal²

¹PG Student (M.Tech. Structural Eng.), ²Assistant Professor, Civil Engineering Department, Institute of Engineering and Technology, Lucknow

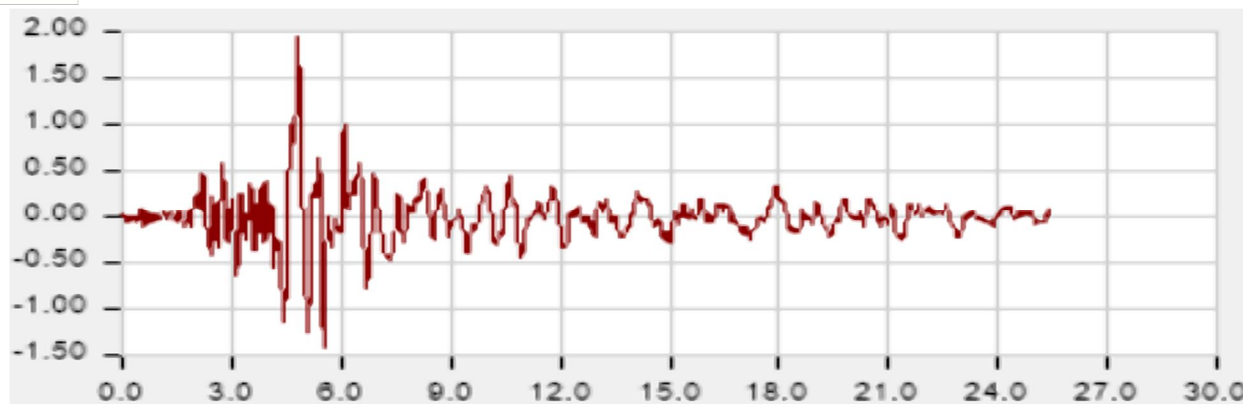
Acceleration vs Time data along Horizontal **N-W** Direction
