Volume: 12 **Issue:** V **Month of publication:** May 2024

DOI: <https://doi.org/10.22214/ijraset.2024.60009>

Automated Structural Health Monitoring System for Mitigating Building Collapse in Nigeria: A Mobile App Approach

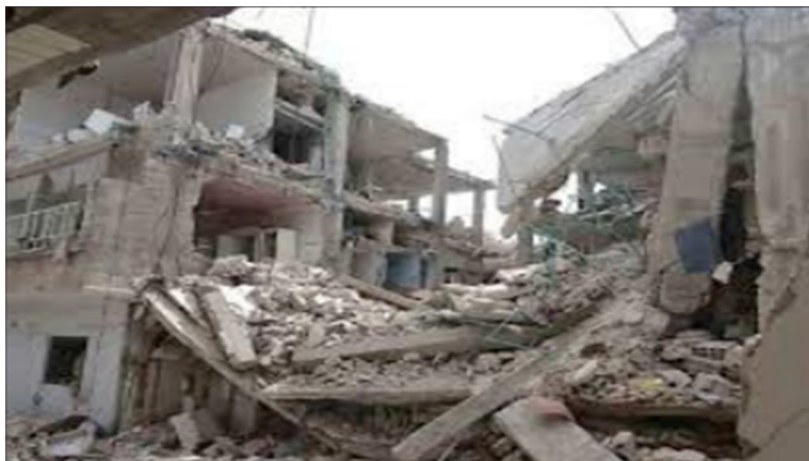
Figure 1.1: School Building Collapse in Lagos, Nigeria 2019

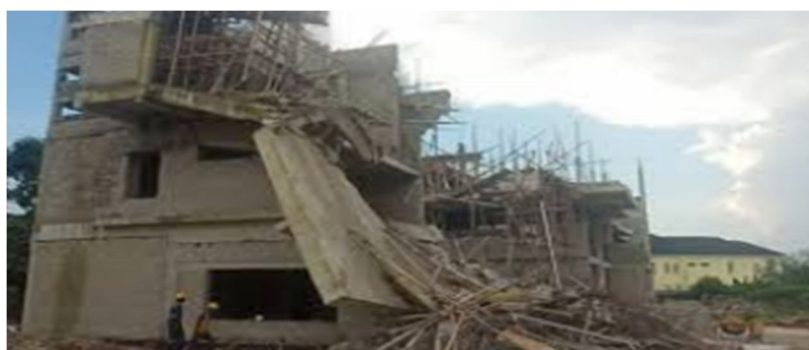
Figure 1.2: Two -Storey Building that collapsed in Abuja, Nigeria (2023)

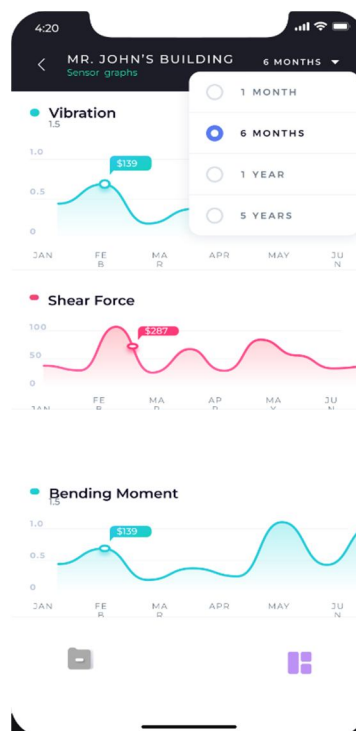
Figure 3.8: Graphs of Monitored Parameters

Figure 3.7 shows the Monitored Parameters that upon selecting a particular building, users would navigate to a screen showing the parameters being monitored for that specific building. Parameter include structural conditions, environmental factors, or any other relevant metrics contributing to the risk of building collapse. The information presented in a good format with clear labels and values. Whereas the graphs of monitored parameters screen presents graphical representations of the monitored parameters for enhanced data visualization. Graphs are line chart showing the trends and fluctuations of the parameters over time. Users can interpret the graphs to identify patterns or anomalies that might indicate potential risks or issues with the building's structural integrity as shown in Figure 3.8. Overall, these screens collectively provide users with a comprehensive tool for monitoring and managing buildings, aiming to address the frequent building collapse issue in Nigeria, especially in Lagos and Abuja. The design prioritizes user authentication, building management, and detailed monitoring of key parameters to ensure a holistic and effective solution.
