Automated Structural Health Monitoring System for Mitigating Building Collapse in Nigeria: A Mobile App Approach

Edemirukaye U. Orodje¹, Eden Emmanuel², Adegboyega Israel. A³

Abstract: Building collapses have become a distressing and recurring issue in Nigeria, necessitating urgent action to mitigate their occurrence. This paper introduces an innovative approach to address this challenge by developing an Automated Structural Health Monitoring System (ASHMS) utilizing a mobile app. Focusing on major cities like Lagos and Abuja, the proposed system employs strategically placed sensors to gather data from various structural elements of buildings. The collected information, encompassing seismic activity, vibrations, bending moments, shear forces, and other key parameters, is wirelessly transmitted to the cloud where it can then be accessed and visualized using mobile app.

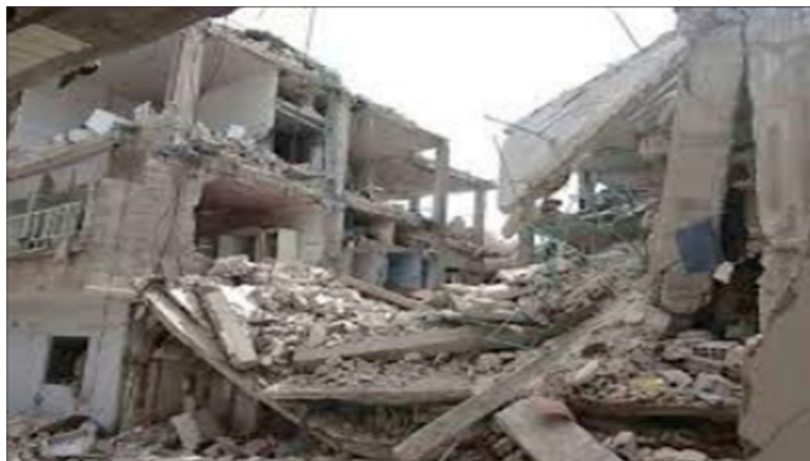
Figure 1.1: School Building Collapse in Lagos, Nigeria 2019

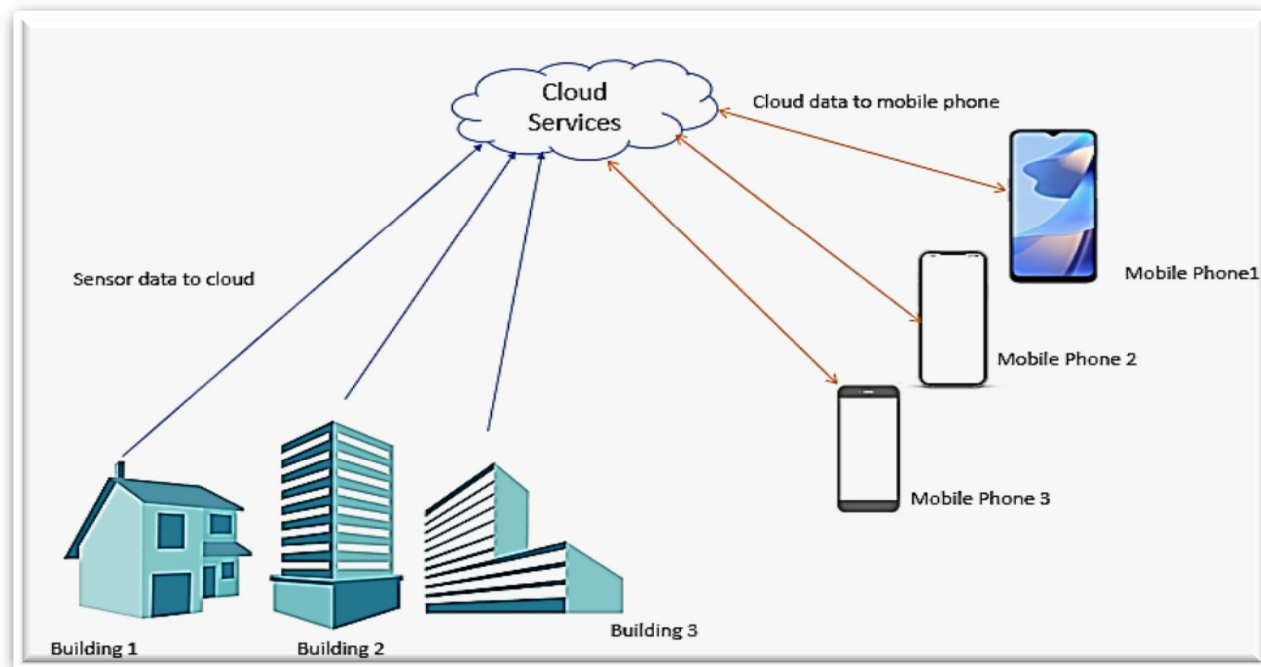
Figure 3.3: The System Diagram

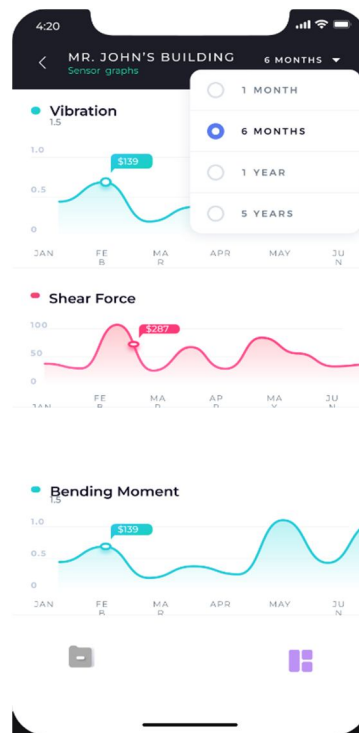
Figure 3.8: Graphs of Monitored Parameters

The results on the user's mobile app reveal vital structural indicators for an automated Structural Health Monitoring (SHM) system. Recorded values encompass a vibration level of 0.5 units, shear force at 20 units, bending moment reaching 50 units, and a vertical wall angle measuring 89 degrees. These readings are pivotal in evaluating the structural integrity of buildings. A vibration level of 0.5 units implies a fairly stable structure, while a shear force of 20 units and a bending moment of 50 units highlight the exerted forces, requiring attention to ensure they fall within safe limits. The 89-degree vertical wall angle offers insights into structural alignment, with any deviation potentially indicating an issue.
