Design Modification of Cluster Gear Shaft of Synchronmesh Gearbox in Tractor

Abstract: A cluster shaft is a rotating member/machine element, which is used to transmit power from one place to another. A cluster shaft is a shaft that runs parallel to the main shaft in a gearbox, and carries the pinion wheels. The failure of the second gear mounted on the cluster shaft occurred due to wear and tear. The objectives of the paper is to study the existing cluster gear shaft, and providing the proper solution so as to avoid the failure of cluster gear shaft. There are various reasons due to the gear may fail, few of them could be application error, design error, manufacturing error or application error. According to American gear manufacturing association, the failures of gear can be classified into four major categories namely surface fatigue, wear, plastic, and breakage. It has been observed that in most of the cases the failure starts from the bearing. After FEM analysis it is found that the maximum equivalent stress occurred on the second gear which is equal to 12.45 MPa.

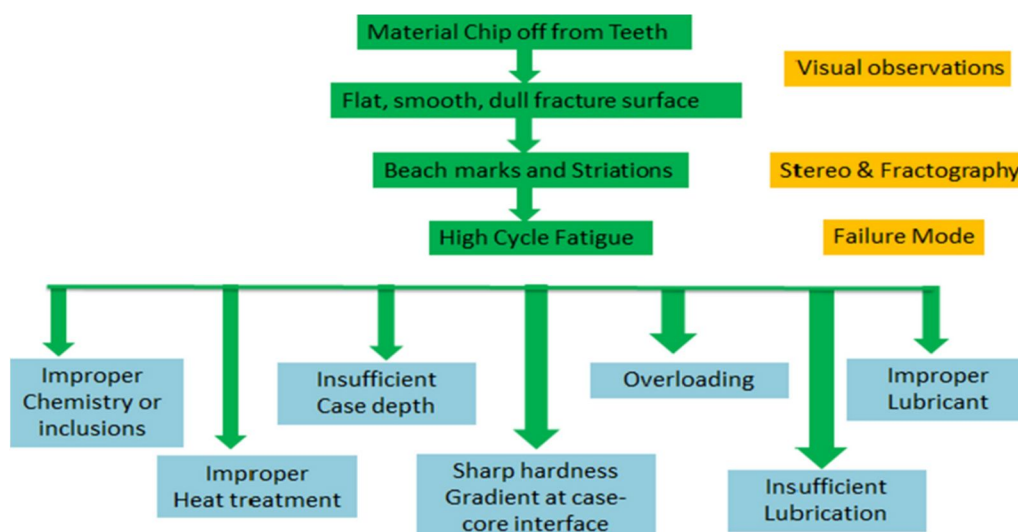
Figure 1: Failure analysis of cluster gear shaft

When two gears mesh, the bigger gear is referred to as a gear, while the smaller gear is referred to as a pinion. Blanking, casting, powder metallurgy, extrusion, and forging are some of the manufacturing procedures used to make the gears. Positive drive gears are used, and the velocity of the gears stays constant during power transfer. When compared to other drives, the efficiency of a gear drive is quite high, and it may be employed for low-speed applications. The gears are small and capable of transmitting a lot of torque. Figure 1 depicts the failure analysis of cluster gear shaft.
