# Comparative Study on Damage Index of RCC Frame Considering Fiber Discretization Technique

**Abstract:** Damage indices which take into account both maximum deformation and cyclic effects were developed by Park and Ang. In the field of structural engineering, it's observed that the Park and Ang damage index is mostly used for RCC structure. The damage index parameter assessed based on plastic hinge approach which is not effective to consider the coupled response between axial force and flexural moment especially in nonlinear domain. The accurate damage evaluations of structure are depending on other parameter such as, accurate modelling of frame, selection ground motion records. Masonry infill walls are widely used as partitions all over the world. Commonly masonry walls are not considered in the damage evaluation process because they are supposed to act as non-structural members or elements. Fiber discretization technique is used to consider inelastic behaviors of member. Single strut is model as infill wall in multidirectional. Results obtained from this study show that the accuracy of damage index totally depends on damage parameter consideration and modeling of building. The

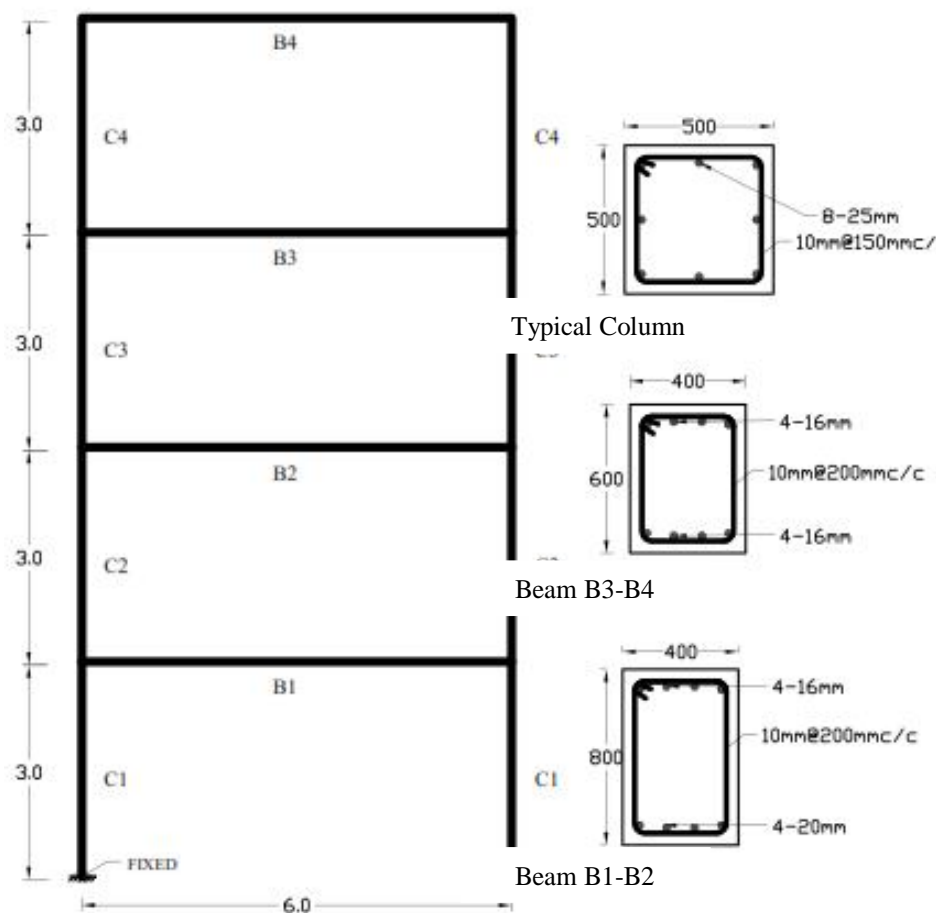
The geometrical configuration, element description, dimensions and reinforcement details are shown in Figure 1 the structure designed is based on ACI code. The damage was evaluated by using Seismo Struct software.

Figure 1: Geometry and design of 4-storey frame

From the results obtained it is observed that most of damage belongs to bottom storey columns. The damage in C1 column has reached collapse state for both cases, analysis performed and reference literature. Also the damage obtained from analysis is approximately equal to damage evaluated in Ref. [12] but there is some variation in results because of insufficient material properties available in Ref. [12].

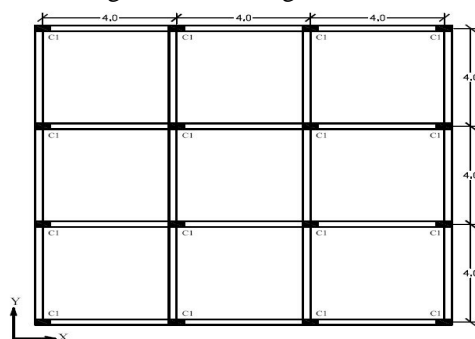
As an example the damage analysis is performed for typical ground+3 storey reinforced concrete building. The building is designed according to the IS 456-2000 code. The plan area of building is 12 x 12 m with 3.2 m as height of each typical storey. The foundation considered as fixed support. The sectional properties of various elements are obtained based on gravity loading. The building plan and computational model of the building as shown in Figure 2

Figure2: Plan of Ground+3 RCC Building

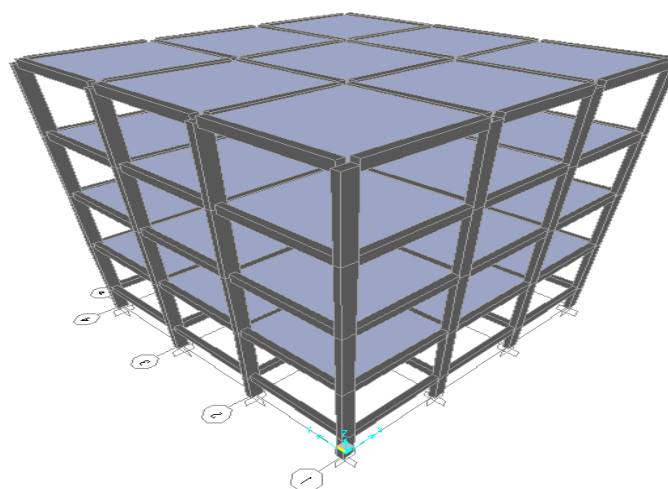
Figure 3: Computer Generated Model of Ground + 3 Storey RCC Building in SAP 2000

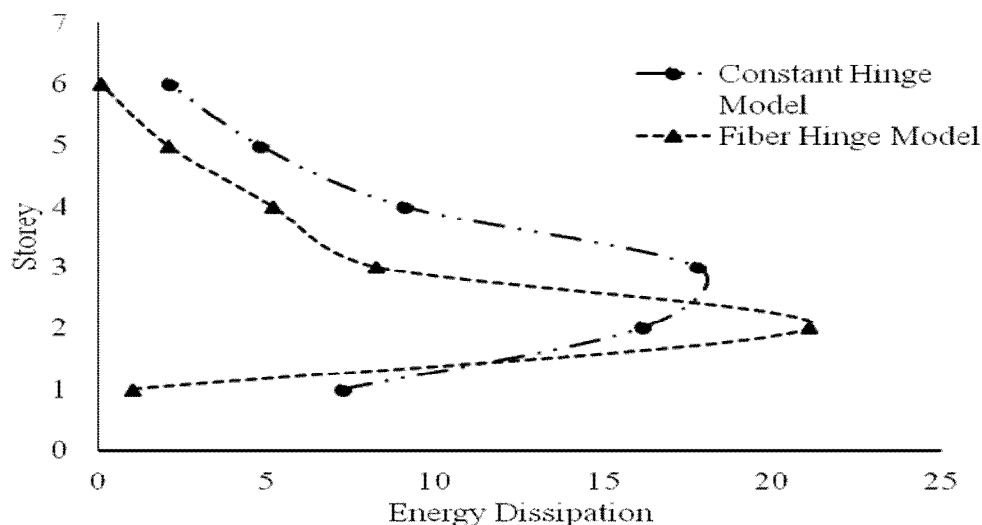
The hysteretic energy distribution over storey height in both cases for constant and fiber hinge approach are shown in Figure 3

Figure.3: Comparison of Energy Dissipation over Storey Height

At the top storey less energy dissipation shows in fiber hinge than the constant hinge, this occur because fiber hinged consider axial force and moment interaction, at 5<sup>th</sup>, 4<sup>th</sup>, 3<sup>rd</sup> storey the axial force is less than the balance axial force in tension region. It is produced confinement effect to member. Hence due to confinement increased moment resistance.

In case of uncoupled effect of axial force and flexure moment, axial force cross the design ultimate value at the bottom storey column (i.e. column had reached collapse damage state). The comparison for energy dissipation in both cases the fiber hinge gives realistic energy dissipation at bottom storey than the constant hinge. When the member had cross collapse state value then perfect plastic hinge formation occurs.

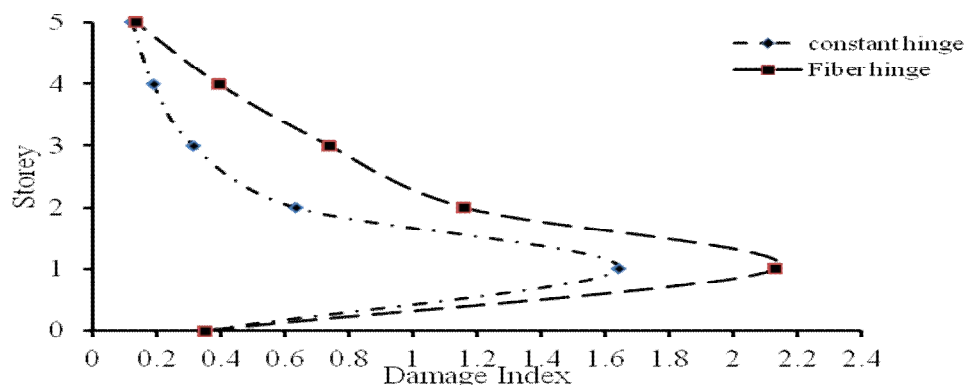
Figure 4 shows the comparison of storey damage index considering coupled and uncoupled effect of axial force and flexure moment under the El-Centro motion.

Figure.4: Comparison of Storey Index for El-Centro Ground Motion

In the above Figur 4 by comparing damage distribution of storey index, the fiber hinge shows more damage than constant hinge and is increasing gradually with bottom storey axial force up to failure occur. The maximum axial forces are inducing in bottom storey column still softening damage index does not progress to any damages.

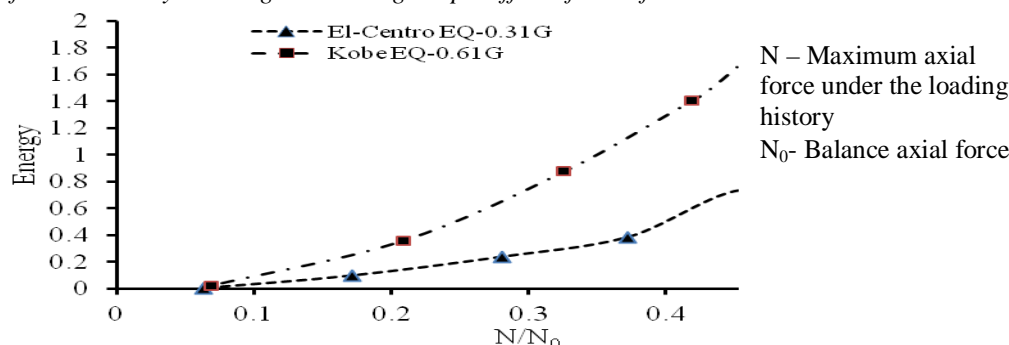
Figure.5: Influence of Axial Load on Energy Dissipation

The plot of energy dissipated in element verses ratio of axial force in element to ultimate capacity of element is as shown in Figure 4 when axial load is beyond the axial load ratio of 0.45(balance axial load to maximum axial load capacity of section) element does not exhibit ductile behaviour. In compression control region of interaction diagram due to brittle behaviour, sudden failure is expected. In addition, the brittle failure is so immediate that the computation of damage index is not possible.

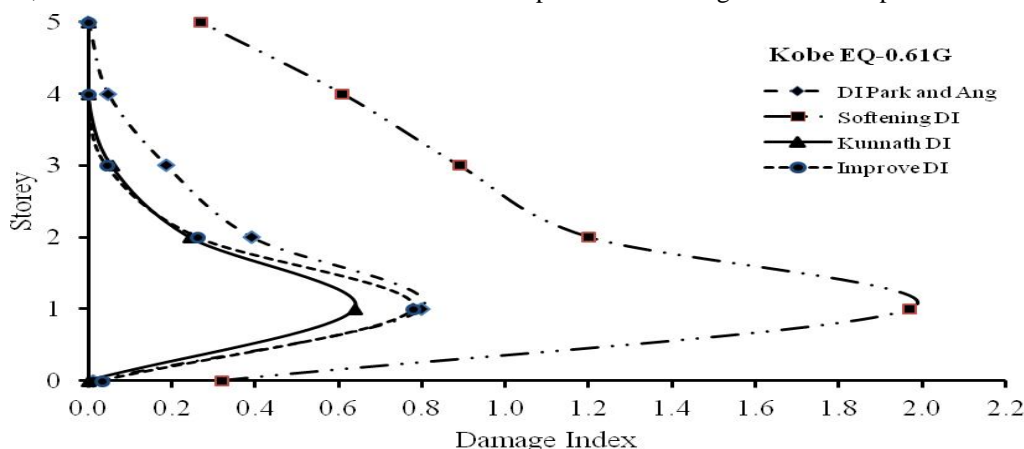
Figure.6: Comparisons of Storey Damage Index for Kobe EQ

The plot of different storey damage index over the storey height is as shown in Figure 6. The softening storey damage index are obtained from ratio of inter storey drift .By comparing softening DI with other damage index, it is observed that overestimation damage. The Kunnath and Improved damage index have same distribution of damage over the storey height.
