Comparative Study on Damage Index of RCC Frame Considering Fiber Discretization Technique

Mr Vishal M. Sapate¹, Mr Nikhil S. Jadhav²

Abstract: Damage indices which take into account both maximum deformation and cyclic effects were developed by Park and Ang. In the field of structural engineering, it's observed that the Park and Ang damage index is mostly used for RCC structure. The damage index parameter assessed based on plastic hinge approach which is not effective to consider the coupled response between axial force and flexural moment especially in nonlinear domain. The accurate damage evaluations of structure are depending on other parameter such as, accurate modelling of frame, selection ground motion records. Masonry infill walls are widely used as partitions all over the world. Commonly masonry walls are not considered in the damage evaluation process because they are supposed to act as non-structural members or elements. Fiber discretization technique is used to consider inelastic behaviors of member. Single strut is model as infill wall in multidirectional. Results obtained from this study show that the accuracy of damage index totally depends on damage parameter consid

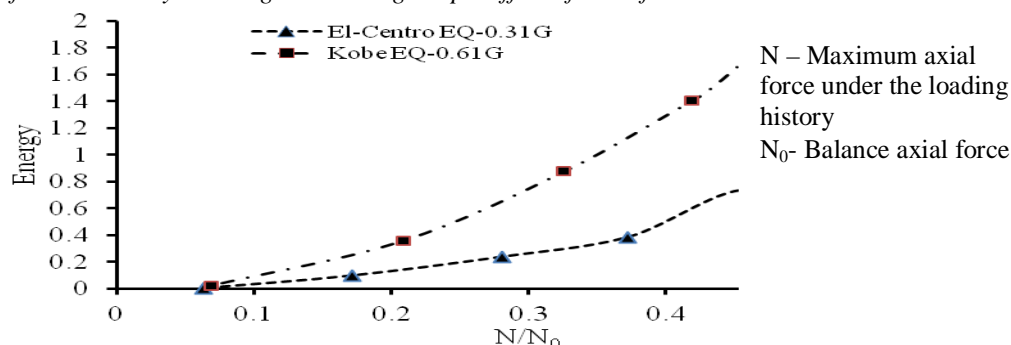
Figure.5: Influence of Axial Load on Energy Dissipation

The plot of energy dissipated in element verses ratio of axial force in element to ultimate capacity of element is as shown in Figure 4 when axial load is beyond the axial load ratio of 0.45(balance axial load to maximum axial load capacity of section) element does not exhibit ductile behaviour. In compression control region of interaction diagram due to brittle behaviour, sudden failure is expected. In addition, the brittle failure is so immediate that the computation of damage index is not possible.

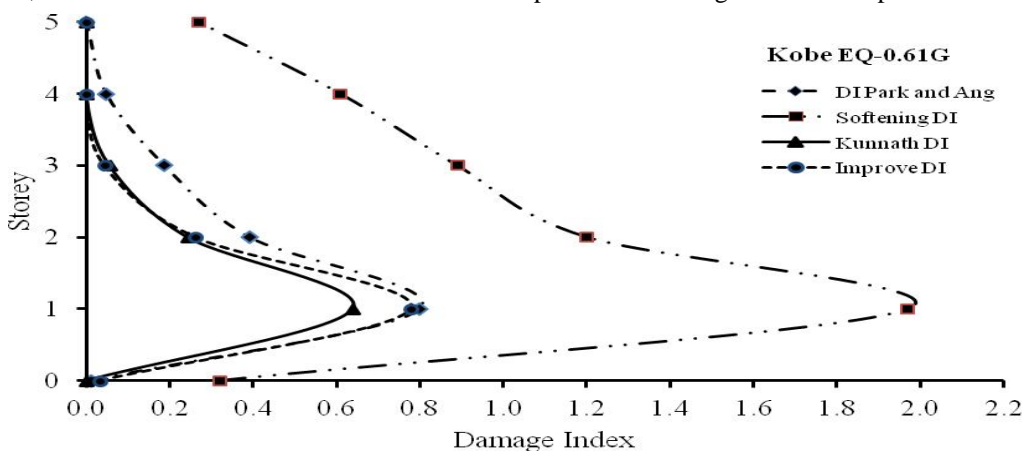
Figure.6: Comparisons of Storey Damage Index for Kobe EQ

The plot of different storey damage index over the storey height is as shown in Figure 6. The softening storey damage index are obtained from ratio of inter storey drift .By comparing softening DI with other damage index, it is observed that overestimation damage. The Kunnath and Improved damage index have same distribution of damage over the storey height.
