Effects of Tsunami Forces on RC Framed Structure Subjected to Bracing and Shear Wall

Sajit A. Samasindhi¹, Dr. K. B. Parikh²

¹PG student, ²Associate Professor and Head, Applied Mechanics Department, Government Engineering College, Dahod, India

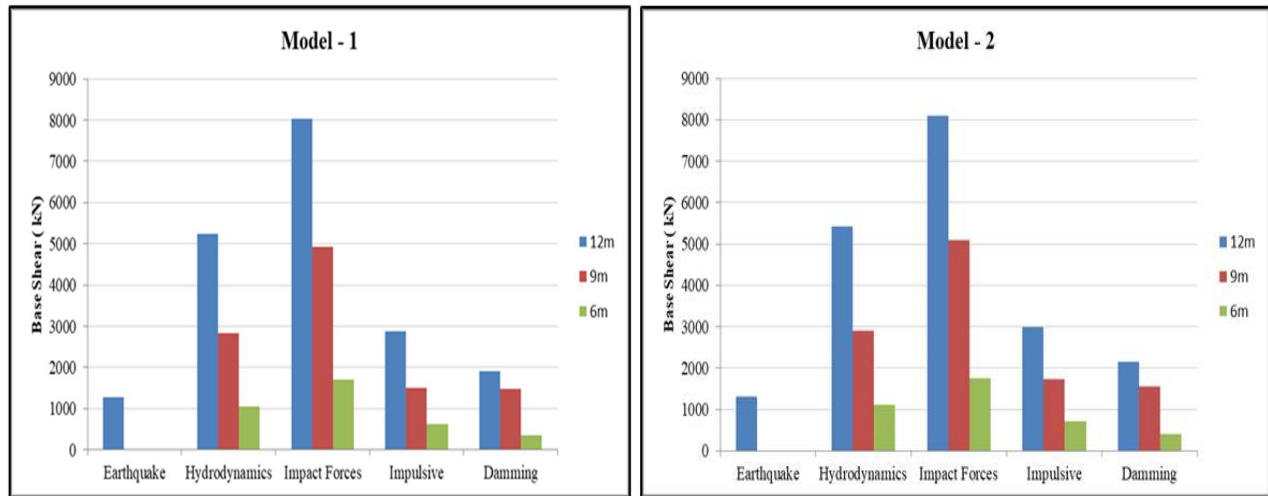
- 3) *Base shear Due to Earthquake and Tsunami Forces:* The base shear due to earthquake and Tsunami forces are evaluated for the two Tsunami loading Cases and are plotted as shown below.

- It was found that when the base shear of structure due to Tsunami was greater than or equal to 12 times the base shear due to earthquake then almost all the columns were found to reach their capacity or have been overstressed. Hence it can be said that when the structure which was designed for earthquake can act as Tsunami resistant structure until and unless base shear due to Tsunami does not exceed 12 times the base shear due to earthquake for the particular zone of earthquake.
