Investigation on Effects and Properties of Concrete Structure after Exposed to Fire

Prof. S. V. Dhoke¹, Akshay Chikate², Abhijit Andhare³, Anikesh Sable⁴, Ashish Gabhane⁵, Himanshu Bhabutkar⁶, Yash Gandhe⁷

P.R.Pote (Patil) college of Engineering and Management, Amravati
Sant. Gadge baba Amravati University – India

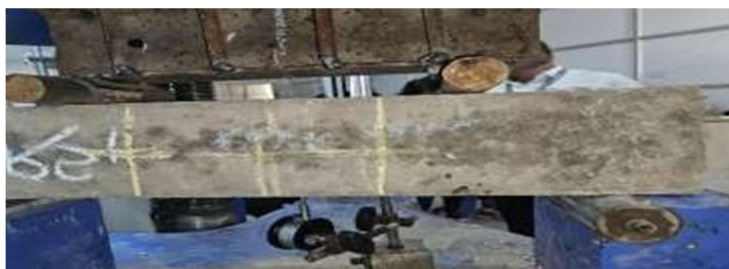
2) Apply Load On (RS1)

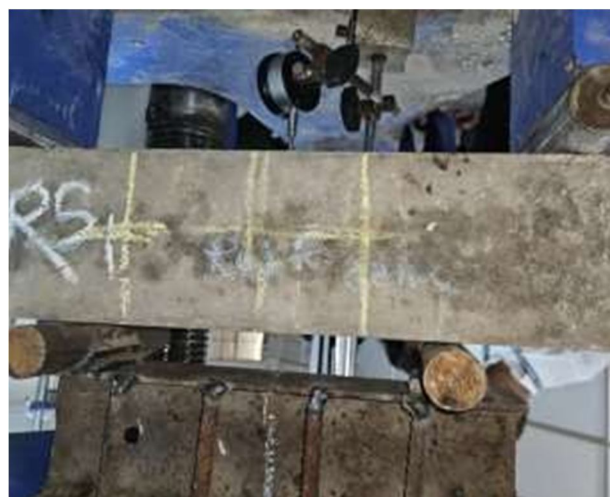
4.1.1 Reference Specimen one

This Reference specimen is use as reference point of view. This Reference specimen compare with the fired beam. Remaining beam are fire provided is different by using muffle Furnace after the testing of that beam all results compare RS1.

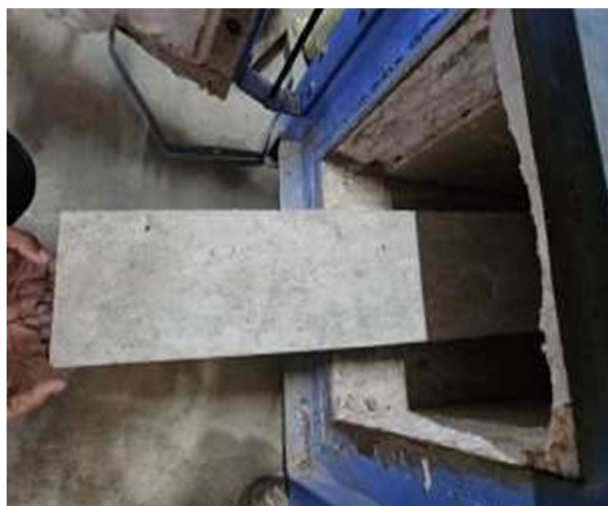
(a) Fired Process on Beam At (500°C)
