Numerical Analysis of Steel Frame Using Electro-Mechanical Impedance Technique

Abstract: Nowadays, piezoelectric materials are most widely used in structural health monitoring (SHM) system for non-destructive evaluation. In this paper the damage study using electro-mechanical impedance (EMI) technique, which is non-destructive method of SHM. This paper presents a numerical analysis of four-story steel frame and multiple damages were induced in the steel frame by utilizing smart material like Lead Zirconate Titanate (PZT). A PZT-4 piezoelectric material was embedded in the beam of the frame. The type of damping used in steel frame model was Rayleigh damping. The numerical analysis was done in COMSOL MULTIPHYSICS 6.2 and frequency domain analysis was done, from that admittance values were found out for 30-300KHz frequency range. The real part of the admittance gives conductance values. Then, conductance versus frequency graph was created that will indicate the structural health and performance. Moreover, root mean square deviation (RMSD) index was found out for each case that provides a quantitative measure of deviation.

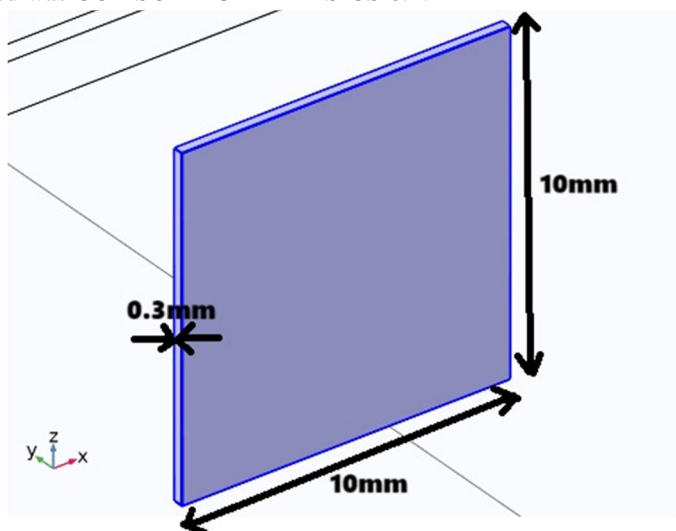
Fig.1 PZT patch

Using third equation, α and β can be easily determined for viscous damping or Rayleigh damping [15]. This paper deals with the four-storey steel frame structure, in which PZT-4 sensor was embedded as shown in fig.1. The dimension of the PZT patch was $10 \times 10 \times 0.3 \text{ mm}^3$. Multiple damages were induced in the beam which will discuss in this paper and type of finite element analysis software used was COMSOL MULTIPHYSICS 6.2.

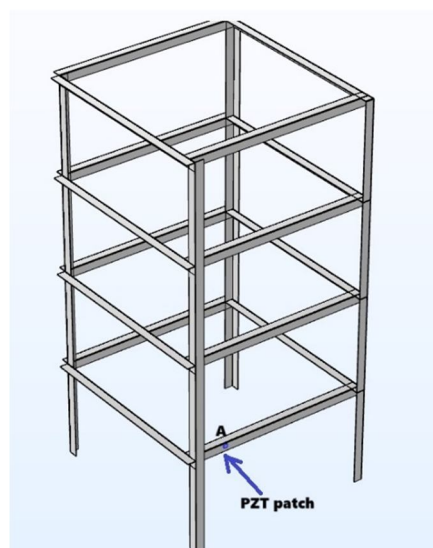
Fig.2 Steel model with embedded PZT transducer

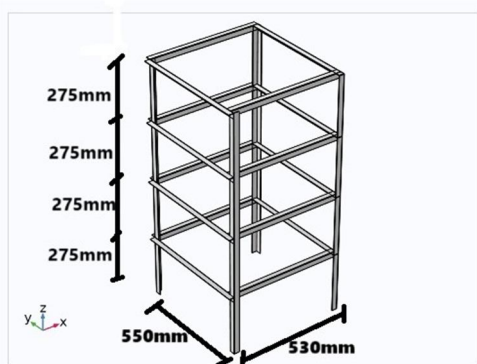
Fig.3 Isometric view

The isometric view of the four-story steel model is shown in fig.3 in which height of each floor was 275mm. The side view of the steel frame is shown in fig.4 in which left and right-side length of the beam was 550mm. The top view of the steel frame is shown in fig.5 in which the size of angle was $24.4\text{mm} \times 2\text{mm}$.

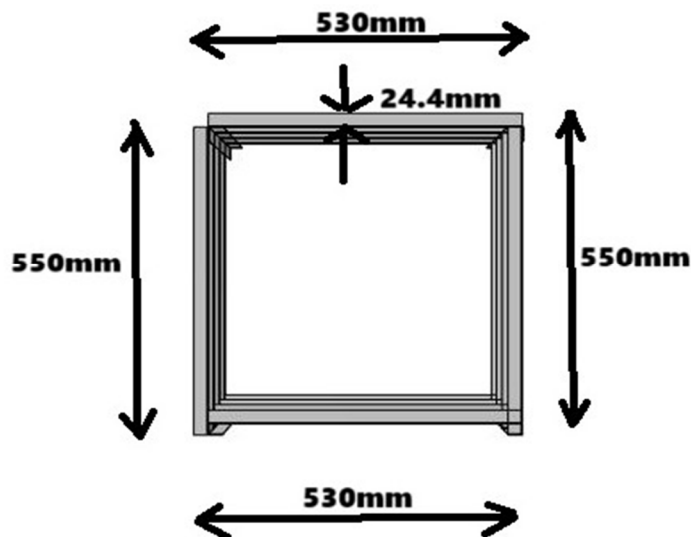
Fig.5 Top view

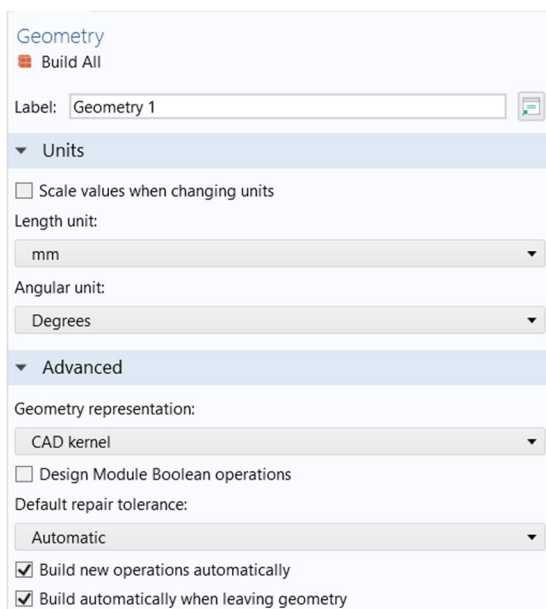
Fig.6 Units option in geometry command

In COMSOL MULTIPHYSICS a four-story steel frame model was made, the all components of the model like beams, columns etc were made by using “block” command which was available in the “geometry” tab. First of all, the dimensions were set like length in mm and angular unit in degree as shown in fig.6. Then, after that the length, width, height of the block was mentioned as shown in fig.7. There were some other parameters that involved in this like position of base, axis type, work plane, rotation angle whose values were also assigned by clicking on the build all objects option. The whole model was prepared in the same way as the single block was made. After making the all blocks of the model “form union” command was used to make the structure as a whole structure.

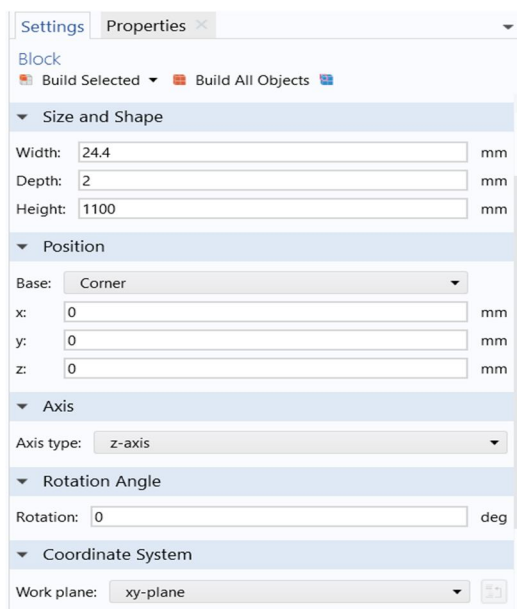
Fig.7 Size and shape in block command

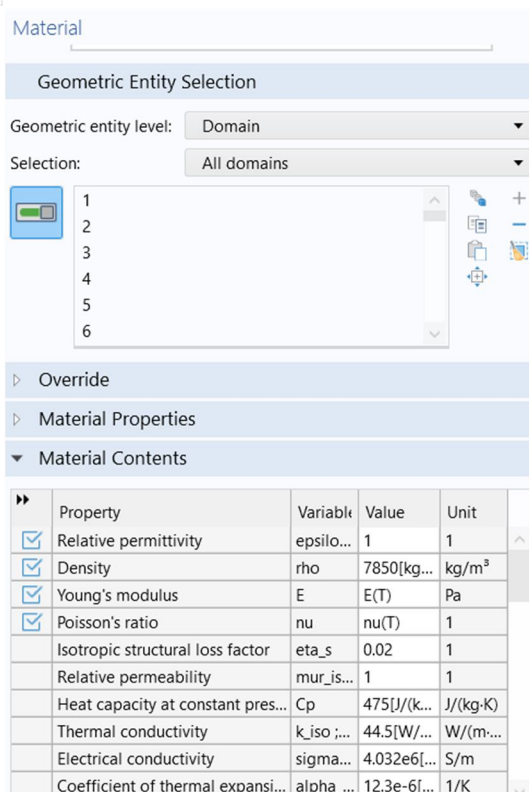
Fig.8 Material property selection shown

The material properties were defined to all the structural components like beams, columns of steel model. The properties were defined by using option “add material”. In “add material” command go to the “built-in” then “select structural steel” then after that select the all domains as shown in fig.8. and PZT selection shown in fig.9.

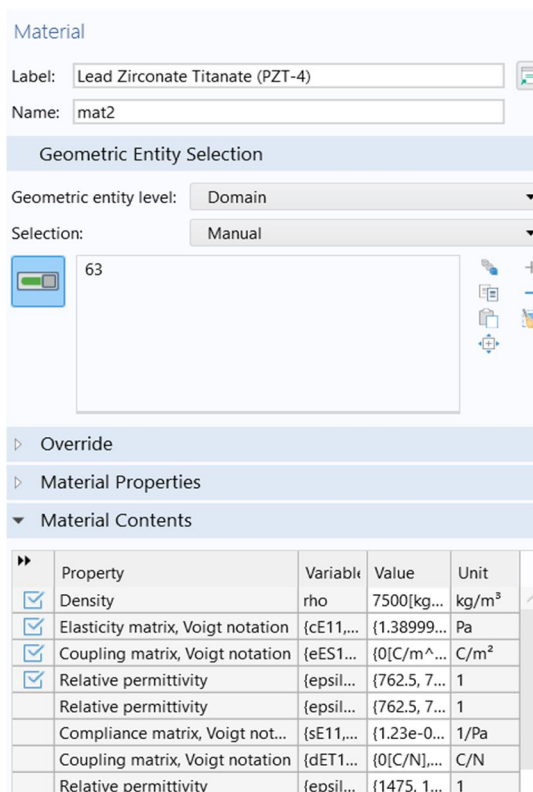
Fig.9 PZT selection

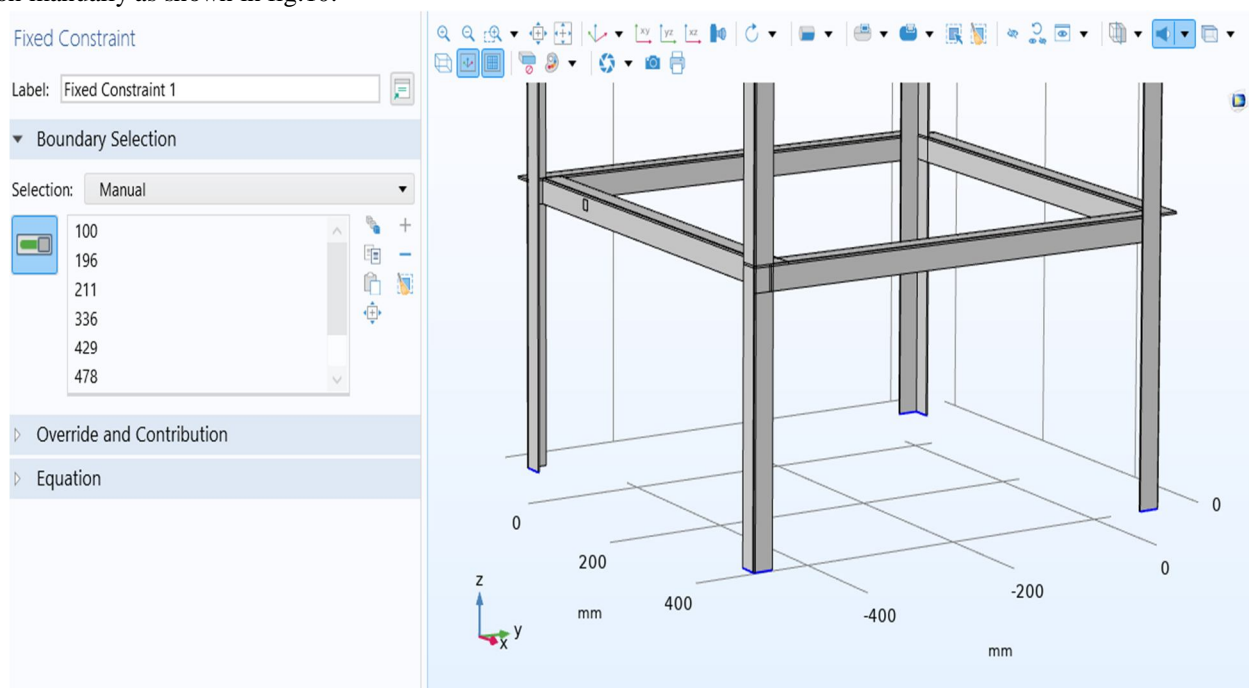
Fig.10 Fixed ends at the bottom of frame shown

The boundary conditions were assigned to make steel frame as a fixed frame from the bottom. So, the commonly used fixed type of supports were used in steel frame. For this, go to the “solid mechanics” then go to the “fixed constraints” and then do boundary selection manually as shown in fig.10.

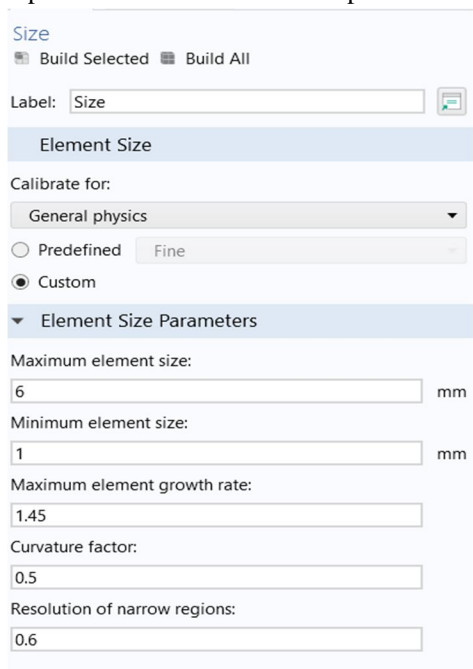
Fig.11 Meshing element size

The meshing was done in the whole steel structure by go to the “mesh” then calibrate for “general physics” and select size then choose “custom” option and define element size parameter as shown in fig.11. The select the type of mesh as “free tetrahedral”.

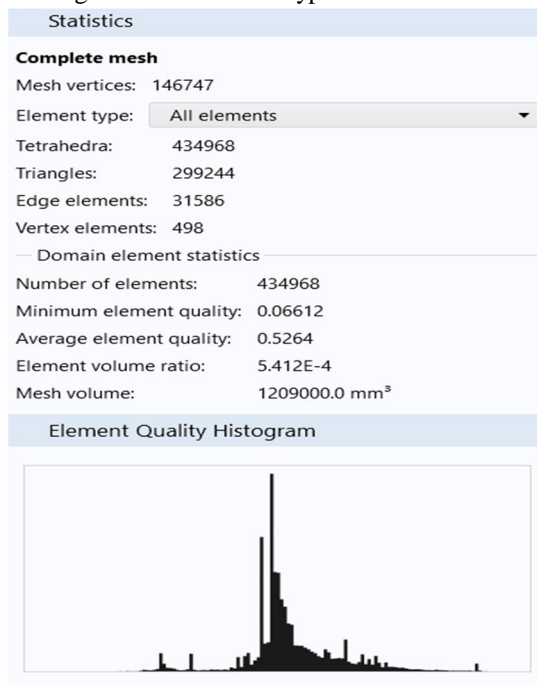
Fig.12 Mesh statistics of steel frame

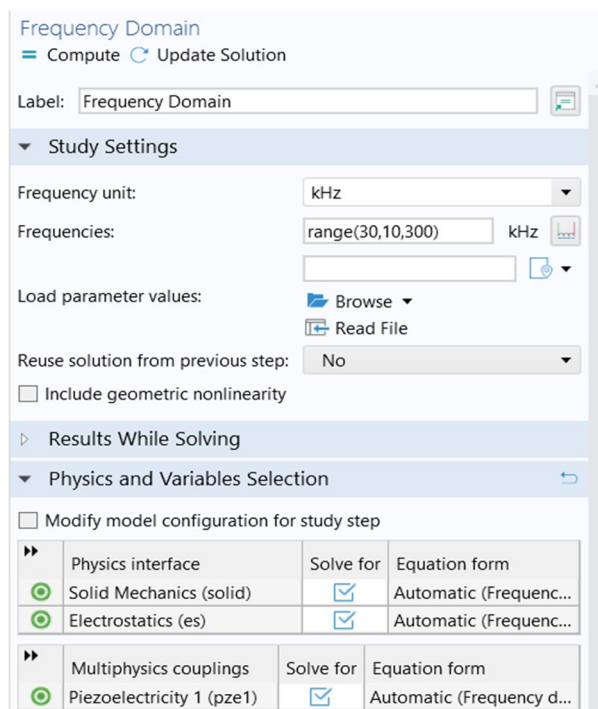
Fig.13 Computation of frequency domain

After assigning all parameters we move towards the “study” option and select the type of study as “frequency domain”. The unit of eigen frequency was selected as KHz. Then choose the range of frequency from 30 to 300KHz at interval of 10, then click on “compute” as shown in fig.13.

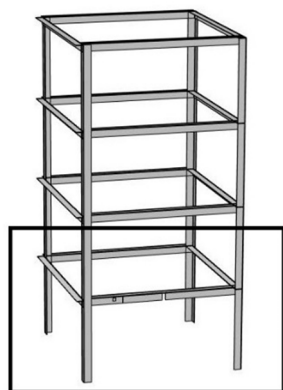
Fig.14 Steel model with multiple damages

In the four-story steel model, the damage was done on the front side of the beam whose length was 530mm at height of 275mm. In all types of damages, the length and thickness of the damage was same except the width of the damage. The length and thickness of the damage were 24.4mm and 2mm. At point “C”, there was a damage of constant width of 10mm at distance of 265mm from corner of x axis in all cases as shown in fig. 15. At point “B” there were variable width damage of 1mm, 5mm and 10mm at distance of 132.5mm from corner of x axis. The PZT patch was embedded at point “A” which was at 100mm distance from corner of x axis as shown in fig.15. The dimension of PZT patch was $10 \times 10 \times 0.3 \text{ mm}^3$. The three cases of damage were-

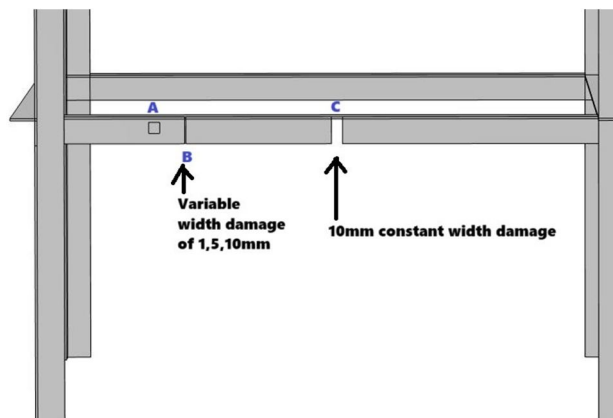
Fig.15 Zoomed image indicating damage location

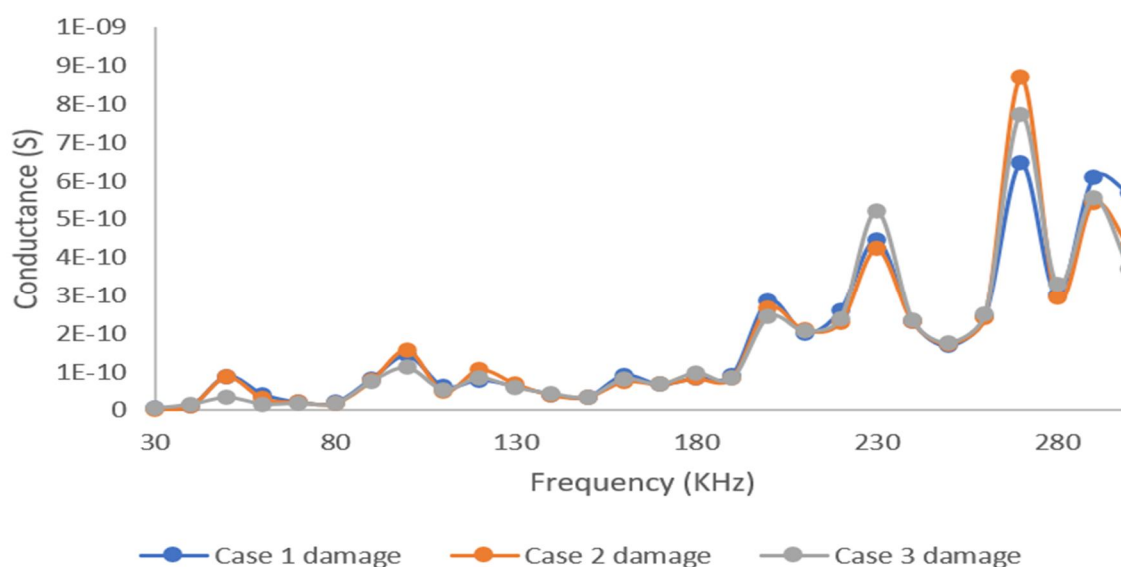
Fig.16 Conductance response obtained for frequency range of 30-300KHz

After the frequency domain analysis, the probe table of admittance and frequency was generated in the COMSOL MULTIPHYSICS 6.2 software, in which the frequency was varying from 30KHz to 300KHz. In admittance the real part denotes the conductance and an imaginary part denotes the susceptance. Here, we need only real part of the admittance which is conductance. From that we made conductance verses frequency graph which is known as signature of the damage steel frame model.

To get the quantitative measure of damage the root mean square deviation was find out for Case 1 damage it was 27.604%, for Case 2 damage it was 28.57%, for Case 3 damage it was 30.76%.

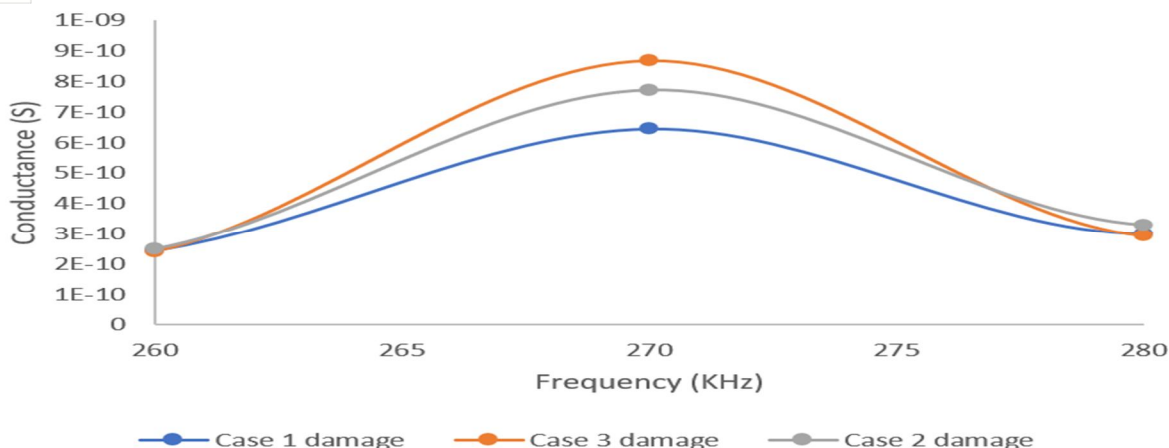
Fig.17 Conductance response obtained for frequency range of 260-280KHz
