Quality Improvement of Oil and Fuel Leakage in Diesel Engine by using Semi Automatic Setup

Swapnil D Kurhekar¹, Abhijeet B Tamse²

^{1,2}Assistant Professor, Mechanical Engineering Department at Sanmati Engineering College Washim

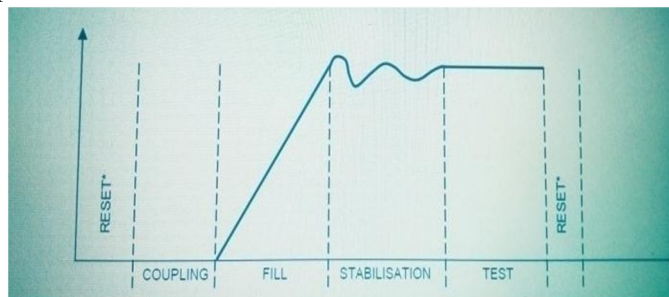
The ATEQ D520 is a flow meter which measures a drop in pressure with a differential sensor (transducer) which is placed at the extremities of a calibrated flow tube. When fluid (air) moves through a calibrated flow tube (laminar flow), a drop in pressure occurs, the value of which is proportional to flow.

Fig. 2 Principle of cycle

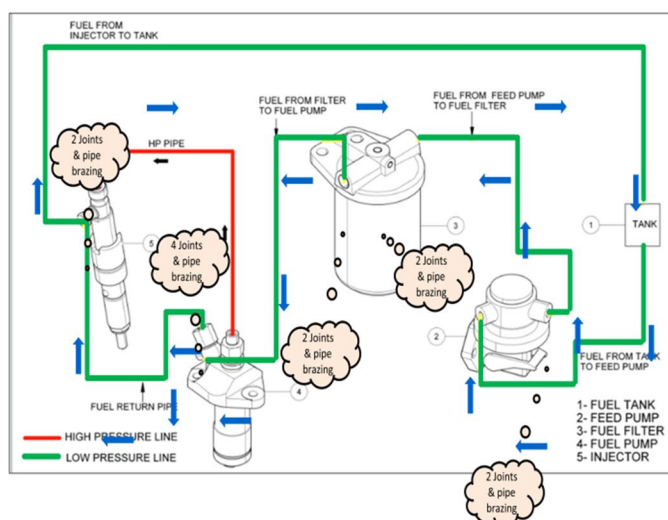
Fig. 3 Fuel Line Air Supply Circuit Diagram

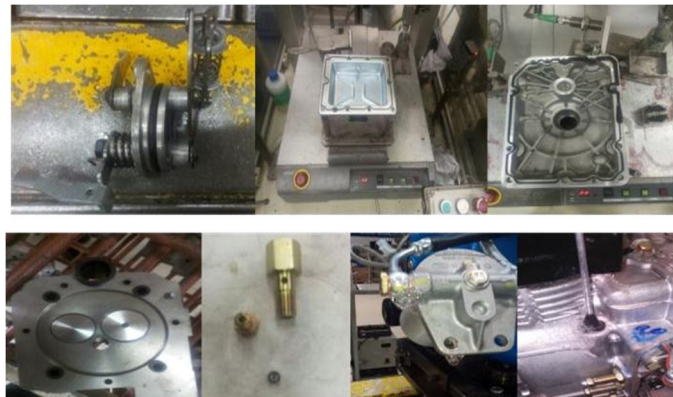
Fig. 6 Major Problem Occurring Phenomenon Analysis

- 1) Governor support Stop lever and O-ring leakage
- 2) Oil pan oil leak due to discontinuous loctite profile
- 3) Power takes off (PTO) enlarged loctite size
- 4) 400WG Cylinder head leakage due to water seals.
- 5) Leakage from FIP (Fuel Injector Pump) NRV (Non Return Valve) Banjo bolt
- 6) Leakage from diesel filter
- 7) Leakage from deep stick
