Repair of Cracks in Nicol Blocks of a Reinforced Earth Wall

Abstract: Bangladesh's first access-controlled expressway is the Dhaka-Khulna (N-8) Expressway. The project consists of 8 lane road of 55 km length, 54 culverts, 20 underpasses, 2 interchanges, 4 major bridges, 25 minor bridges, and 5 flyovers. Teghoria Interchange of this project is structured with 19 Reinforced Earth Wall, out of which a crack appeared in a wall that has 146 meters length and 7 meters height. Detailed inspection and analysis were followed by repair and rectification work. The aim of this paper was to find out the likely causes of this crack, discuss detailed retrofitting methodology and bring forth some recommendation. This crack may form due to weak workmanship during compaction and installation of tendons of reinforced earth, environmental load, heavy-loaded vehicle travel above the RE wall etc. The specialist team of the consultants of the project and experts from development partner inspected the problem and worked out how to repair the cracked area. The development partner developed repair methodology and executed the crack repair work as well as the treatment plan under strict supervision of consu

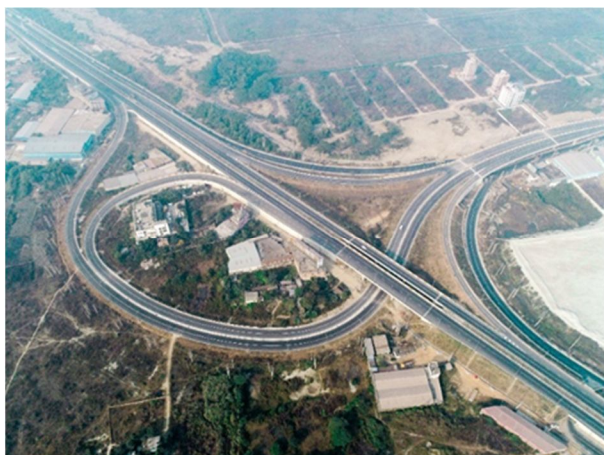
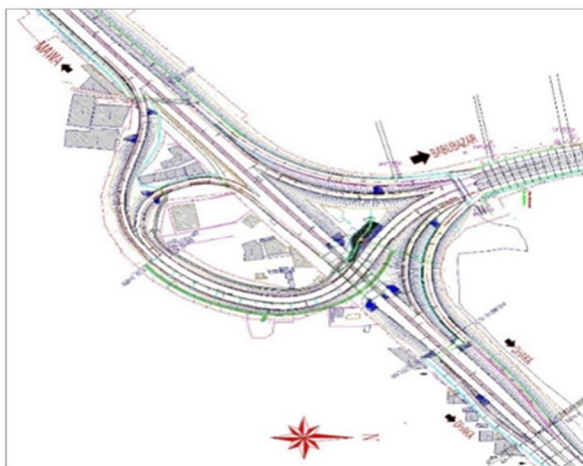
This interchange connects Jatrabari to Mawa Express Highway and Babu Bazar Link Road together. This a Trumpet type of Interchange. The trumpet interchange allows for interchange of secondary two-way streets to a multi-lane roadway with minimal traffic mix. It takes the place of a T-intersection which is often used when a roadway ends at the intersection of another roadway.

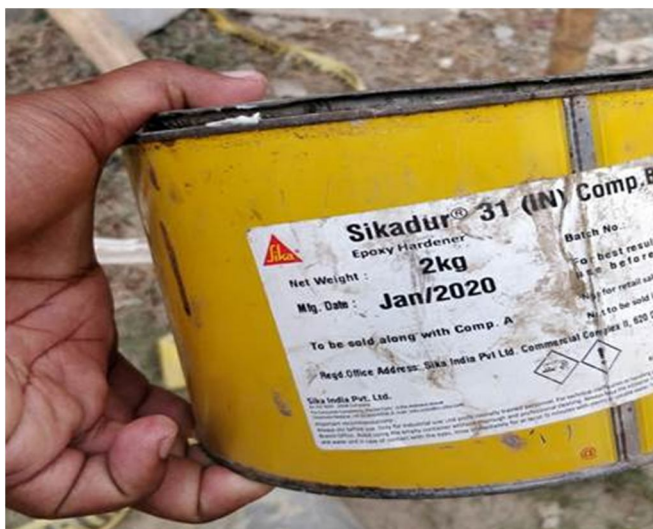
- The damaged block(s) in question should be broken back with a mechanical chisel to a depth of 40 to 50mm.
- The tongue at the bottom of the precast veneer or the tongue on the existing block from the higher layer are to be cut off with an electric grinder so that the precast veneer can be inserted deeper.
- Cleaning the dust with air compressor and water.

g) *Precast Veneer*

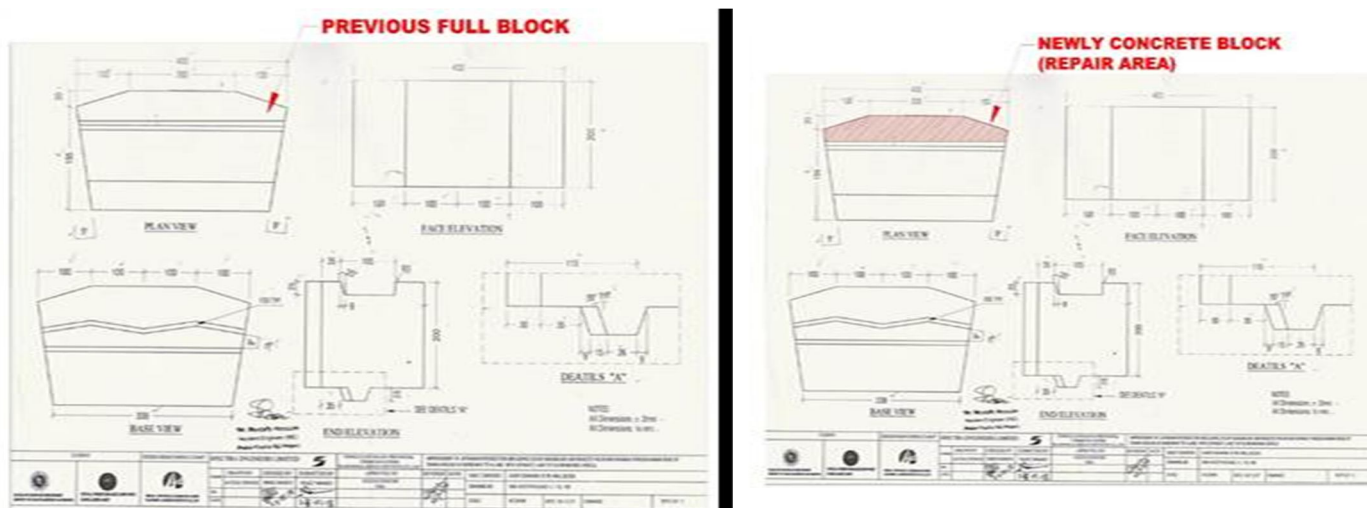
- Apply mixed epoxy-based mortar to the horizontal veneer.
- Insert the horizontal veneer to fill horizontal gaps between blocks.

i) *Finishing*

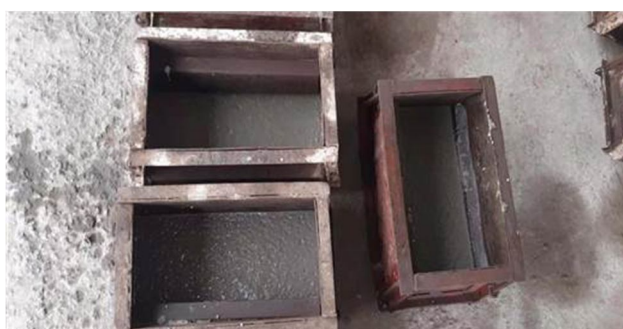
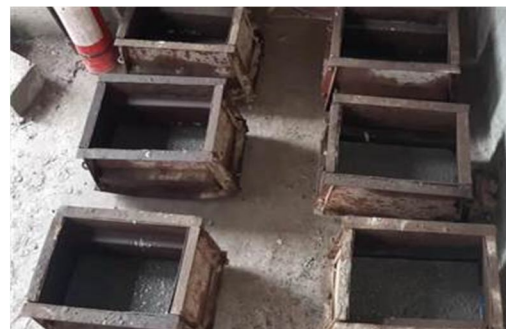
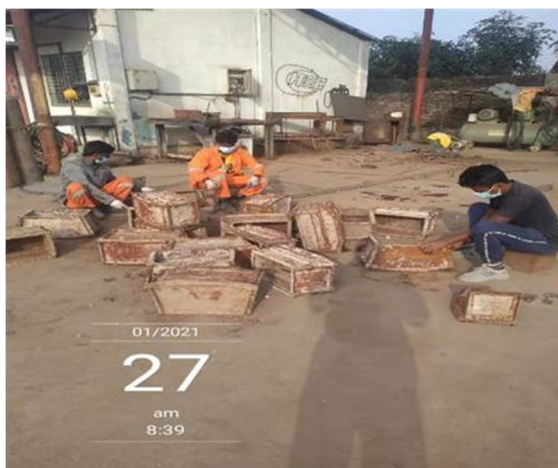
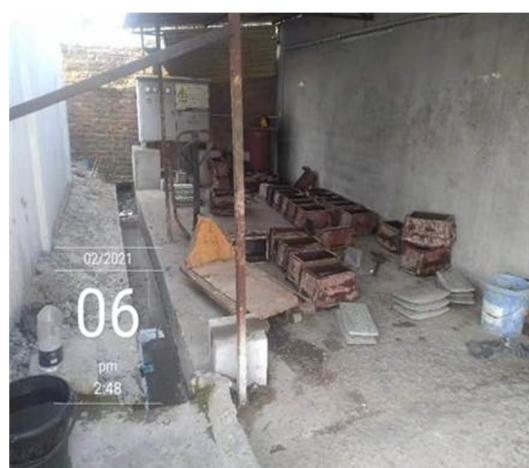
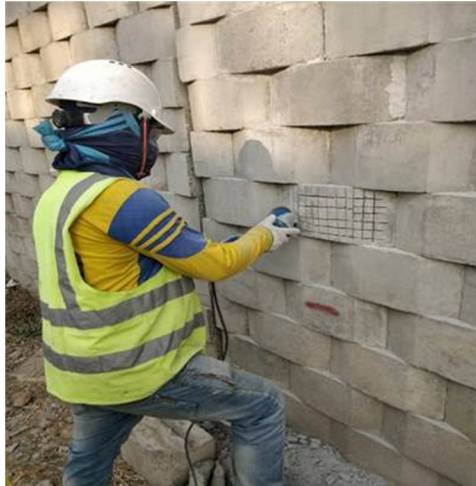
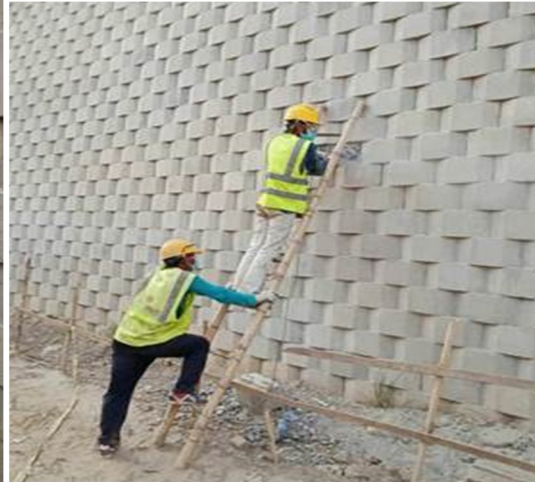
Longitudinal Cracks were found on the surface of some modular blocks of reinforcement earth wall at Tegoria Interchange Bridge abutment-3.

- 1) *Crushing, Cracking and Surface Damage of Individual Blocks:* Localised damage to the face such as cracking or crushing of individual blocks is unlikely to cause any threat to overall structural stability (Referenced from "Guidelines for the maintenance of Tens Artech Modular Block Retaining walls"). If the depth of the damage is 40-50mm generally, the detail procedures of repairing are as follows:

- The damaged block(s) in question should be broken back with a mechanical chisel to a depth of 40mm to 50mm.
- Cleaning the dust with air compressor and water.

- Cleaning the steel formwork.
- Marking thickness of formwork to match the depth of chipped block.
- Close formwork after sealing the gaps in the formwork by the most appropriate method (sponge, water plug, etc.).
- Pouring concrete.
- The formwork shall be removed when the concrete strength meet with requires.
- The surface of veneer shall be covered by Geotextile after remove the formwork.
- Curing using water.
- Precast veneer shall be grinding by electric grinder.

- Apply mixed epoxy-based mortar to the replacement veneer and the prepared face of damaged block.
- "Glue" the replacement veneers on to the prepared face of damaged block.

Protruded epoxy-based mortar shall be cleaned.

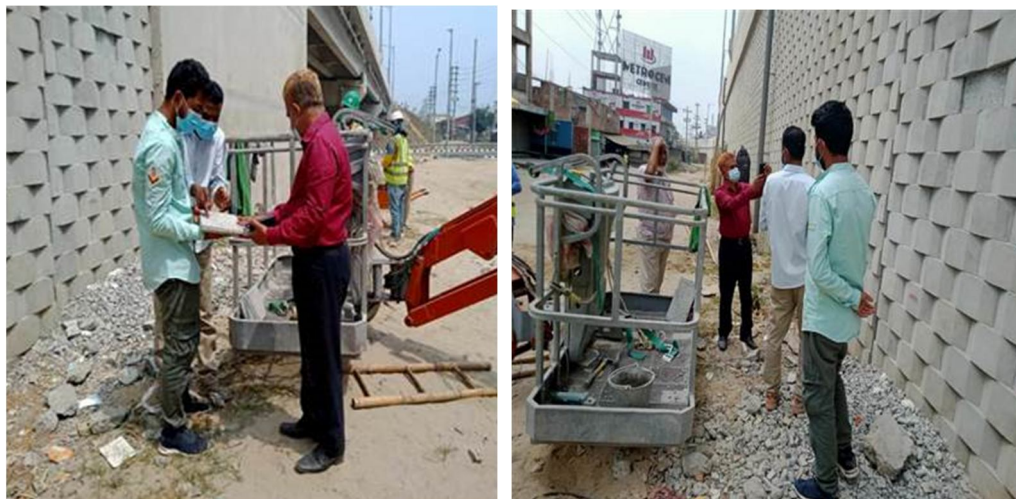
Crack repairing work was done base on the approved methodology, which was constantly monitored by CSC Consultant and Client Representative Team.
