Repair of Cracks in Nicol Blocks of a Reinforced Earth Wall

Abstract: Bangladesh's first access-controlled expressway is the Dhaka-Khulna (N-8) Expressway. The project consists of 8 lane road of 55 km length, 54 culverts, 20 underpasses, 2 interchanges, 4 major bridges, 25 minor bridges, and 5 flyovers. Teghoria Interchange of this project is structured with 19 Reinforced Earth Wall, out of which a crack appeared in a wall that has 146 meters length and 7 meters height. Detailed inspection and analysis were followed by repair and rectification work. The aim of this paper was to find out the likely causes of this crack, discuss detailed retrofitting methodology and bring forth some recommendation. This crack may form due to weak workmanship during compaction and installation of tendons of reinforced earth, environmental load, heavy-loaded vehicle travel above the RE wall etc. The specialist team of the consultants of the project and experts from development partner inspected the problem and worked out how to repair the cracked area. The development partner developed repair methodology and executed the crack repair work as well as the treatment plan under strict supervision of consu

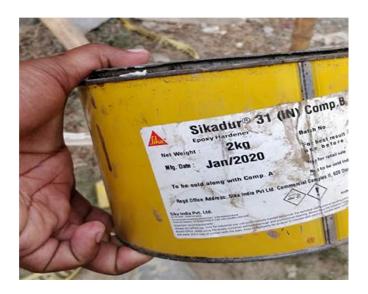
- f) Surface Preparation
- The damaged block(s) in question should be broken back with a mechanical chisel to a depth of 40 to 50mm.
- The tongue at the bottom of the precast veneer or the tongue on the existing block from the higher layer are to be cut off with an electric grinder so that the precast veneer can be inserted deeper.
- Cleaning the dust with air compressor and water.
- g) Precast Veneer

- h) Mixing epoxy based mortar (Sikadur $\circ R$ -31IN)
- Chemical Base: Epoxy Resin
- Packaging: Part A: 2 kg, Part B: 1kg
 3 kg x 2 sets,
 Part A: 4 kg, Part B: 2kg
 6 kg x2sets,
 Part A: 20 kg, Part B: 10kg
 30 kg x 1 set
- Colour: Grey Paste
- Shelf Life: 12 months from date of production
- Storage Conditions: Store properly in original unopened sealed and undamaged.
- Packaging: Dry conditions at temperatures between + 5°C and +40°C. Protect from direct sun light.
- Density: Part A+B Mixed: 1.80 ± 0.1 kg/L at 30° C
- Company Name: Sika India Pvt.Ltd.
- i) Repair
- j) Finishing
- 2) Horizontal gaps between adjacent layers of blocks: Settlement of RE walls are likely to achieve an equilibrium by 4 months continuous monitoring at Ramp B (close to abutment 3 of Teghoria Interchange Bridge) and Ramp D (close to abutment 0 of Link Road Flyover).
