Seismic Analysis of Re-Entrant Corner Plan Irregular Buildings with Roof Openings Using STAAD Pro: A Case Study for Zone III Earthquake Intensity

Sanjay Mayda¹, Surajmal Patidar²

¹PG Scholar, Civil Engineering Department, VITM College, Indore, India

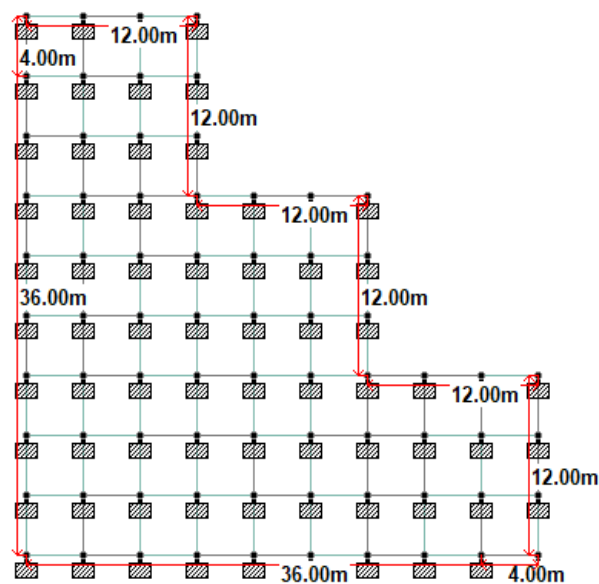
Fig. 1 Plan of G+6 structural model M1 with 0% Diaphragm Discontinuity

S.no	Model ID	Value
1	No. of Story	G + 6 Stories
2	Plan Area	36 Meters X 36 Meters
3	Story Height	3 Meters
4	Beam Size	500 millimeters X 500 millimeter
5	Column Size	600 millimeters X 600 millimeters
6	Column Spacing	4 Meters
7	Slab Thickness	150 millimeters
8	Grade of Concrete	M-25
9	Grade of Steel	Fe-550
10	Zone	Zone III
11	Shear Wall Thickness	150 millimeters

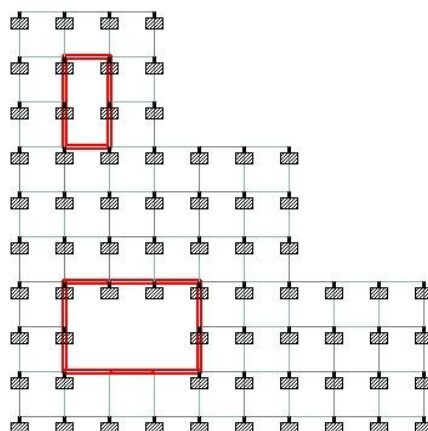
Fig. 2 Plan of G+6 Irregular Structural Model M2 with 15% Diaphragm Discontinuity in Centre and Side Corners

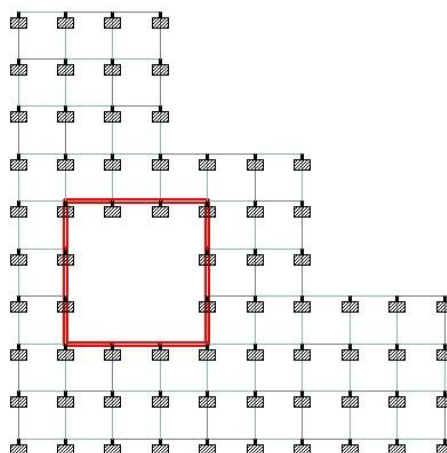
Fig. 3 Plan of G+6 Irregular Structural Model M3 with 17% Diaphragm Discontinuity in Centre

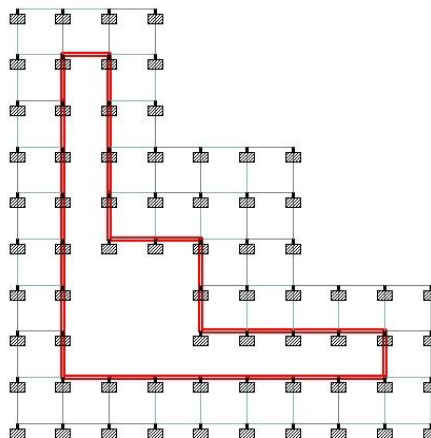
Fig.4 Plan of G+6 Irregular Structural Model M4 with 30% Diaphragm Discontinuity in L- Shape in Centre

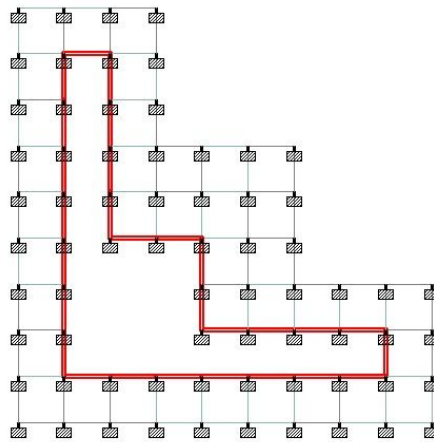
Fig.5 Re-entrant Plan Irregular Building with L Shape of Diaphragm Discontinuity

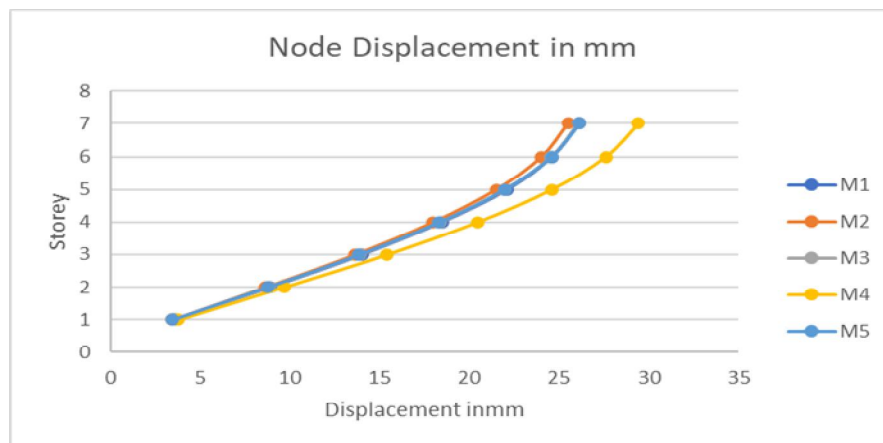
Graph No.1 Node Displacement For All Model

- 1) Models M2 and M4 generally exhibited higher node displacements across all storeys, suggesting decreased lateral stability as the percentage of diaphragm discontinuity increased.
- 2) Model M3 consistently showed lower node displacements, indicating better overall lateral stiffness and stability.

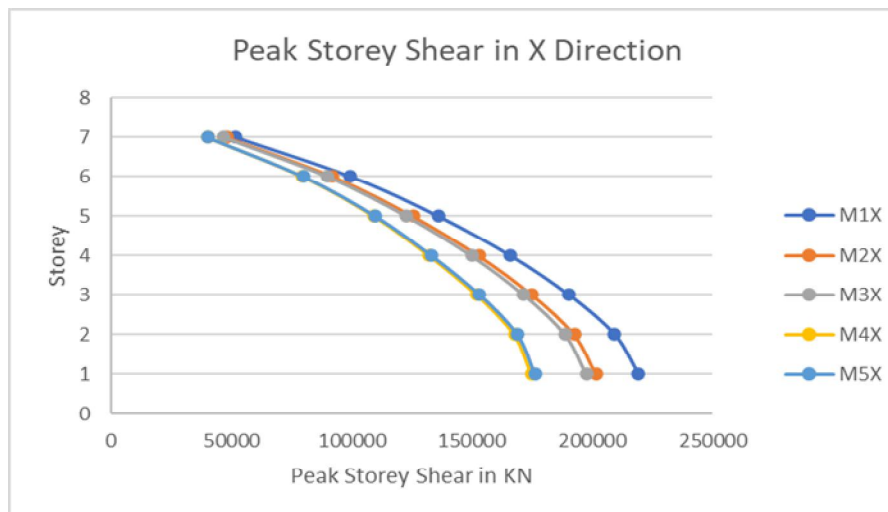
Graph No.2 Peak Storey Shear for all Model In X Direction

- 1) Model M2 consistently demonstrated the highest storey shear values, both in the X and Z directions, indicating that it experiences the highest lateral shear forces among the models.
- 2) Model M3 often followed M2 in terms of storey shear values, although the values were generally slightly lower.
- 3) Models M1, M4, and M5 exhibited lower storey shear values, with M1 frequently having the lowest shear values among them.

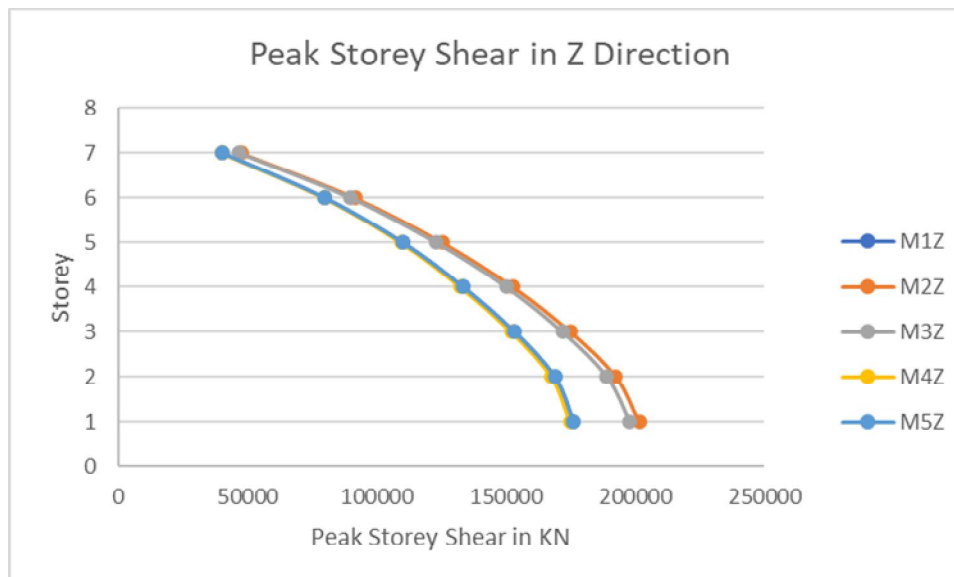
Graph No.2 Peak Storey Shear for all Model In Z Direction
