Seismic Analysis of Re-Entrant Corner Plan Irregular Buildings with Roof Openings Using STAAD Pro: A Case Study for Zone III Earthquake Intensity

Sanjay Mayda¹, Surajmal Patidar²

¹PG Scholar, Civil Engineering Department, VITM College, Indore, India

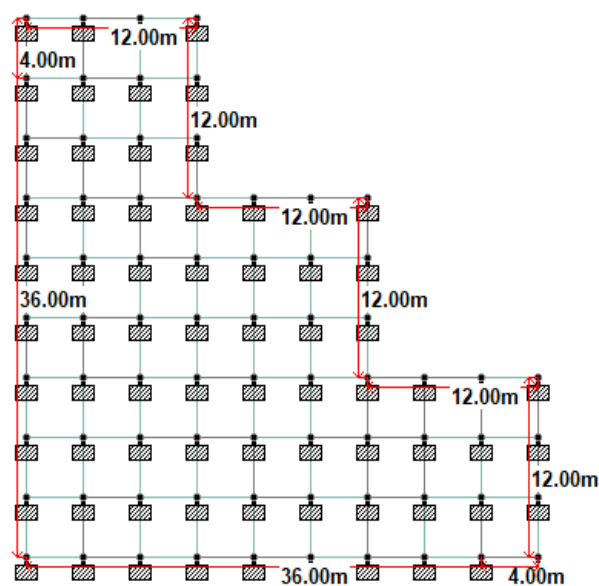
Fig. 1 Plan of G+6 structural model M1 with 0% Diaphragm Discontinuity

S.no	Model ID	Model Description
1	M1	Re-entrant Plan Irregular building with 0% Diaphragm Discontinuity
2	M2	Re-entrant Plan Irregular Building with 15% Diaphragm Discontinuity
3	M3	Re-entrant Plan Irregular Building with 17% Diaphragm Discontinuity
4	M4	Re-entrant Plan Irregular Building with 30% Diaphragm Discontinuity
5	M5	Re-entrant Plan Irregular Building with 32% Diaphragm Discontinuity

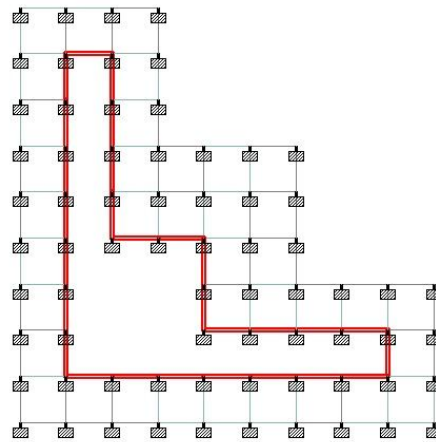
Fig.5 Re-entrant Plan Irregular Building with L Shape of Diaphragm Discontinuity
