Volume: 10 Issue: V Month of publication: May 2022

Seismic Retrofit or Rehabilitation of the Structures/Buildings - A Review

Jaineshwar Verma¹, Satish Parihar²

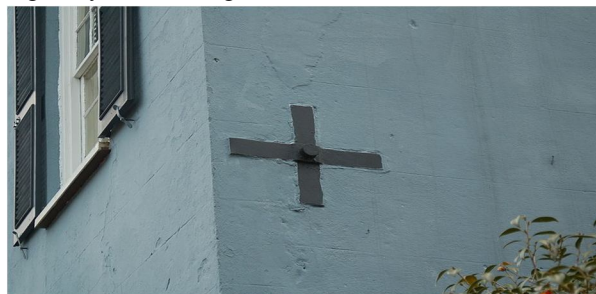
The uses of external post-tensioning for new structural systems have been developed in the past decade. A large-scale U.S./Japan joint research program, unbounded post-tensioning high strength steel tendons have been used to achieve a moment-resisting system that has self-centering capacity.

Pre-stressing can increase the capacity of structural elements such as beam, column and beam-column joints. External pre-stressing has been used for structural upgrade for gravity/live loading since the 1970s.

Fig. External post-tensioning

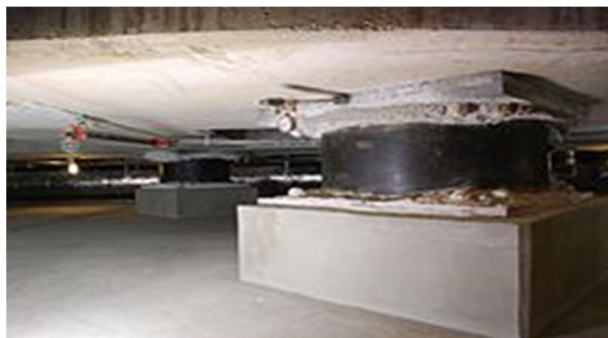
Base isolation is a collection of structural elements of a building that should substantially decouple the building's structure from the shaking ground thus protecting the building's integrity and enhancing its seismic performance. This earthquake engineering technology, which is a kind of seismic vibration control, can be applied both to a newly designed building and to seismic upgrading of existing structures. Normally, excavations are made around the building and the building is separated from the foundations. Steel or reinforced concrete beams replace the connections to the foundations, while under these, the isolating pads, or base isolators, replace the material removed. While the base isolation tends to restrict transmission of the ground motion to the building, it also keeps the building positioned properly over the foundation. Careful attention to detail is required where the building interfaces with the ground, especially at entrances, stairways and ramps, to ensure sufficient relative motion of those structural elements.

Fig. Base isolation

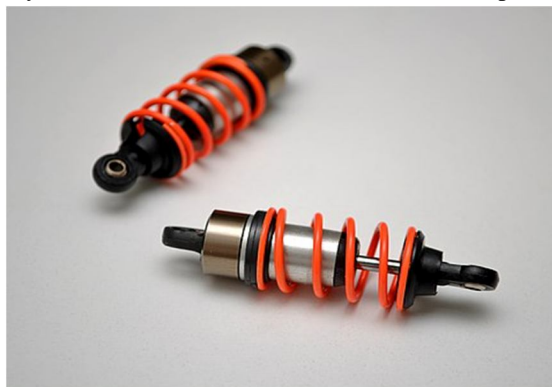
Supplementary dampers absorb the energy of motion and convert it to heat, thus damping resonant effects in structures that are rigidly attached to the ground. In addition to adding energy dissipation capacity to the structure, supplementary damping can reduce the displacement and acceleration demand within the structures. In some cases, the threat of damage does not come from the initial shock itself, but rather from the periodic resonant motion of the structure that repeated ground motion induces. In the practical sense, supplementary dampers act similarly to Shock absorbers used in automotive suspensions.

Fig. Supplementary dampers

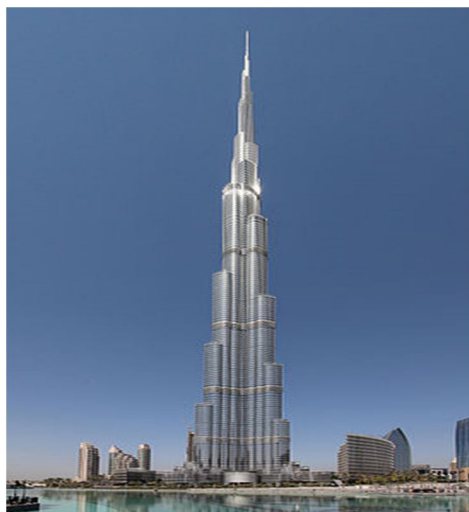
Very tall buildings ("skyscrapers"), when built using modern lightweight materials, might sway uncomfortably (but not dangerously) in certain wind conditions. A solution to this problem is to include at some upper story a large mass, constrained, but free to move within a limited range, and moving on some sort of bearing system such as an air cushion or hydraulic film. Hydraulic pistons, powered by electric pumps and accumulators, are actively driven to counter the wind forces and natural resonances. These may also, if properly designed, be effective in controlling excessive motion – with or without applied power – in an earthquake. In general, though, modern steel frame high rise buildings are not as subject to dangerous motion as are medium rise (eight to ten story) buildings, as the resonant period of a tall and massive building is longer than the approximately one second shocks applied by an earthquake.

Fig. Skyscrapers

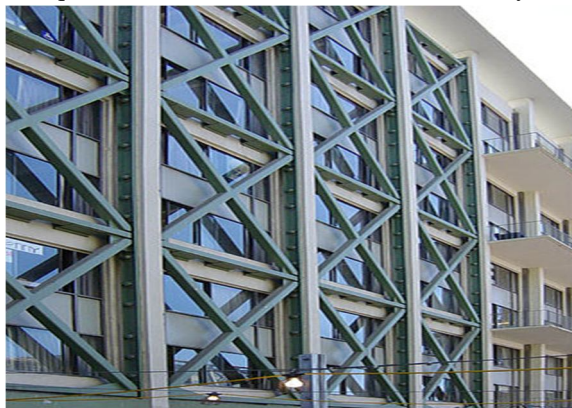
Shown here is an exterior shear reinforcement of a conventional reinforced concrete dormitory building. In this case, there was sufficient vertical strength in the building columns and sufficient shear strength in the lower stories that only limited shear reinforcement was required to make it earthquake resistant for this location near the Hayward fault.

Fig. Infill shear trusses

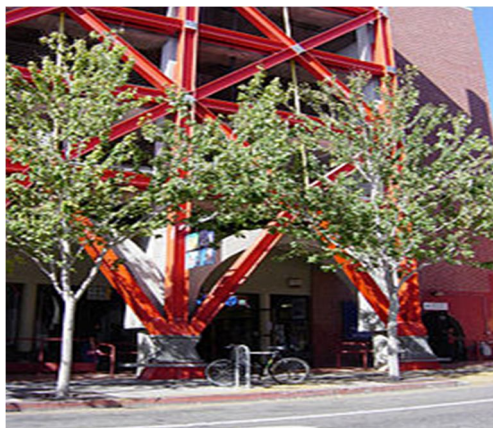
In other circumstances, far greater reinforcement is required. In the structure shown at right — a parking garage over shops — the placement, detailing, and painting of the reinforcement becomes itself an architectural embellishment.

Fig. Massive exterior structure

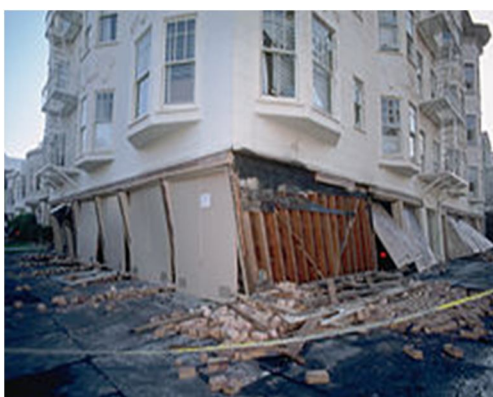
Fig. soft story collapse

This collapse mode is known as soft story collapse. In many buildings the ground level is designed for different uses than the upper levels. Low rise residential structures may be built over parking garages which have large doors on one side. Hotels may have a tall ground floor to allow for a grand entrance or ballrooms. Office buildings may have retail stores on the ground floor with continuous display windows.

Typically, where this type of problem is found, the weak story is reinforced to make it stronger than the floors above by adding shear walls or moment frames. Moment frames consisting of inverted U bents are useful in preserving lower story garage access, while a lower cost solution may be to use shear walls or trusses in several locations, which partially reduce the usefulness for automobile parking but still allow the space to be used for other storage.
