Seismic Retrofit or Rehabilitation of the Structures/Buildings - A Review

Jaineshwar Verma¹, Satish Parihar²

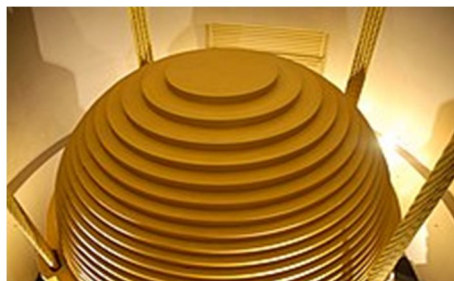
Tuned mass dampers (TMD) employ movable weights on some sort of springs. These are typically employed to reduce wind sway in very tall, light buildings. Similar designs may be employed to impart earthquake resistance in eight to ten story buildings that are prone to destructive earthquake induced resonances.

Fig. Tuned mass dampers

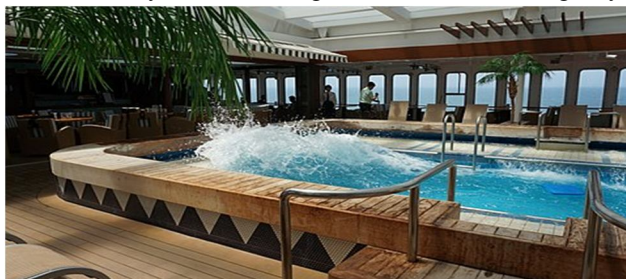
A slosh tank is a large container of low viscosity fluid (usually water) that may be placed at locations in a structure where lateral swaying motions are significant, such as the roof, and tuned to counter the local resonant dynamic motion. During a seismic (or wind) event the fluid in the tank will slosh back and forth with the fluid motion usually directed and controlled by internal baffles – partitions that prevent the tank itself becoming resonant with the structure. A slosh tank is a passive tuned mass damper. In order to be effective the mass of the liquid is usually on the order of 1% to 5% of the mass it is counteracting, and often this requires a significant volume of liquid. In some cases these systems are designed to double as emergency water cisterns for fire suppression.

Fig. slosh tank
