# Speed and Crash Analysis: A Case Study of Bangalore-Mysore Expressway

**Keywords:** *crash risk analysis, speed, road safety audit, spot speed analysis, black spot*

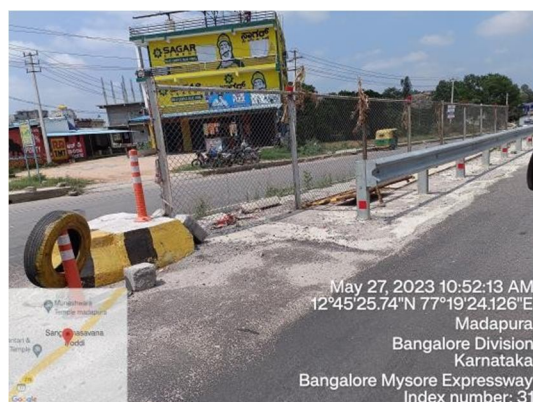
No End Treatment

- 13) Install W-Beam Crash Barriers on the raised median and across deep drainage ditches (with a rough surface).
- 14) The modern solution is to provide the crash cushion or impact attenuators at the end of the W-beam guard rail, which must be flared away.

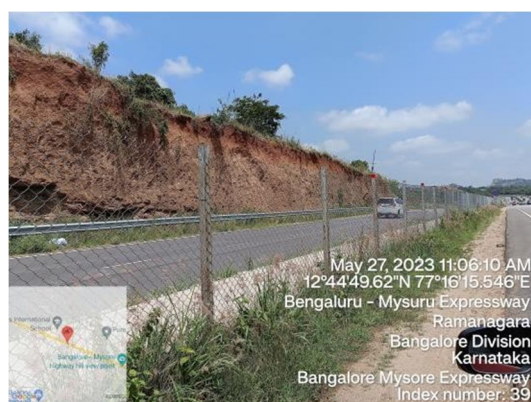
No Slope Protection

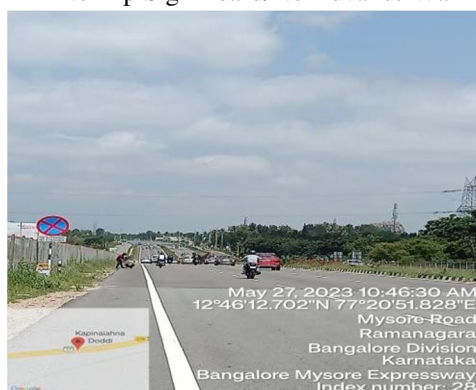
No Dip Sign Board/No Advance Warning

- 3) Guardrails were missing and medians were not adequately maintained; as a result, IRC-119 must be notified that guardrails are present.
- 4) Proper signage that should be posted in accordance with IRC-67 is missing.

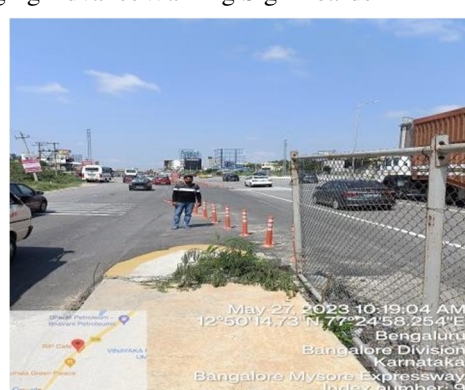
No Merging /Diverging Advance Warning Sign Boards

- 12) Provide a convergent and divergent Chevron marking sign in accordance with the appendix IRC Table A.3 for 2015 8. For the full longitudinal Stretch, provide Edge Line Marking LM24/25 and LaneMarking LM18/19.

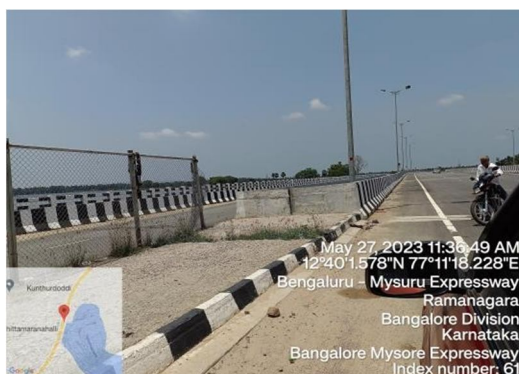
Illegal Approach From Service Road To Nh

- 9) At the Service Road Diversion, post a Hazard Marker and a Pass on either Side Sign.
- 10) In addition to EMERGENCY, the Warning Signs for the cut in the median must be visible at 180-245 meters from the Hazard. turn with caution while maintaining a reasonable distance

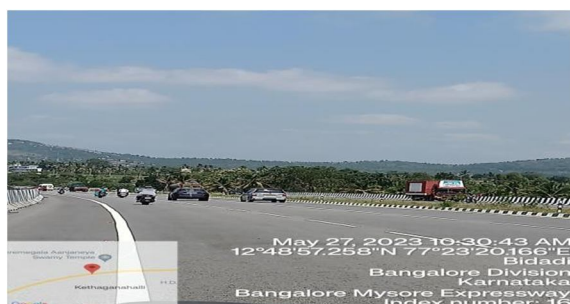
No Advance Warning About Curve/Cheron Marker/Delinataor

- 1) The influence of a warning sign before a sharp bend on approaching and navigating cars will vary depending on where it is placed.
- 2) The location of warning signs affects how drivers lane-position their cars before sharp turns. In comparison to warning signs placed at 0 m or 50 m, drivers would drive more closely to the centerline in tangents if they were placed at 100 m, 200 m, or 400 m before acute curves.

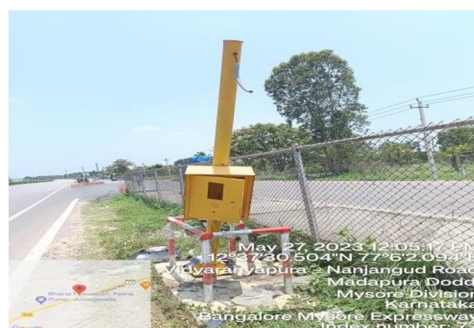
Sos Not Working
