Speed and Crash Analysis: A Case Study of Bangalore-Mysore Expressway

Sanketh Gowda B S¹, Akshatha², Kushal Kumar R³

The proposed route is the NH 275 expressway from Bangalore to Mysore (toll from Bangalore to Nidaghatta– State of Karnataka) which is 50.5 km long. This study deals with the inventory of roads, the inventory ofsignaling, the inventory of traffic volumes, the study of point speed, the study of speed and delays, and other investigations. Accident data has been collected for the 2017-2022 stretch period and analysis is beingconducted. The goal of the study is to evaluate the road safety audit of a section of the Six-Lane National Highway (NH)-275 and the speed analysis and focus on assessing the benefits of proposed actions as a result of deficiencies identified through the audit process. Missing and medium marks must be made and speed readings should match the speed. Speed restriction and control of speed in curves and straight portionsare also deficient, requiring immediate action.

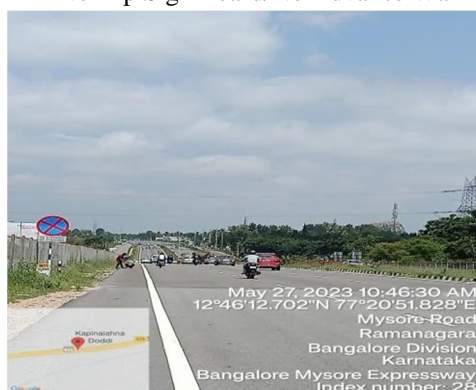
No Dip Sign Board/No Advance Warning

- 3) Guardrails were missing and medians were not adequately maintained; as a result, IRC-119 must be notified that guardrails are present.
- 4) Proper signage that should be posted in accordance with IRC-67 is missing.

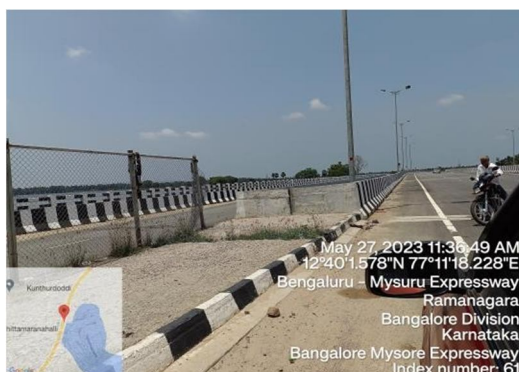
Illegal Approach From Service Road To Nh

- 9) At the Service Road Diversion, post a Hazard Marker and a Pass on either Side Sign.
- 10) In addition to EMERGENCY, the Warning Signs for the cut in the median must be visible at 180-245 meters from the Hazard. turn with caution while maintaining a reasonable distance

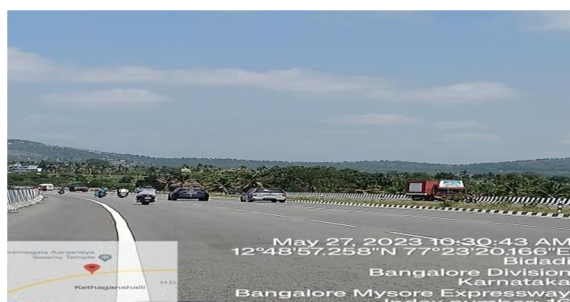
No Advance Warning About Curve/Cheron Marker/Delinator

- 1) The influence of a warning sign before a sharp bend on approaching and navigating cars will vary depending on where it is placed.
- 2) The location of warning signs affects how drivers lane-position their cars before sharp turns. In comparison to warning signs placed at 0 m or 50 m, drivers would drive more closely to the centerline in tangents if they were placed at 100 m, 200 m, or 400 m before acute curves.

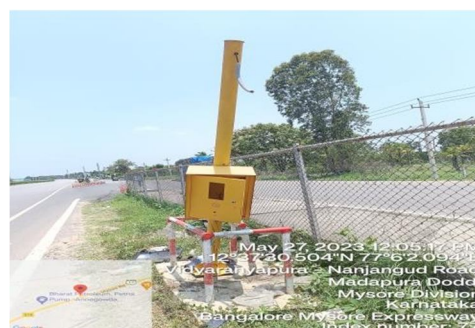
Sos Not Working
