# Speed and Crash Analysis: A Case Study of Bangalore-Mysore Expressway

Sanketh Gowda B S<sup>1</sup>, Akshatha<sup>2</sup>, Kushal Kumar R<sup>3</sup>

*The proposed route is the NH 275 expressway from Bangalore to Mysore (toll from Bangalore to Nidaghatta- State of Karnataka) which is 50.5 km long. This study deals with the inventory of roads, the inventory of signaling, the inventory of traffic volumes, the study of point speed, the study of speed and delays, and other investigations. Accident data has been collected for the 2017-2022 stretch period and analysis is being conducted. The goal of the study is to evaluate the road safety audit of a section of the Six-Lane National Highway (NH)-275 and the speed analysis and focus on assessing the benefits of proposed actions as a result of deficiencies identified through the audit process. Missing and medium marks must be made and speed readings should match the speed. Speed restriction and control of speed in curves and straight portions are also deficient, requiring immediate action.*

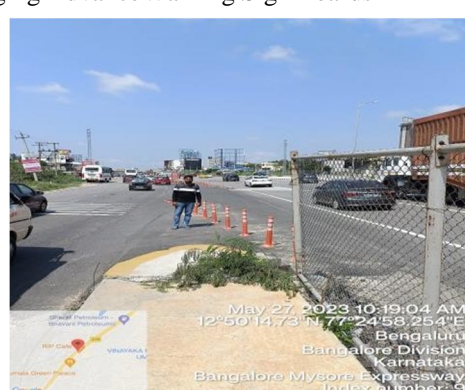
No Merging /Diverging Advance Warning Sign Boards

- 12) Provide a convergent and divergent Chevron marking sign in accordance with the appendix IRC Table A.3 for 2015 8. For the full longitudinal Stretch, provide Edge Line Marking LM24/25 and LaneMarking LM18/19.

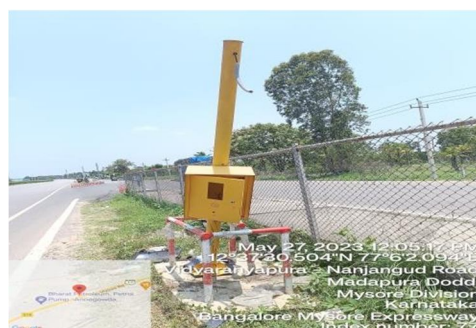
Sos Not Working
