Improving Strength in Brick Column by Providing Electro Welded Wire Mesh

Abstract: This research paper has been selected to explore the procedure of making the brick masonry columns more strong and durable in resisting the compressive forces by using the wire mesh and hence reduces the cross sectional area of column, which increases our floor area. The size of wire mesh is2mm diameter of wire and 15mm X 15mm spacing. Three samples of sizes 9 inch X 9 inch have been used. Out of which the sample no. 1 is simple and In sample no. 2 & 3 wire mesh have been placed in the odd and even mortar joints (coarse no.1, coarse no.3, coarse no. 5 & coarse no. 2, coarse no.4). The ratio of Cement & Mortar is kept same for all the samples i.e. 1:3 (one part of cement and three parts of sand). The tests shows that the sample no.2 gave the strength 1.9 times the strength of sample no.1 and sample no.3 gave the strength 1.8 times the strength of sample no.1. Thus the columns become stronger and columns also show ductile behavior during failure.

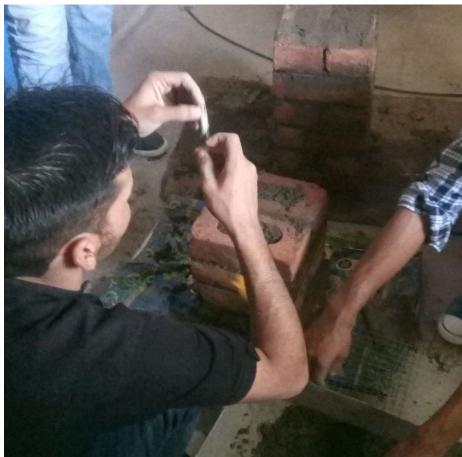
1) Sample no. 1: As discussed earlier that the sample no.1 is simple which means that it is not reinforced with any material. In this the bricks are laid on a prepared platform which is mainly of wood and the mortar thickness is kept ½ inch. As shown in figure below

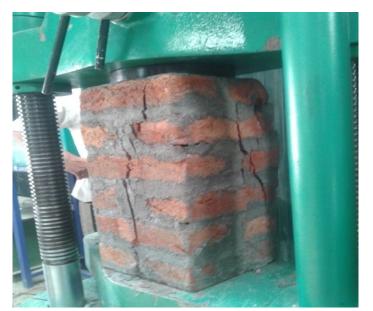
Failure pattern of sample no. 1

- C. Testing
- 1) Test of sample no. 1:In case of plane brick columns, all the two samples show brittle failure. Major cracks were vertical, however, few horizontal cracks were also observed. The vertical cracks passed through the joints and bricks, while horizontal cracks were through joints only. he cracks widening and propagation was quite fast after their first appearance. Near failure, the specimen demonstrated outwardbulging on all four faces. As shown in figure below:

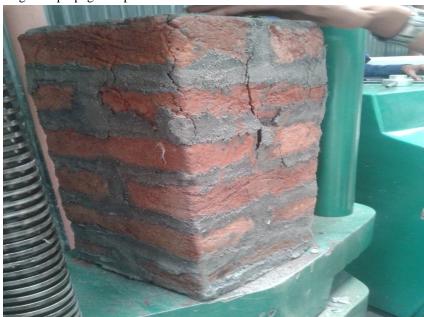
Failure pattern of sample no. 2

2) Test of sample no. 2:In this case wire mesh is placed in the odd horizontal joints i.e. 1, 3 & 5. The column develops the very few minute vertical cracks on application of axial load. The vertical cracks fail to pass through the reinforced joints and no horizontal cracks were developed. The crack growth was quite stable and widening rate was much slower than the other samples. This slow rate of crack growth can be attributed to wire mesh presence inside the joints which helped in arresting the cracks during their propagation process.

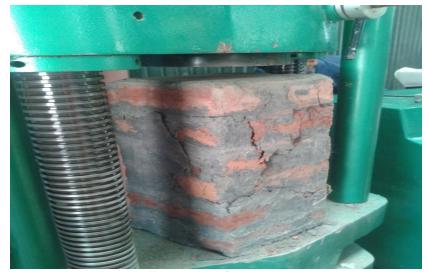
Failure pattern of sample no.3

3) Test of sample no. 3:In this case wire mesh is placed in the even horizontal joints i.e. 2, 4. The column develops the major cracks vertically as well as horizontally while applying the axial loads. The vertical cracks fail to pass through the reinforced joints but the face of the column bulges out at the centre above the reinforced joint due to the restrictions developed by mesh. Near failure small chunks of bricks and mortar fell of the specimen, but no significant spilling was observed.
