Analysis of Transformer Bushing Failure Based on Frequency Response Analysis (FRA)

Abstract: Frequency Response Analysis (FRA) is the most reliable technique for detecting any failure within electrical power transformers. In this paper the FRA technique to identify non-mechanical faults such as transformer bushing failures. The transformer failure on the mark of the FRA strategy has been explored, no standard code has been broadly received. Moreover, the FRA technique is ineligible in identifying minor levels of energy transformer fault that declines the transformer's capacity to withstand any further electrical, thermal and mechanical stresses. The FRA technique properly, the base discovery of transformer issues ought to be evaluated. This paper expects to recognize the effect of the base level of transformer bushing failure on the FRA signature that can be outwardly identified. A 3-phase control transformer is recreated (in light of the Finite Element Analysis (FEA) technique) to mirror its genuine operation amid both solid and broken conditions. The effect FRA marks (in light of FEA) for different bushing failure levels was acquired and afterward contrasted with the solid mark,

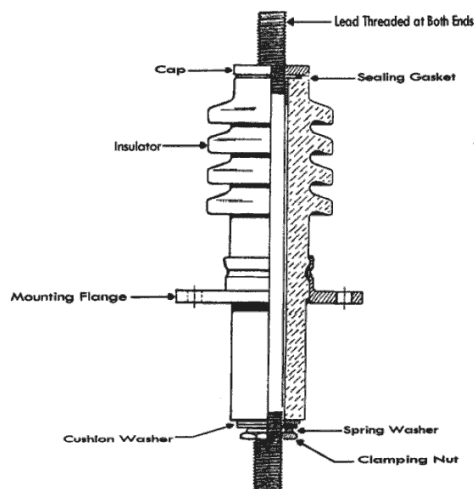
Fig.1. The general constructional diagram of bushing

The power transformer bushing is a sort of porcelain or ebonite post encasing put on the best or side of the transformer tank through which associations are made to the outer circuit. The general constructional points of interest are appeared in Fig.1. The dynamic piece of the bushing comprises of oil Impregnated Paper (OIP) center made from unrivaled review Kraft protecting paper with condenser evaluated layers for field control twisted under strain on focal tube/conductor. The deepest condenser layer is electrically associated with the settling rib through a test tap. The center is dried under warmth and vacuum and afterward impregnated with prevalent review of protecting oil. Porcelain covers on the upper and lower sides of the bushing, oil insulation brilliant elastic gaskets and 'O' rings are held together with the focal tube by methods for an arrangement of intense springs. The settling rib is given a test tap for the estimation of Capacitance and Tan delta, air discharging screw to discharge the air caught in the transformer amid fixing up of oil or can be associated with Buchholz transfer, name plate giving the item points of interest, handle/eyebolt for lifting and space for ring sort CT's on the oil end of the bushing. At the oil end, an epoxy covered anxiety shield or base plate is given to control the high worries in oil inside the transformer. A separable base circular segment shield is accommodated bushing evaluated 245 KV or more. The interceding space between the center of the transformer and the porcelain covers is loaded with uncommonly treated mineral oil under vacuum. A kaleidoscopic (upto 300KV) or attractive (upto 400 KV) oil locate glass is given on the

development bowl . A best terminal is given to interface with the over head line. Arcing horns are given on ask for in the middle of best shield and base plate.

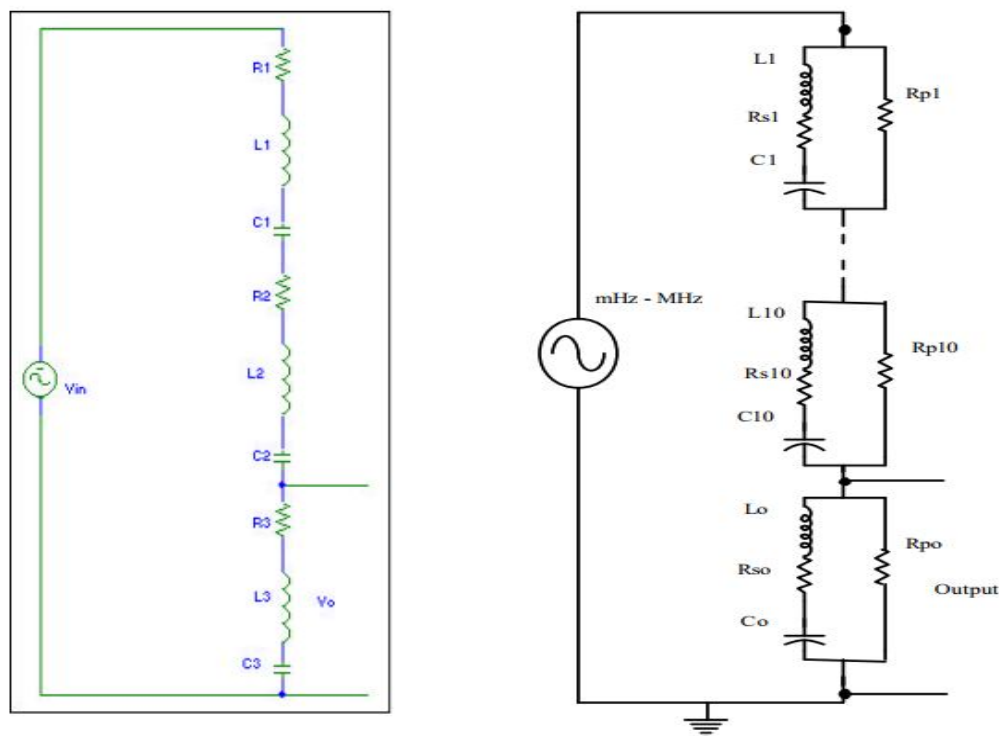
Fig.2. Equivalent Circuit model of bushing

To set up the attainability of utilizing TFA/FRA for fault location in bushings a bushing proportional circuit display is considered. Despite the fact that when all is said in done bushings are considered as non-inductive capacitor and resistive component organize, in the present examination the leftover (self) inductance is additionally considered to think about the impact of this inductance on the affectability of the method. The aggregate misfortunes in the bushing can be either spoken to as a proportional arrangement or parallel insulation. In the models considered both arrangement and parallel portrayals are considered alongside some conceivable

mixes of both arrangement and parallel resistors (eight combinational circuits were dissected). This has been done to build up the affectability of the method to equal circuit portrayal and comprehend the physical wonders.

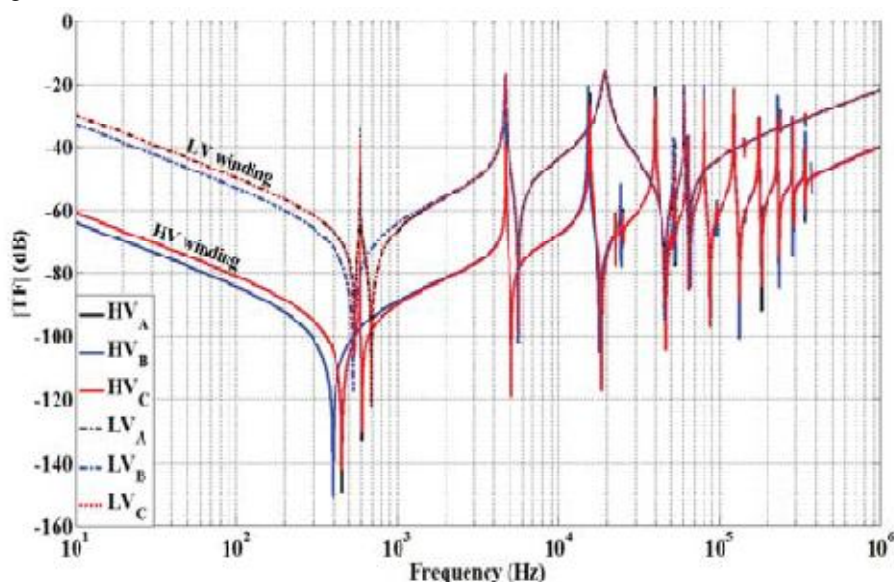
Fig.3. HV and LV windings FRA analysis.

The FRA technique is directed on the 40MVA transformer to get a solid FRA magnitude signature by infusing a variable frequency low amplitude AC voltage (v_{in}) at one terminal of the HV winding, and measuring the reaction signal over another terminal of HV winding (v_{out}). The FRA mark of the 40MVA transformer HV winding is plotted as a transfer function work for the three phases (A, B and C) shown in Figure

As can be found in Fig.3, the marks are characterized by resonances and anti-resonances frequencies over the whole frequency. As the frequency expands, more space harmonics are developed in the winding. At a low frequency range, resonances and anti-resonances frequencies are influenced by the inductive segments while the impact of capacitive segments is appeared in the high frequency run. Further, the FRA marks of the three phases are practically indistinguishable aside from the center (phase B). This variety can be ascribed to the slight contrast of the attractive motion amid phase B (contrasted with phases A and C).

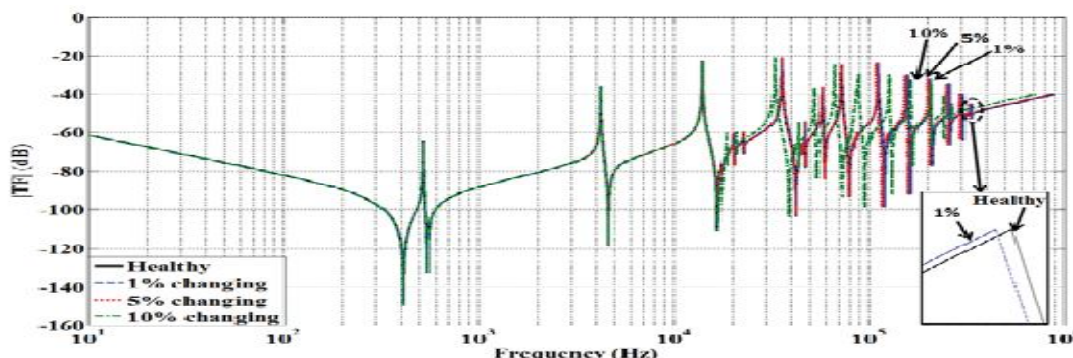
Fig.5. The failure levels of transformer bushing of 40MVA transformer HV winding on FRA signature.

As appeared in Figure 5, the effect of a 1% transformer bushing failure (changing the dielectric elements of transformer bushing by 1%) on the 40MVA transformer HV winding stage A FRA mark is gotten and contrasted with a sound mark. As uncovered Figure5, the sound and broken marks are practically indistinguishable, and it is hard to recognize any variety. A slight variety however can be outwardly recognized in the high recurrence go (50 kHz) when the transformer bushing failure increments to 5% (as appeared in Figure 5) that movements resonances and hostile to resonances frequencies in the high recurrence range to one side. The effect of the transformer bushing failure on the FRA signature turns out to be more articulated when the bushing failure level is expanded by 10% as appeared in Figure 5.
