Study of Current Quality Status of Groundwater around Tirunelveli Corporate Dumpsite in Ramayanpatti

Abstract: A common waste disposal method is dumping of solid waste on land and practiced almost all cities around the world. The nature of water quality depends on disposing of solid waste around the dump site. The present research is focused on monitoring ground water quality in the region of dumpsite leachate. Tirunelveli is one among the Indian cities facing acute problem in administering the solid waste. Sixteen locations were identified and samples were collected from the wells with in immediate vicinity and further away from the dumpsites for analysis. The samples were analyzed for pH, dissolved oxygen, chemical oxygen demand, acidity, alkalinity, electrical conductivity, total dissolved solids, hardness, chlorides, and sulphates. This study concluded that the leachate from dumpsite had intruded in ground water in particular direction making it not suitable for domestic purpose.

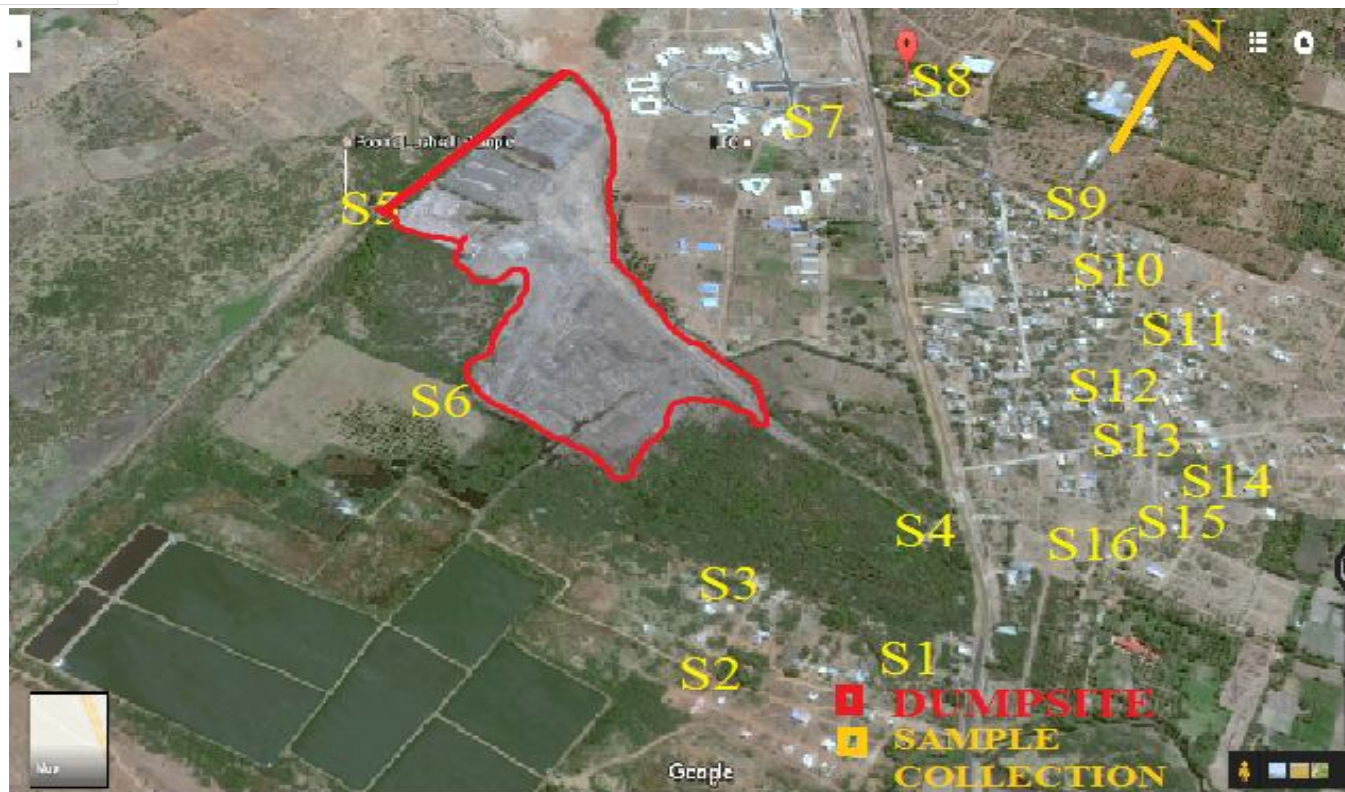
Fig No. 1. Sample Collection Points At Ramayanpatti Dumpsite

The dumping site spreads for about 118 acres of land having an elevation of 47m. Tirunelveli Corporation disposes nearly 180 tons of garbage every day in which the per capita waste is around 379g. The average rainfall is 1511.5mm. Due to improper maintenance of dumping site area the surrounding bore holes have been contaminated.
