Monitoring Geomorphic changes due to Flooding in an Arunavati River Basin by Total Station

Sanjay U Chaudhari¹, Hemraj R. Kumavat², Vikram J Patel³

Abstract: *The research study was conducted along the river line of the Arunavati, which are frequently affected by the floods and due to that erosion is happening. Total station survey (TSS) useful for detecting the land cover change & estimation of sediment capacity, therefore suggesting the necessary steps for precautions needed for future flooding pattern. Research focus on the problem of an unnecessary widening of bank full width by TSS. This problem is serious and should be inspected regularly. Otherwise, there is a chance of river widening which can lead greater damage to surrounding features which is located near the site of river line. Observations taken by TSS include flood and existing river line, Geomorphic changes in Bank full width, channel migration, longitudinal profiles and cross section. In the first section, the left side of river span increases 35 to 40% of its actual span. Due to curvature the outer span of the river is scouring rapidly, the same time the silt is continuously deposited on the inner span, So that e

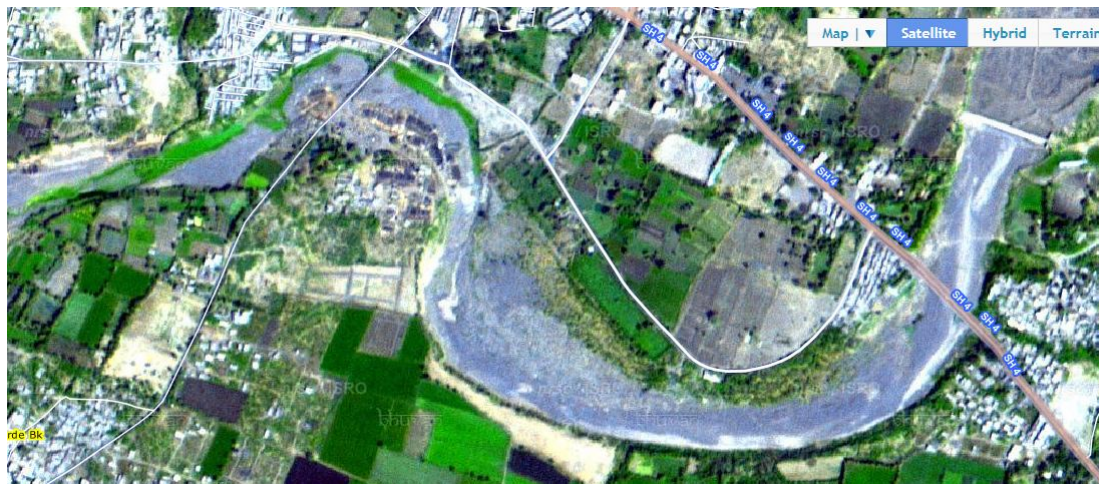
Fig. 1 Satellite image of Study Area

In addition to observations of the study area in form of Satellite image in figure no.1, the field work included identification of various landforms, processes, origin, structure deposition, weathering, soil and sedimentary profiles, drainage network, the channel forms, gradient types of flow channel, cross-section parameters, erosional and depositional features.
