# Evaluation and Visualization of surface Defects on Automotive Body Panels by Root-Cause Methodology

N. Nandakumar<sup>1</sup>, S. Siva<sup>2</sup>

<sup>1,2</sup>Department of Mechanical Engineering, Government College of Technology, Coimbatore.

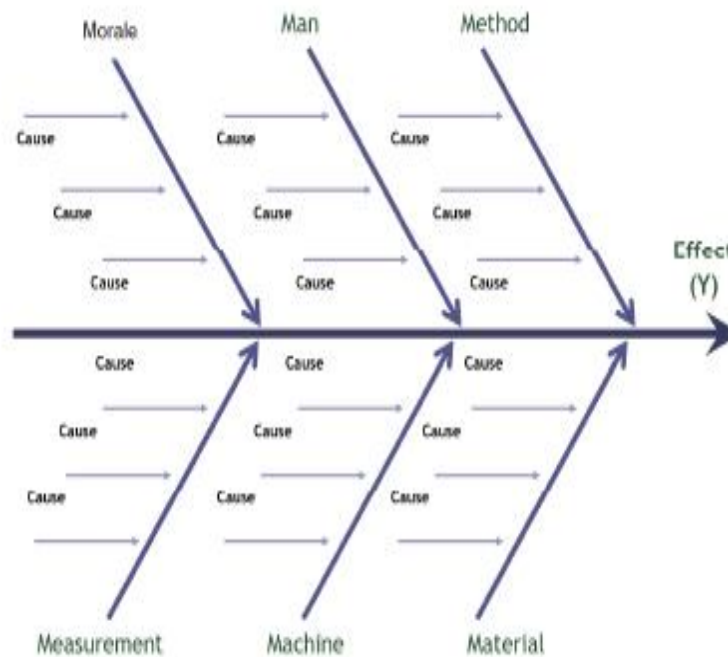
Figure 3 Fish Bone Diagram

This fishbone diagram is prepared using 6M principle of Toyota Production System (TPS). The potential causes for Inefficient Time Management are contributed by Man / People, Material, Method /Process and Measurement. Our solution tries to address these elementary level causes as much as possible. After the problem was identified the group was split into two. One group analyzed the causes for dents and the other identified the causes for scratches. The fish bone diagram is depicted below. Linear analysis was done in various stations across the plant.

6M analysis was carried out each and every station of the different lines through personal examination of the works. The operations of the workers, the tools used, the materials used were observed thoroughly.

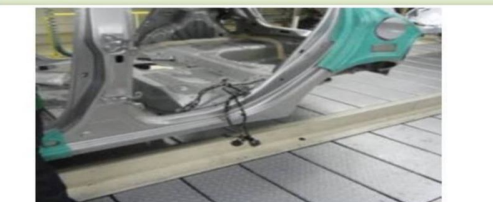
<p>Wiring loom and tail gate release cable hitting with body at aperture area</p> <p>Proposed</p>

<p>Aperture to be covered and parts handling to be improved by operators</p>
3	Door sub assembly 6M Methodology METHOD	Door	Doors are not tightly locked, easily shaking	<p>Dent at edges</p> <p>Current condition</p>

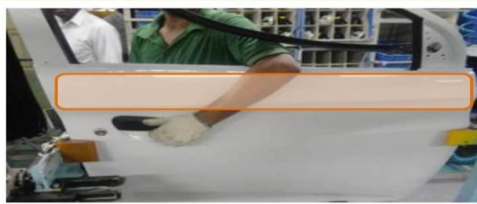
7	Door sub assembly 6M Methodology  METHOD	Divisional channel	Outside mirror plate and O/Side handle hitting with door	<p><b>Scratch</b></p> <p><b>Current condition</b></p>   <p>Fixing outside mirror plate and plastic door handle from the other side causes dent and scratches in door</p>

<p>Camouflage for the shaded area of doors supported at the side edges</p>
8	Final 3 6M Methodology  METHOD	Sill panel	Removal of Sill Protectors at beginning of final 3	<p style="text-align: center;"><b>Scratch and dent</b></p> <p style="text-align: center;"><b>Current condition</b></p>

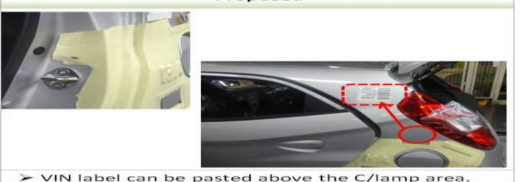
<p>Protectors got damaged due to improper seating of protector (Magnetic pad removed to accommodate VIN Label)</p> <p><b>Proposed</b></p>

<p>➤ VIN label can be pasted above the C/lamp area. ➤ Damaged protectors to be replaced and magnetic pad to be fixed again</p>
14	Final 3 6M Methodology  MAN	Aperture, Door	Operators handling many screws at a time	<p><b>Scratch</b></p> <p><b>Current condition</b></p>

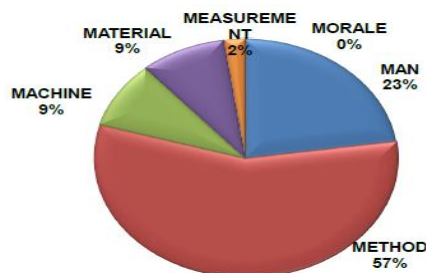
Figure 4 Chart representation of study result

Total number of observations made = 22

Total number of observations attributed to MAN = 5

Total number of observations attributed to METHOD = 13

Total number of observations attributed to MACHINE = 2

Total number of observations attributed to MATERIAL = 2

Total number of observations attributed to MEASUREMENT = 1
