# Magnetic Particle Inspection of Transmission Shaft using Machine Vision

**Abstract:** This paper aims to explain Industrial Process Automation. A system to automate the process of Magnetic Particle Inspection (MPI) has been proposed. This system incorporates Image Processing Techniques to automate the MPI process. The goal is to improve the accuracy of the current manual system and also reduce the falsification of jobs due to manual errors. The time of inspection of this system for one job will be 40 seconds compared to the current system which is approximately 50 seconds. In addition to this, the new system is also economical compared to the conventional system.

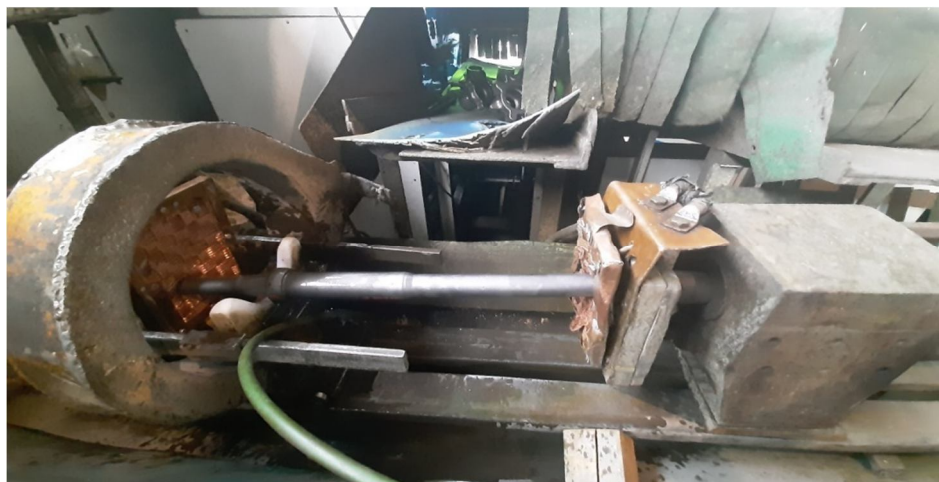
Fig I.1 Conventional System

In conventional system the shaft is mounted between two magnetic copper coils as shown in the figure and the worker sprays the ferromagnetic solution on it with the help of a pipe. This magnetizes the shaft after which it is sent to the UV light room for inspection. The worker in the UV light room then inspects the job for cracks under UV light. The time required for it is approximately 50 seconds. Now if the worker is working in second or third shift in the industry, the chances of him making manual errors due to fatigue are high and the time of inspection due to fatigue also increases. Hence, to eliminate the manual errors a new automated system has been proposed. In this system, the shaft will be mounted on two roller supports and a stepper motor coupled to it at one end to rotate the shaft. A rack and pinion mechanism will allow the camera to move along the length of the shaft. A DC motor will be coupled to the pinion and the UV will be mounted adjacent to the camera as shown in the figure.

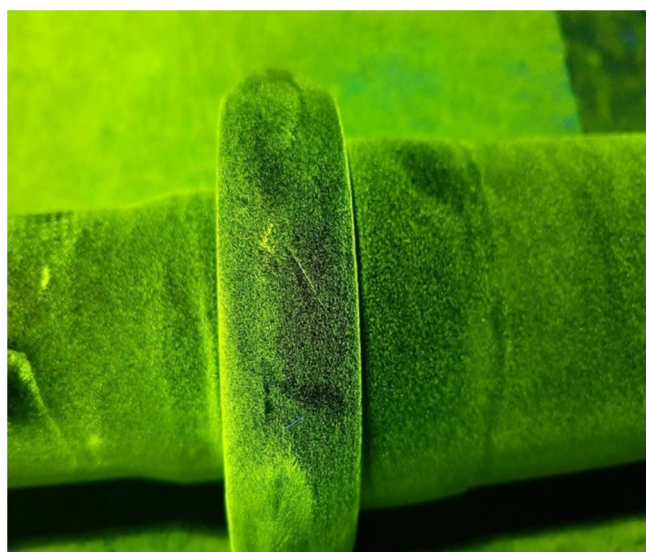
Fig II. 5 Crack detected under UV Light

The snaps taken by the camera get stored in the local memory of the microcontroller. The microcontroller will then send these snaps to the host device for image processing. The program for image processing is written using Canny Edge Detector Algorithm in Python. The program is written in such a way that if there is even 1 crack on the job, it will show the message “job rejected” and if there are no cracks on the job, it will show the message “job accepted.” So in this way, after the job is mounted, the entire process is automated and it will simplify the inspection process as a result of which the manual errors will be eliminated.
