# Automated Fabric Defect Detection

**Abstract:** Fabric defect detection is a significant phase of quality control in textile industry. Manual defect inspection lacks the accuracy and the labour cost is high. Automating this process is challenging due to large number of fabric types and defect types. Large number of Fabrics defects have the characteristics of low contrast and unclear, manual detection is very tedious and is inefficient. In order to resolve the key technology problem of automated fabric defect detection, is to develop a system to detect defects in uniform texture fabrics with image processing techniques and Neural Networks. The results indicated that the use of light beams based on the color of the material is more efficient than the white light beam.

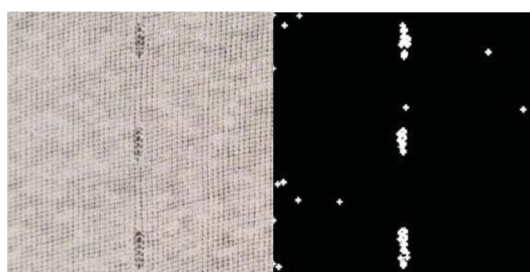
Fig 7, 9 and 11 show the original image samples that were used from the fabric defect glossary created by Cotton Incorporated. The above described operations were applied to those images. Fig. 8, 10 and 12 illustrate the resultant images, which highlight the defects of the fabrics. Then these images were used as the inputs to the Convolution Neural Network.

Fig 9: Dropped Stitches

Fig 10: Feature Extracted stitches
