Volume: 8 Issue: VIII Month of publication: August 2020

Mitigation of Salt-Induced Corrosion of Reinforcing Steel in Concrete using Rebar-Coating Technique

MS. Phan Văn Chương¹, Dr. Phạm Văn Khoa², Dr. Nguyễn Nam Thắng³

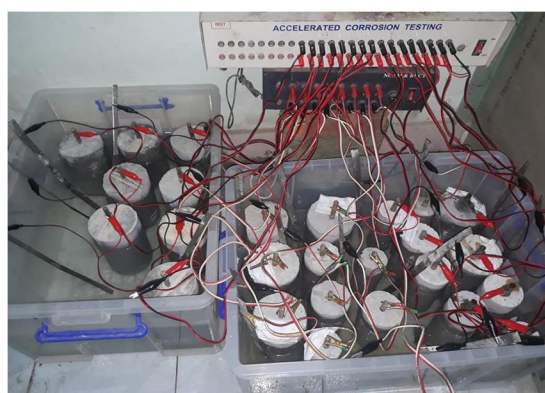
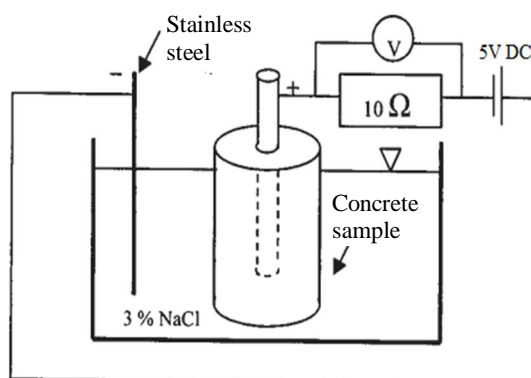
The technique of accelerated corrosion of reinforcing steel in concrete was adopted in the study. The reinforced concrete samples was cured for 28 days, then, put into the accelerated corrosion test. The samples were immersed in 3% NaCl solution so that water level was always 3cm away from the top of each sample. A rebar was connected to the anode of a 5V DC power supply while the cathode was connected to another stainless steel electrode immersed in a solution. Under the influence of the current, the diffusion rate of Cl^- ion into concrete increased sharply whilst the rebar corrosion accelerated; as a result, rust appeared and initiated the cracks in each sample. The amperage was measured regularly every 24 hours; at the same time, the surface state of the samples was observed. At the time of a surge in amperage, cracks together with rust appeared on the surface along the length of the rebar. The stronger the corrosion was, the less time it took from the starting time of the test to the time of current surge. The data of time served as a basis to clarify the difference in the corrosion levels of reinforcing steel in different types of concrete affected by different salinity levels and having the various types of rebar coatings. The testing diagram and samples are shown in Figure 1. Concrete aggregates used in the study are shown in Table 1.

Figure 1. Sample composition and testing diagram

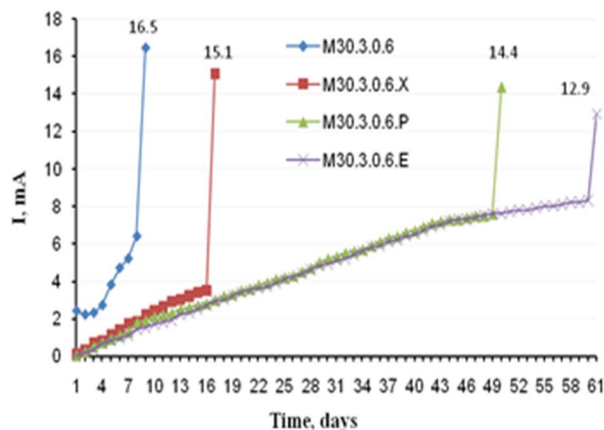
Figure 2. Effect of coating of rebar in concrete with $Cl^- = 0.6$ kg/m³ on time to crack initiation in sample

- 1) Concrete with salinity of 0.6 kg/m^3 : M30.3.0.6.P, M30.3.0.6.E, M30.3.0.6.X samples had times to crack initiation of 50, 61 and 17 days, equal to 556%, 678% and 189%, respectively of that of M30.3.0.6 reference sample.
- 2) Concrete with salinity of 1.2 kg/m^3 : M30.3.1.2.P, M30.3.1.2.E, M30.3.1.2.X samples had times to crack initiation of 47, 58 and 15 days, equal to 522%, 644% and 167%, respectively of that of M30.3.0.6 reference sample.
- 3) Concrete with salinity of 1.8 kg/m^3 : M30.3.1.8.P, M30.3.1.8.E, M30.3.1.8.X samples had times to crack initiation of 45, 54 and 11 days, equal to 500%, 600% and 122%, respectively of that of M30.3.0.6 reference sample.
- 4) Concrete with salinity of 2.4 kg/m^3 : M30.3.2.4.P, M30.3.2.4.E, M30.3.2.4.X samples had times to crack initiation of 42, 52 and 8 days, equal to 467%; 578% and 89%, respectively of that of M30.3.0.6 reference sample.

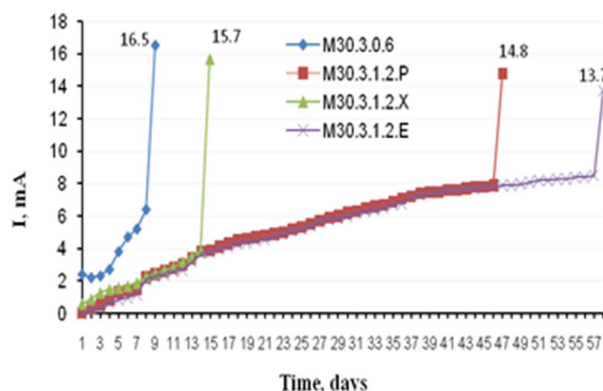
Figure 3. Effect of coating of rebar in concrete with $Cl^- = 1.2$ kg/m³ on time to crack initiation in sample

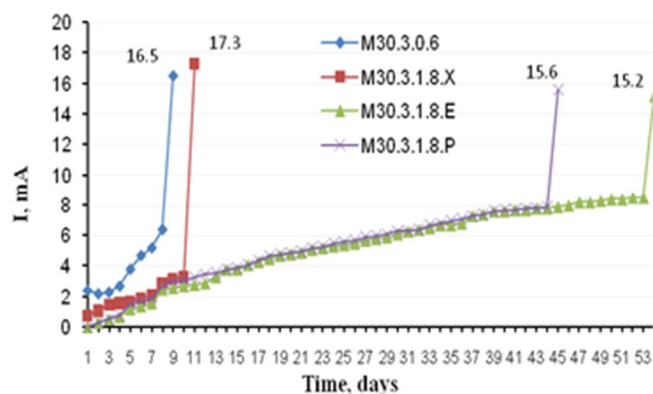
Figure 4. Effect of coating of rebar in concrete with $Cl^- = 1.8$ kg/m³ on time to crack initiation in sample

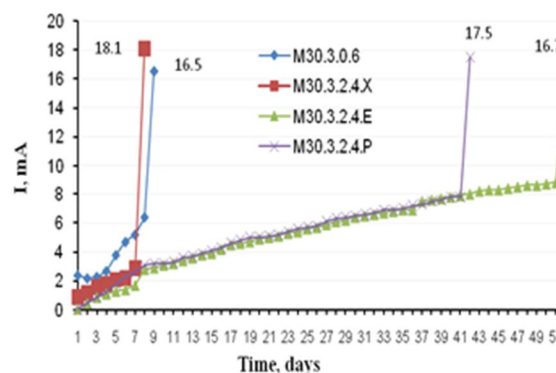
Figure 5. Effect of coating of rebar in concrete with $Cl^- = 2.4$ kg/m³ on time to crack initiation in sample

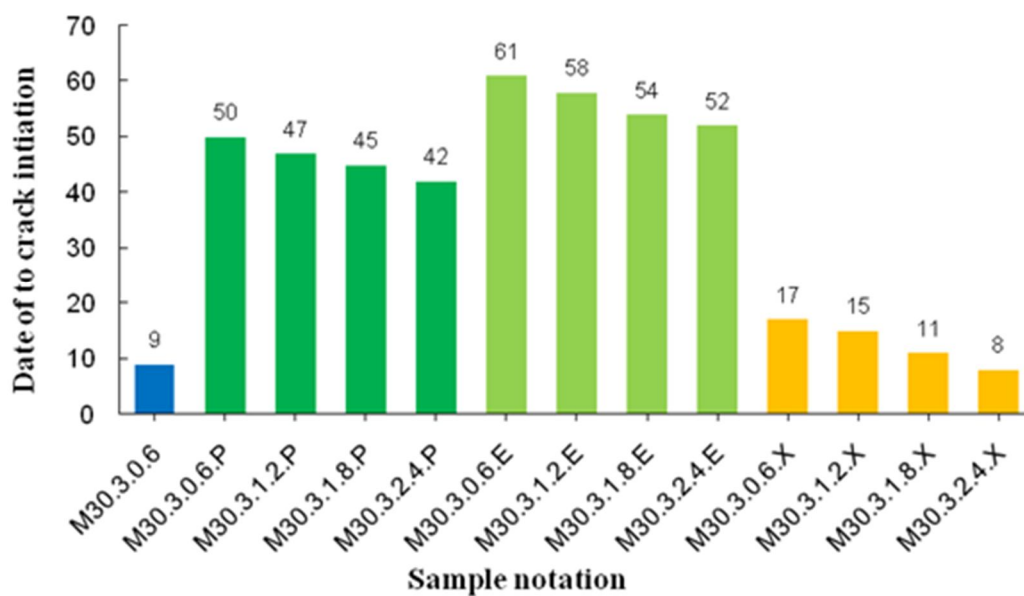
Figure 6 Comparison of cracking time of concrete with waterproofing B10 (M300), steel reinforcement paint with different salinity levels

In terms of the effect on corrosion mitigation for rebar at the times to crack initiation, at the given salinity levels, the surge in amperage values tended to increase while the times to crack initiation decreased. Therefore, the rebar corrosion level was reduced when rebars were coated in turn with epoxy, polyurethane and polymer cement. The epoxy, polyurethane and polymer cement were rated in descending order of film effect on corrosion mitigation for rebar. Specifically, at salinity level of 0.6 kg/m^3 , the times to crack initiation were 61, 50 and 17 days, respectively while amperage values at the times to crack initiation were 12.9, 14.4 and 15.1mA, respectively. At salinity level of 1.2 kg/m^3 , the times to crack initiation were 58, 47 and 15 days, respectively while amperage values at the times to crack initiation were 13.7, 14.8 and 15.7mA, respectively. At salinity level of 1.8 kg/m^3 , the times to crack initiation were 54, 45 and 11 days, respectively while amperage values at the times to crack initiation were 15.2, 14.8, 17.3mA, respectively. At salinity level of 2.4 kg/m^3 , the times to crack initiation were 52, 42 and 8 days, respectively while amperage values at the times to crack initiation were 16.7, 17.5, 18.1mA, respectively.

For this reason, it is said that rebar coating with Polyurethane and epoxy reduced corrosion level of rebar in concrete suffering from salinity from 0.6 to 2.4 kg/m^3 in comparison with that of the reference sample. On the contrary, the coating of polymer cement, in spite of its assured effect on mitigation of rebar corrosion level in case of salinity from 0.6 to 1.8 kg/m^3 , were incapable to reduce the rebar corrosion level in case of salinity of 2.4 kg/m^3 , both in comparison with that of the reference sample.
