Road Safety Audit of SH-26 Section from Khandwa to Chhegaon Makhan - A Case Study (M.P.) India

Siddhant Karahe¹, Dr. Sunil Sugandhi²

¹P.G.scholar, Transportation Engineering, ²Professor and Dean Academic, Civil Engineering Department of Jawaharlal Institute Of Technology Borawan, Khargone (M.P) India

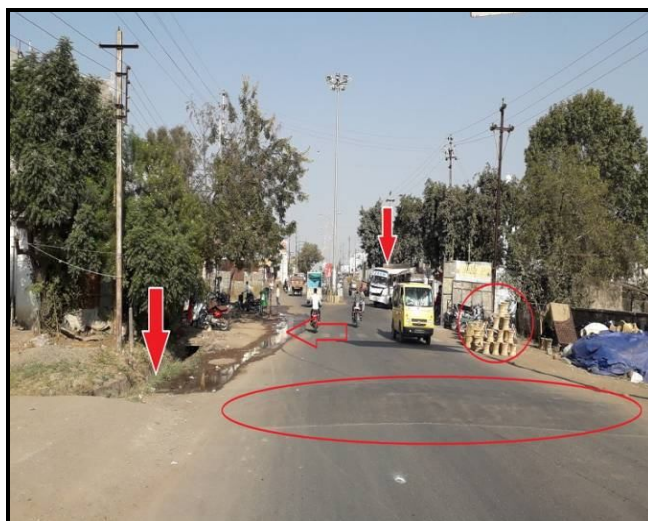
Figure 2:- Passenger boarding and alighting, Drainage problem, road side activity, non-engineered speed breaker at intersection. at bhairaw mandir square

Figure 2 showed that in this intersection Road markings missing, lack of pedestrian facilities and Passenger boarding and alighting at this junction. Road markings should be there to guide the traffic and lane division. Zebra crossings should be there for the safety of pedestrians. Bus stops causes' traffic jams on the highway and even accidents. It was not covered properly and the drainage water flooded at this junction which directly turned in to a major accidental creating situation among pedestrians. At bhairaw mandir square speed-breaker are not marked or poorly marked and contributing to accidents of different natures.

- A. At Bhairaw mandir square bus stops should be 60 meters away from the junction and Passenger boarding and alighting at junction should be avoided and Various roadside activities like temporary shops, tea-stalls, shops, advertising boards and private construction materials should be removed from the shoulder at junction, Retro-reflective materials or paintings to be used at all speed reducing devices, necessary regulatory and warning signs with clear visibility and retro-reflective markings on pavement, Properly marking on speed breaker with sign board.

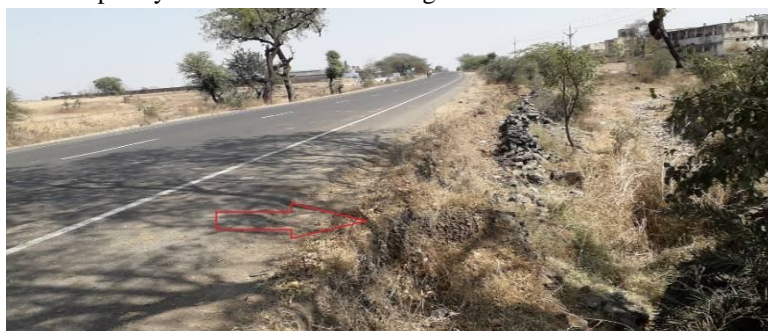
Figure 3:- steep embankments at near dondwada village.

Figure 3 showed that highway as constructed on high (10 to 15 feet) and steep embankments, batter slopes are quite dangerous for run off vehicles. According to Transport Research Laboratory (as cited in Handbook of Highway Safety Design and Operating Practices (1978), Federal Highway Administration, Department of Transportation, USA), standard/ safe batter slope should be between 1:4- 1:6 which is almost absent to the highway. According to locals, many accidents on this highway involve vehicles leaving the road and being in collision with hazardous obstacles such as trees or simply rolling down the high embankment.

- B. At near dondwada village the highway being constructed on high embankments, provision of safe batter slopes is costly. The risk of accidents can be significantly reduced by the use of guard rails or barriers. The purpose of the barrier is to absorb the impact with as little overall severity as possible.

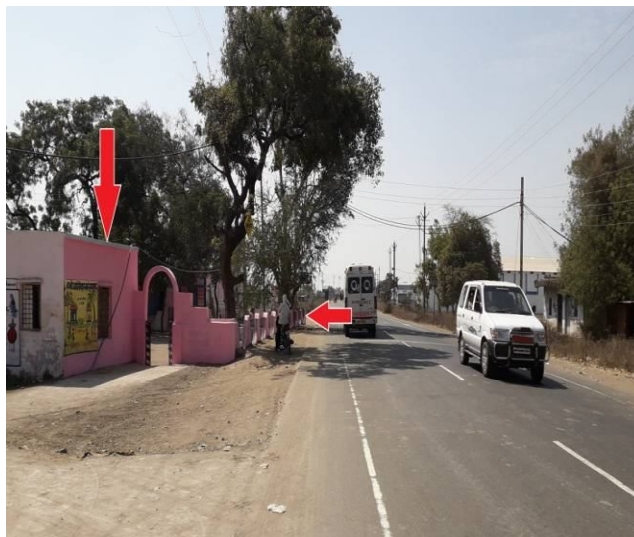
Figure 4:- School is very close to highway at Dondwada village (SH-26)

Figure 4 showed that there is a school on the left side of the highway at Dondwada village. It is approximately nearby village, and it appears most of the young children attending the school walk along the edge of the highway from the village. With an unpaved shoulder, children sometimes walk on the road pavement. This exposes them to a risk of a collision with fast-moving traffic and at Dondwada Village School is very close to highway (SH-26) this place is hazardous and contributing to accident. And the Boundary wall of school is on the shoulder this place is hazardous and contributing to accident. Posing surprise situations to drivers at night.

- C. At dondwada village appropriate signs should be erected to warn through traffics about school zones. In school zone area, raised sidewalks/ separated sidewalks should be provided. It is not possible to remove boundary of school but if we provide Retro-reflective materials or paintings to be used at boundary wall and Sign board for warning also provided.

- E. Pedestrian crossing markings, speed breaker on both side (enter& exist of school zone) with markings should be provided and speed limit sign board to control the speed of the vehicle. Appropriate speed reducing devices prior to the locations are to be provided. Crosswalks with appropriate marking and delineations should be placed. Appropriate signs should be erected to warn through traffics about school zones.

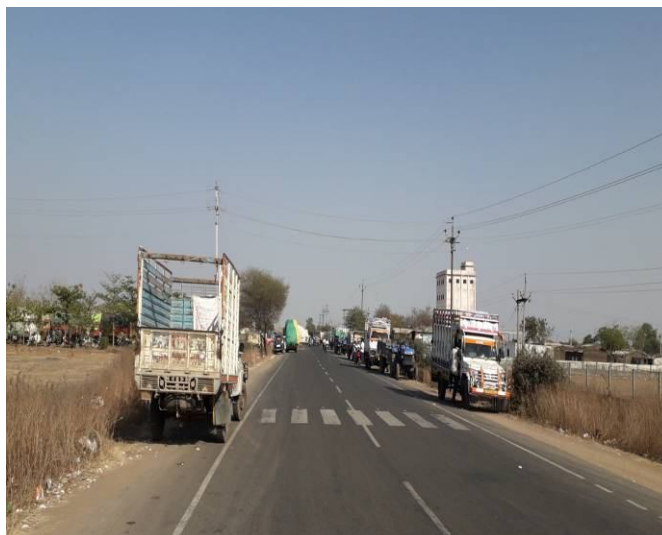
Figure 5:- No independent parking space was provided on road side at In Front of and approx near to Shree Dadaji Institute of technology & science (SH26)

Figure 5 showed The industries has been in working condition where in the peak hours the people working in Industries gets off their duties at that time this path becomes sensitive. The workers of the industries mainly used the two wheelers to reach to homes from industries. On the left side the turn of village it helps to that village. Along this highway the provisions for or restrictions on parking is not satisfactory in relation to traffic safety. There exist no signs or markings allowing or prohibiting parking. Parking manoeuvre is not well-suited with the safety of the highway. Parking on the carriageway/ shoulder creates congestion and compels through vehicles to use opposite lane on the highway. Illegal parking/ stoppage makes movement of through vehicles unsafe. Pedestrians are compelled to use shoulder and carriageway for walking and have to wait for vehicles at shoulder. Pedestrian crossing of the road becomes unsafe and pedestrians are unable to use walkway.

No independent parking space was provided on road side therefore, the vehicles parked randomly on road side and covered a very wide area of the road way. The trucks are waiting for their turn to load the material. Unlit Parked vehicles were observed which were posing surprise situations for running vehicles.

- D. In Front of and approx near to Shree Dadaji Institute of technology & science (SH26) Parking of vehicles at on the highway should be banned. In unavoidable circumstances (vehicle under repair), appropriate lighting should be arranged to make these vehicles visible

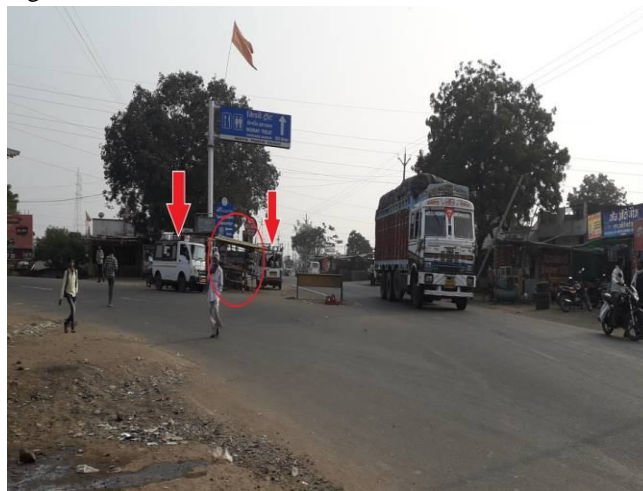
Figure 6:- Required junction improvement and Parking/ stoppage of vehicle on the intersection at SH 26 connects to SH 27 (T-intersection)

Figure 6 showed along this highway the provisions for or restrictions on parking are not satisfactory in relation to traffic safety. The sight distance at intersections and along the route is affected by parked vehicles. Parking/stoppage/ passenger boarding and alighting on the T-intersection congestion and compels through vehicles to use opposite lane on the highway. Illegal parking/ stoppage at junctions makes turning movements to/from highway unsafe. Illegal parking/ stoppage makes movement of through vehicles unsafe. Temporary shop on the carriageway at T-junction posing surprise situations for drivers Signboards, billboards, banners, posters etc on T-junction restricting sight distance.

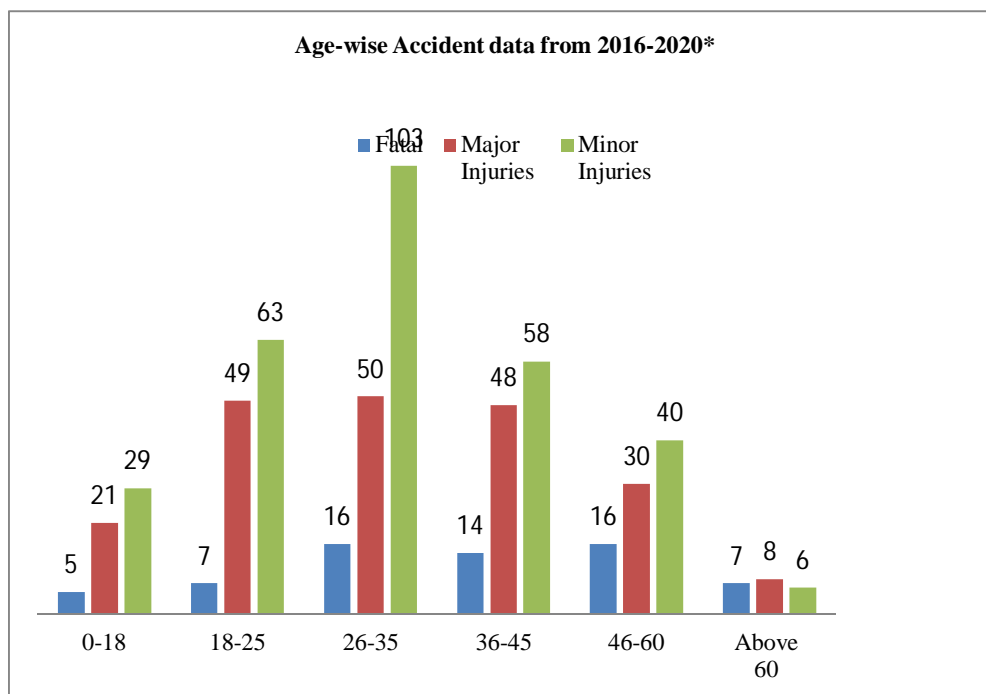
Graph 2 Graphically represent of Age Data

The data in Table reveals that road accident victims largely constitute young people in the age groups of 18 - 25, 25 - 35 and 35 - 45 and this age profile has remained the same in all the Five years i.e. 2016, 2017, 2018, 2019, 2020* underscoring major implications on economic cost of road accidents, apart from their emotional and psychological impact.
