Study on Process and Time Optimization using Flow Process Chart, Time Study and Critical Path

Abstract: *The main aim of the study is to learn and analyze the processes involved in engine repairing and reconditioning section at MSRTC, Central Workshop, Nagpur and to suggest possible Movements to optimize the process to increase efficiency and the output of the plant.*

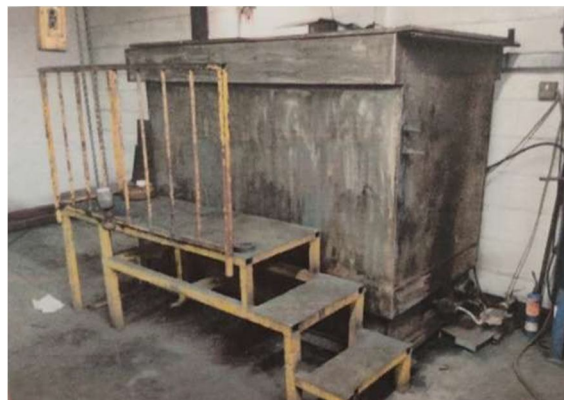
Fig. 3 Degreasing Chamber

In degreasing plant, separated parts and dump in degreasing tank, Trichloroethylene (C_2HCL_3) is poured in the tank and tank is then heated at constant temperature. Fumes generated in the tank helps in cleaning of parts.

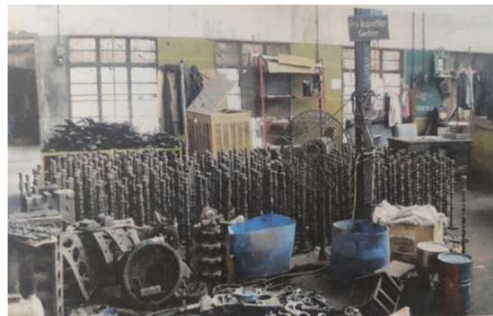
Fig.4 Pre inspection section

Dismantled parts are inspected in this section and the rejected parts are scrapped. The usable parts are then distributed to different sections. In this section the parts are also cleaned and inspected for any damage.

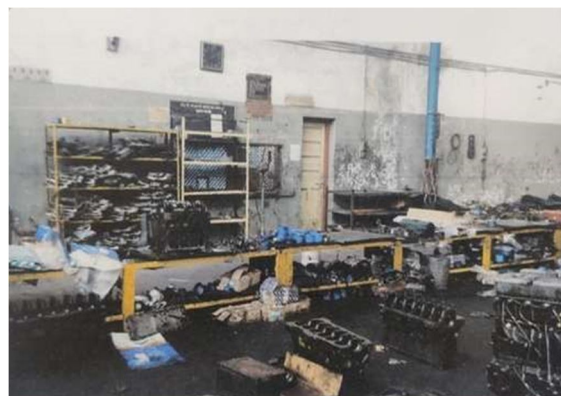
Fig. 5 Assembly area

Parts from different sections are brought and assembled in the assembly section.
