Comparative Study of High-Rise Residential Building for Progressive Collapse as per Indian & American Code

Anurag Jamankar¹, Prof. Atul B. Pujari²

^{1,2}ME Structure, KJCOMER, Pune, Savitribai Phule Pune University.

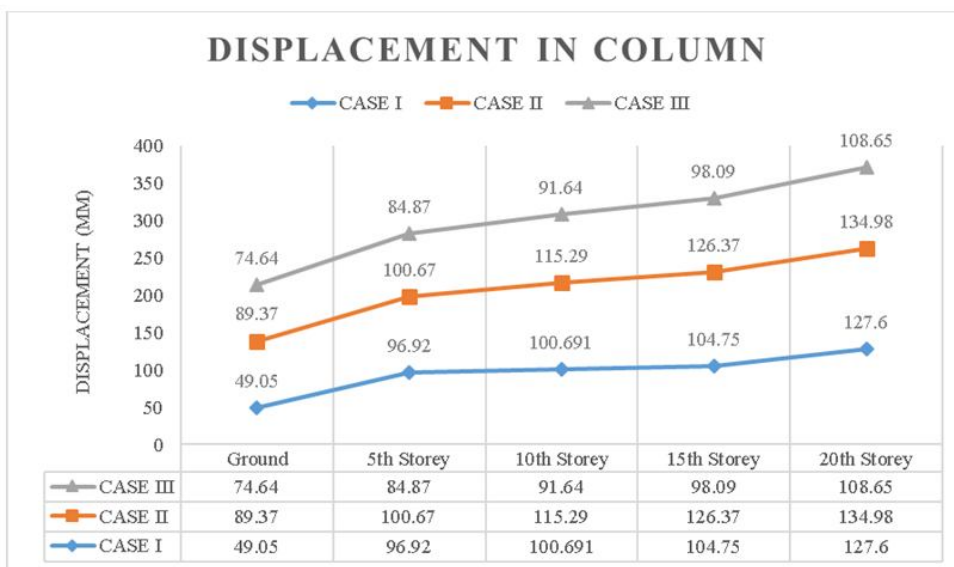
Fig 5. Displacement values in Column (IS Code)

Displacement chart shows the values of column joint displacement in various cases in both codal provisions. The parameters of both the codes were almost same except the fundamental timed period in case of earthquake. In IS code-based displacement values as the height of structure increased displacement got increased. If observed carefully both the charts it is observed that the case-II caused maximum displacement in column joint. Hence it can be also said that removal of column at the corner of structure may cause maximum damage to the structure. Discontinuity of column also breaks the load path distribution in the structure. In such cases alternative path method shall be applied

From above charts, it is observed that the Case-II i.e. removal of corner column of building shows maximum displacement compared to other two. But DCR values in such cases also can be increased and reasons are many for such case. One of the most important reasons for progressive collapse is the strong beam and weak column. Column is the member which supposed to support beams and beams supposed to support slab. But if beam provided is stronger than the column then there is definite failure of structure. Also, Load distribution path completely changes when discontinuity in any structural member is breaks
