# **An Experimental Study of Modal Parameter of Cantilever Beam with Various Cracked Condition**

Mr. Pramod Kumar<sup>1</sup>, Dr. Sankha Bhaduri<sup>2</sup>, Dr. Arbind Kumar<sup>3</sup>

<sup>1,2,3</sup>Department of Mechanical Engineering, Birla Institute of Technology Mesra, Jharkhand, India

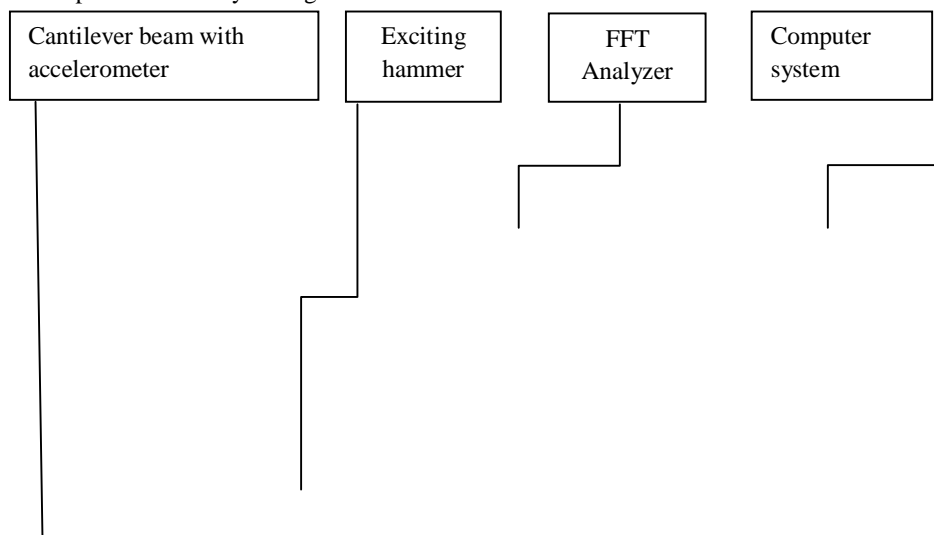
Figure1: Experimental set up

For experimental analysis of beam one end of cantilever is fixed in between two rectangular plates and other end is free as shown in fig 1. An accelerometer is placed on the beam to analyze its vibration through FFT Analyzer. FFT Analyzer further connects with computer system to display the graphical analysis of beam. Beam is analyzed in damaged and un-damaged condition. Crack in beam was generated through hexa blade whose thickness is 1mm (approximately). For vibration analysis of a cracked beam, single open transverse rectangular crack with minimum 2mm depth and width 1mm is considered. The initial position of crack is taken at a location of 100mm from fixed end. Later, for comparative analysis the position of crack is varied from 100mm to 300mm and depth of crack also varied from 2mm to 10mm. Cantilever beam is also analyzed with multiple cracks. The output of experimental analysis is compared with finite element analysis of beam in ANSYS software and it holds good.

All the experiments of this study were conducted in the Central Instrumentation Facility (CIF) Lab of BIT, Mesra, Ranchi and the results obtained from those experimental set up were compared with the finite element analysis. The photograph of the experimental setup is taken in CIF Lab.
